## 5. FLOOD/MUDFLOW INUNDATION ANALYSIS

### Formulation of Flood Inundation Scenario

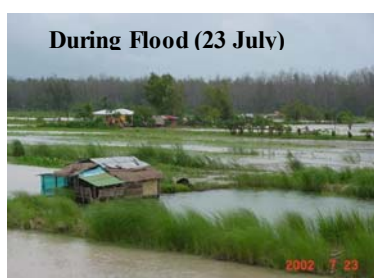
All revetments of the right side dikes in the Bucao River were destroyed during the rainy season in 2002. In the downstream sections of the Bucao River, clearance between the riverbed and the dike crest is less than 2.0 m because the level of the riverbed has risen by 1.5 m. A breach of a part of the dike in the Maloma River was observed in 2001 and 2002 and it has not been repaired yet. In addition, water flow is restricted at the Maloma Bridge during floods, which causes overflow and floods on the right side of the river every year. Several hectares of agricultural land were inundated on the left side downstream of the Maculcol Bridge due to a breach of the dike in July 2002. Areas on the left side 3.5 km upstream of the Maculcol Bridge were also inundated in 2000. Characteristics of floods in July 2002 are summarized in Table 5.1. It is noted that the same section was again breached by small flood on 9 August 2003 and the land side areas were buried by sediment.

**Damaged Dike in the Bucao River**

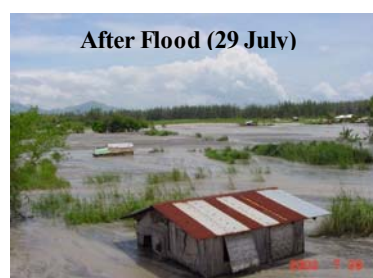
**Agricultural Land Buried by Sediment due to Breach of Left Side Dike in the Downstream of the Sto. Tomas River in July 2002**
