## 8. MASTER PLAN FOR COMMUNITY DISASTER PREVENTION PROGRAM

## 9. ECONOMIC EVALUATION, SELECTION OF PRIORITY PROJECTS AND IMPLEMENTATION SCHEDULE OF MASTER PLAN

## 10. FEASIBILITY DESIGN FOR THE PRIORITY PROJECTS

### 10.1 Dike Heightening and Strengthening in the Lower Bucao River

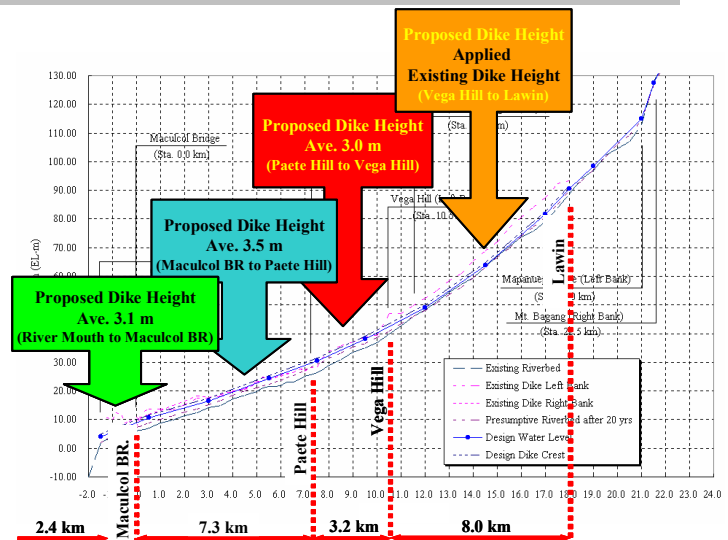
Figure 10.7 Design Dike Profile in the Sto. Tomas River

The same approach as applied to the Bucao River was taken to determine the design flood level and dike profile for the Sto.Tomas River. They are, 1) to estimate future riverbed profile in 2023 by long-term riverbed movement analysis, 2) to conduct non-uniform flow analysis to seek the design flood level under 20-year probable flood, 3) to set the freeboard of 1.0 m on the design flood level, and 4) to design the dike profile. Figure 10.7 shows the results of the design dike profile and average dike height from the present riverbed elevation.

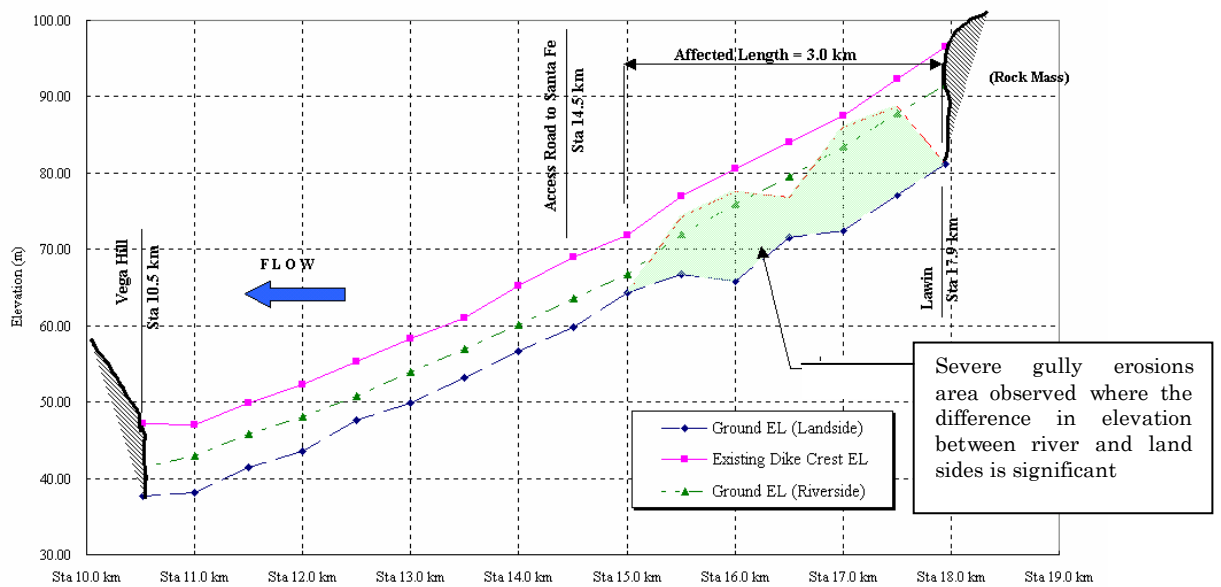
**Figure 10.9 Riverbed and Land Profile at the Middle Reach of the Sto.Tomas River**

Figure 10.9 shows the different elevation of the riverbed and the landside on the left bank of the Sto.Tomas River. The gully erosion is observed on the upstream sites as shown in Figures 10.10 and 10.11, which illustrate the remarkable differences in the elevation between the riverbed and inland side. According to the local people, the seepage water spouts out from the dike slope during the rainy season.

Plenty of deep gully erosions are observed on the existing inland slope of the dike in the middle reaches of the Sto.Tomas River. The gully erosion is not caused by rainfall but is due to the outlet of seepage water on the inland side slope. The erosion at the seepage outlet occurs on a small scale and then develops upslope. The riverbed elevation is about 7 m higher than the land, and the seepage water from the river side through the existing dike is remarkable. There is further concern that slope erosion may be caused by the piping through the dike or boiling.
