THE GOVERNMENT OF THE PHILIPPINES
THE DEPARTMENT OF PUBLIC WORKS AND HIGHWAYS

The Study on Sabo and Flood Control for Western River Basins of Mount Pinatubo in the Republic of the Philippines

JAPAN INTERNATIONAL COOPERATION AGENCY

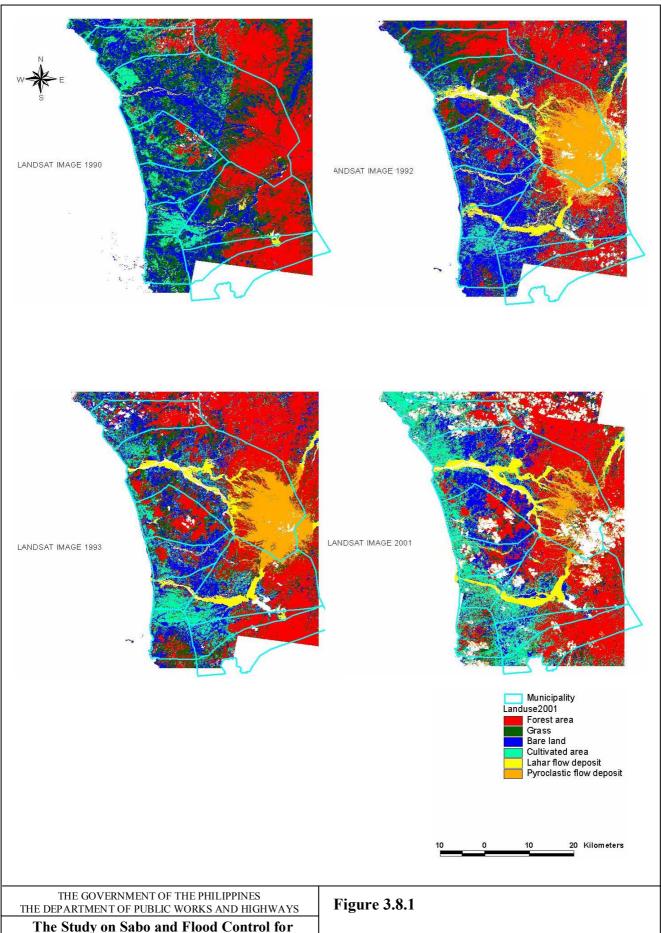
Change Land Use Condition after the Eruption of Mount Pinatubo
