THE GOVERNMENT OF THE PHILIPPINES  
THE DEPARTMENT OF PUBLIC WORKS AND HIGHWAYS

**The Study on Sabo and Flood Control for  
Western River Basins of Mount Pinatubo in  
the Republic of the Philippines**

JAPAN INTERNATIONAL COOPERATION AGENCY

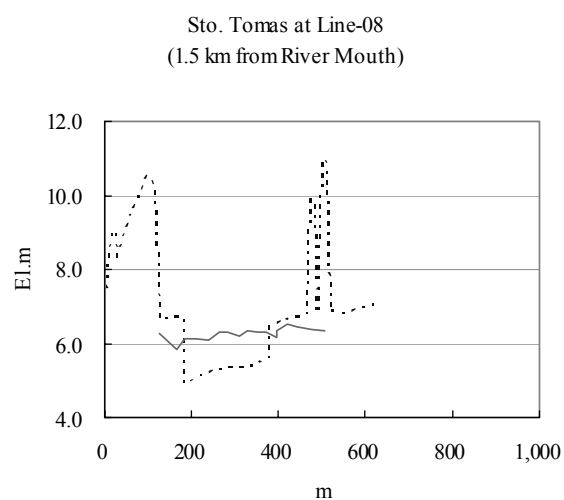
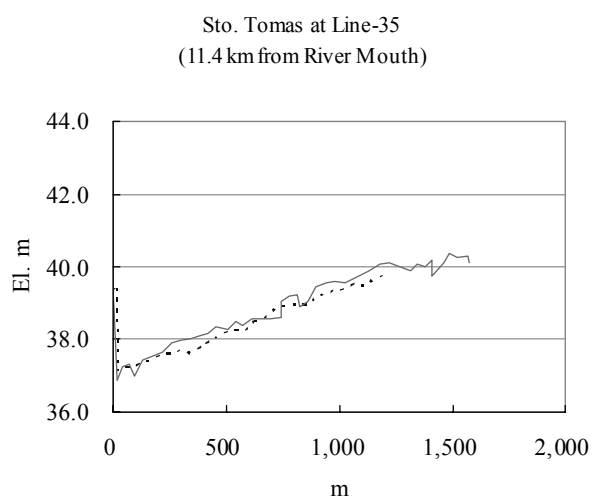
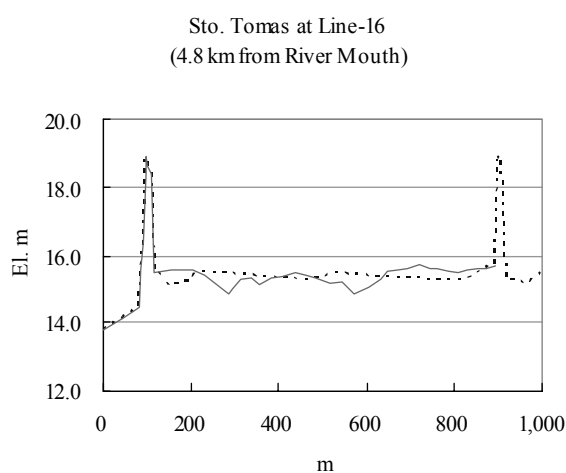
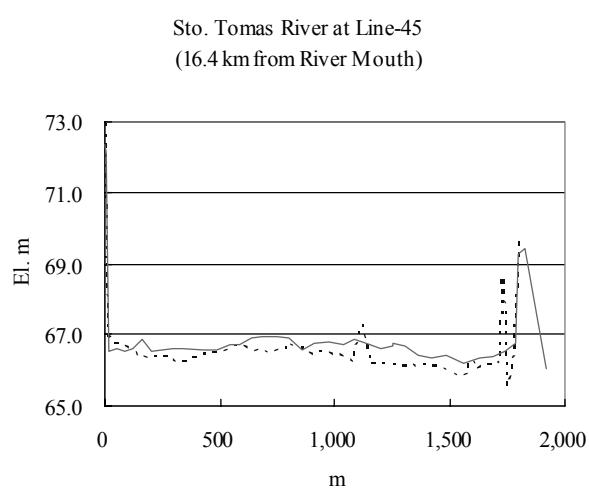
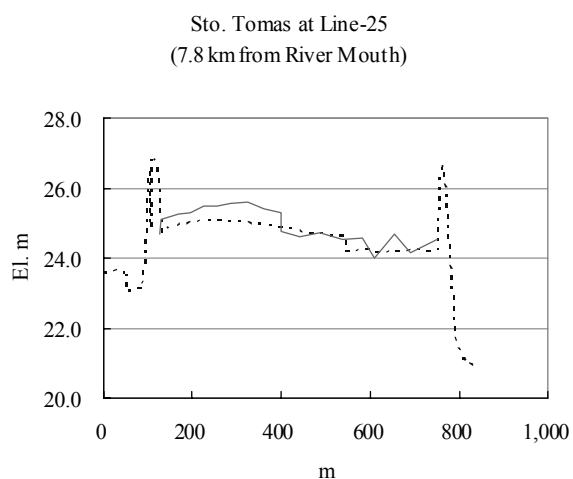
**Figure 6.2.4**

----- Before July 2002    ——— After July 2002

**Comparison of River Cross Sections before  
and after the Flood in July 2002 in the Sto.  
Tomas River**

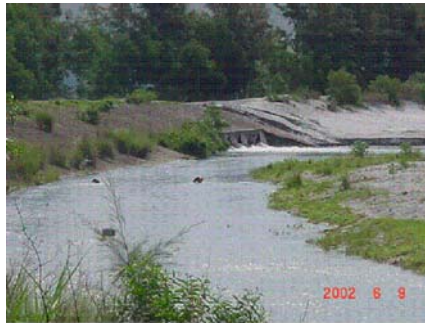
Photo 2. Checkpoint No.2 (before Flood)

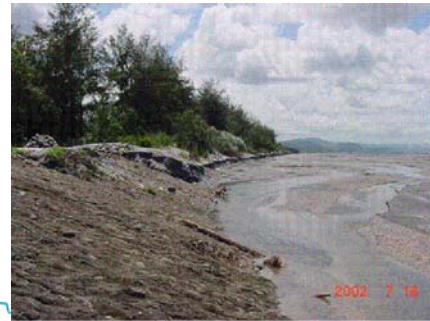
Photo 3. Checkpoint No.2 (after Flood)

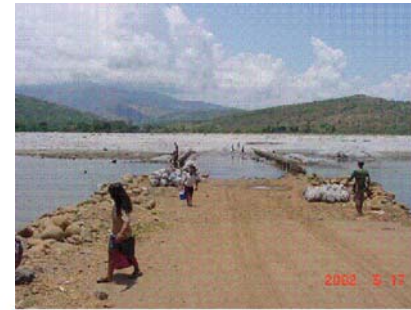
Photo 4. Checkpoint No.3 (before Flood)

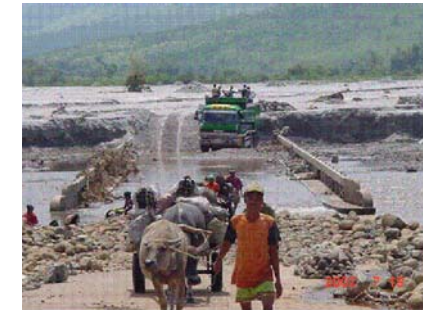
Photo 5. Checkpoint No.3 (after Flood)

The existing culvert structure was completely buried due to sediment deposition caused by the lahar in July 2002 (sediment depth: 2 m)

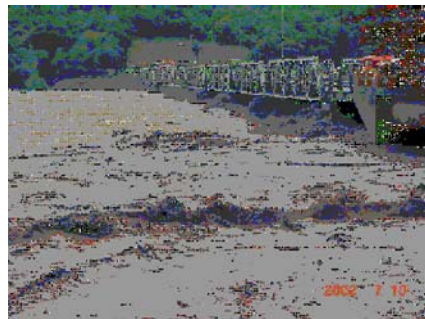
Photo 1. Bucao Bridge during the Lahar on 10 July 2002 (Checkpoint No.1)

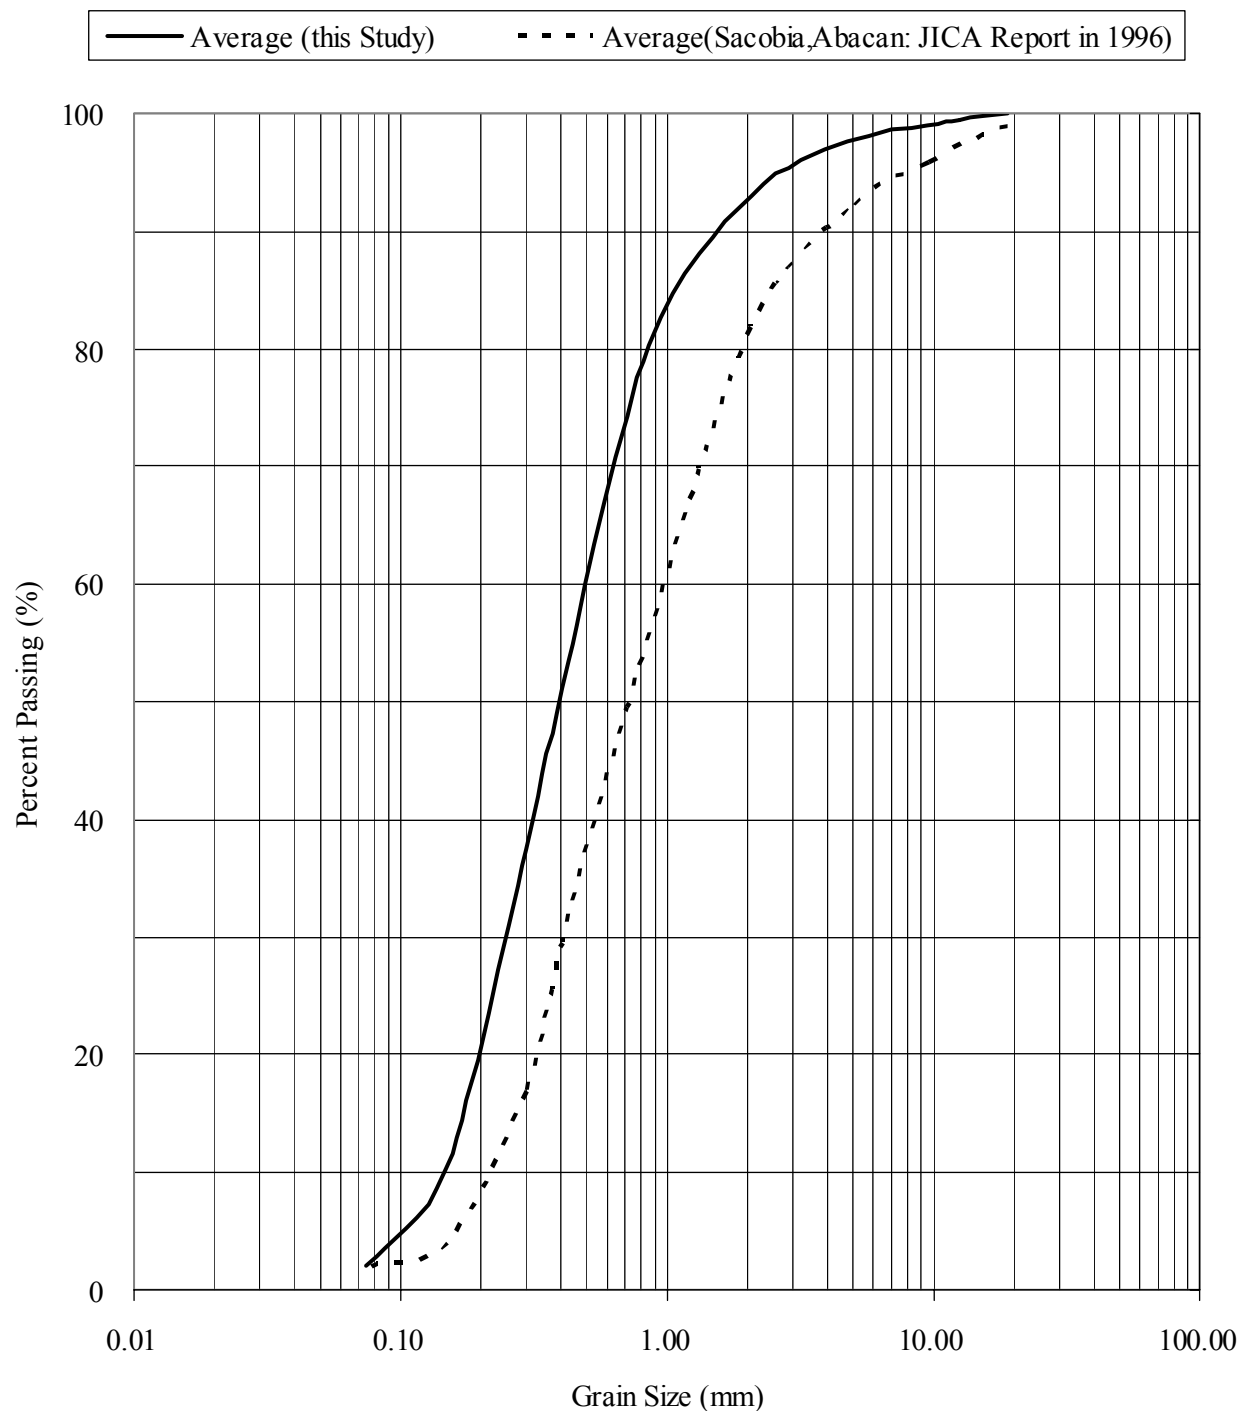
**Figure 6.3.2**

Note : L= Distance from River-mouth  
D = Mean Grain Size

**Grain Size of Riverbed Materials in the Study  
Area**
