THE GOVERNMENT OF THE PHILIPPINES  
THE DEPARTMENT OF PUBLIC WORKS AND HIGHWAYS

**The Study on Sabo and Flood Control for  
Western River Basins of Mount Pinatubo in the  
Republic of the Philippines**

*JAPAN INTERNATIONAL COOPERATION AGENCY*

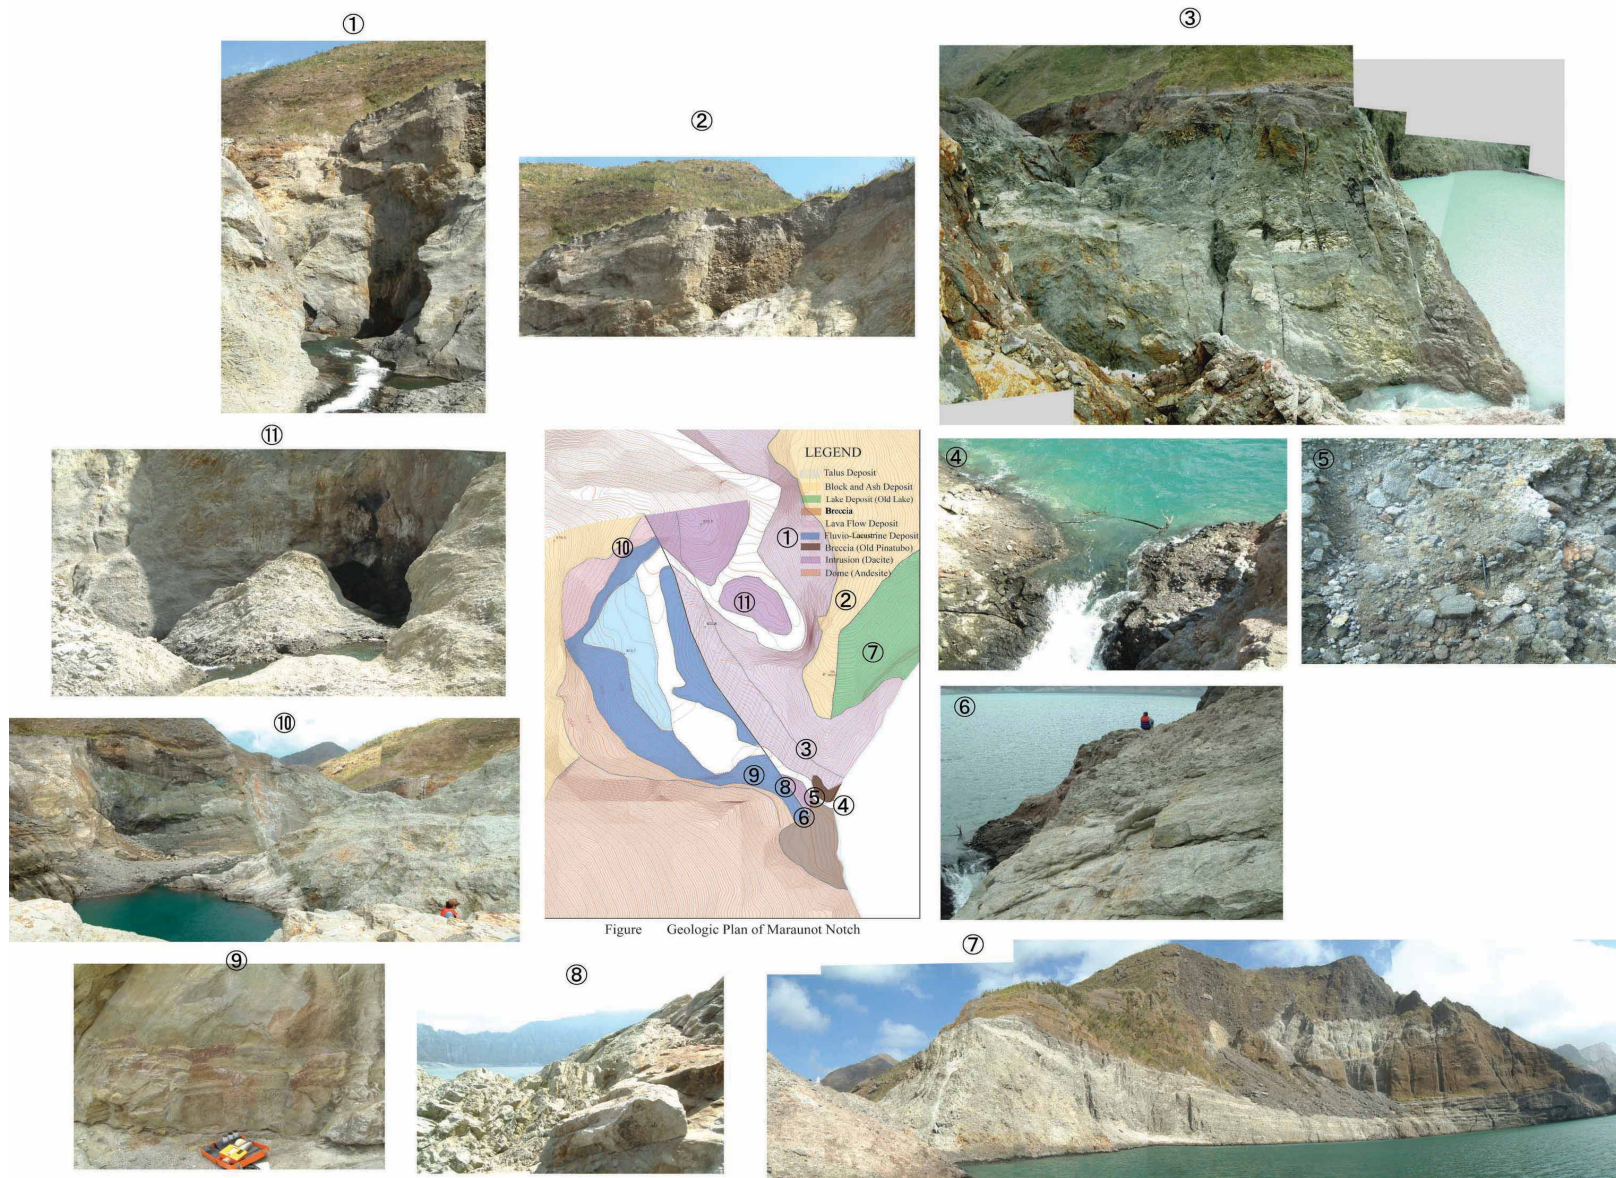
Figure Geologic Plan of Maratunot Notch

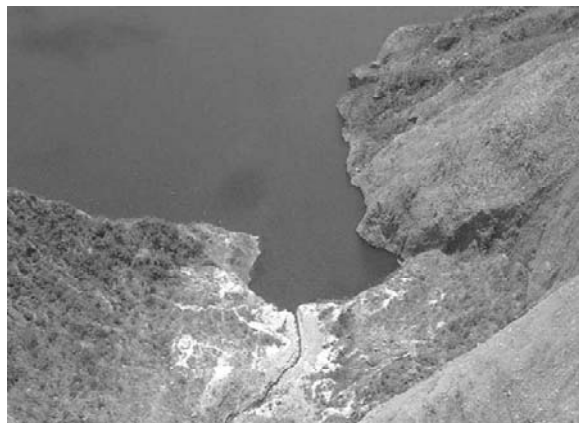
**Figure 8.8.3**

Before Breach

Aerial Photograph of Maraunot Notch

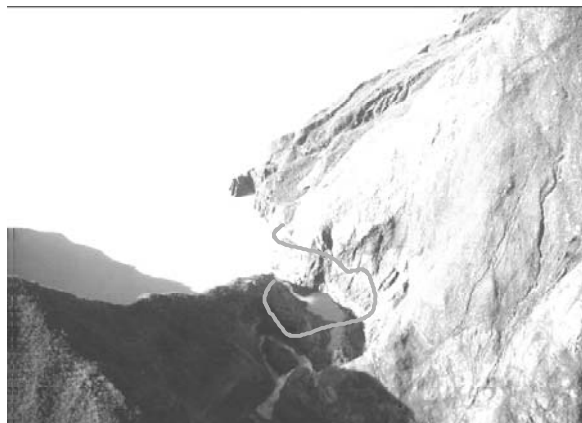
After Breach

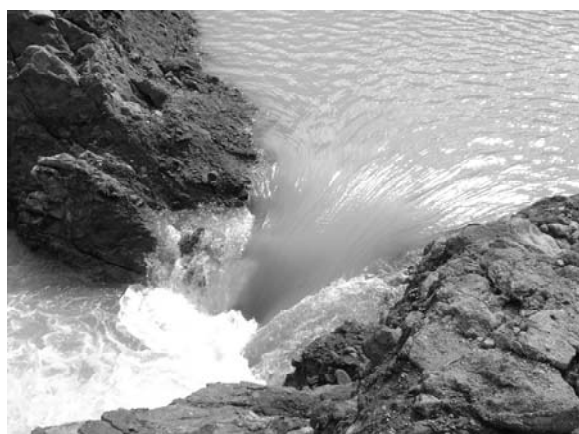
30 July 2002

Current Condition of Maraunot Notch
