THE GOVERNMENT OF THE PHILIPPINES
THE DEPARTMENT OF PUBLIC WORKS AND HIGHWAYS

**The Study on Sabo and Flood Control for
Western River Basins of Mount Pinatubo in the
Republic of the Philippines**

JAPAN INTERNATIONAL COOPERATION AGENCY

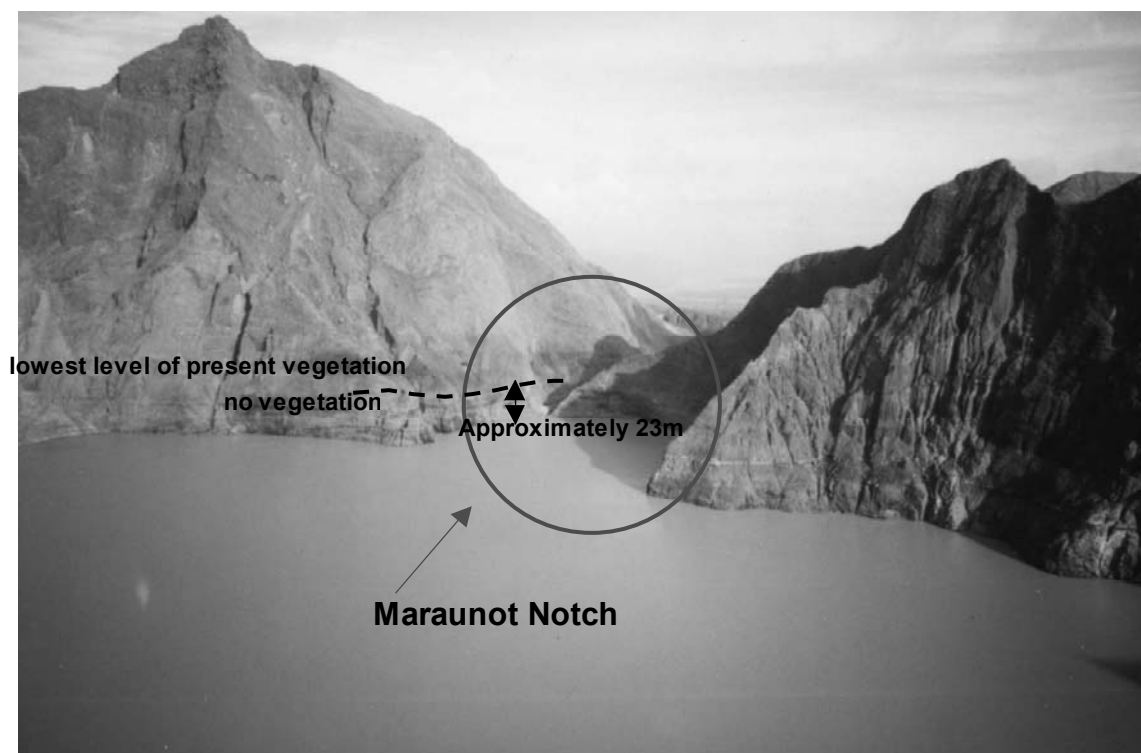
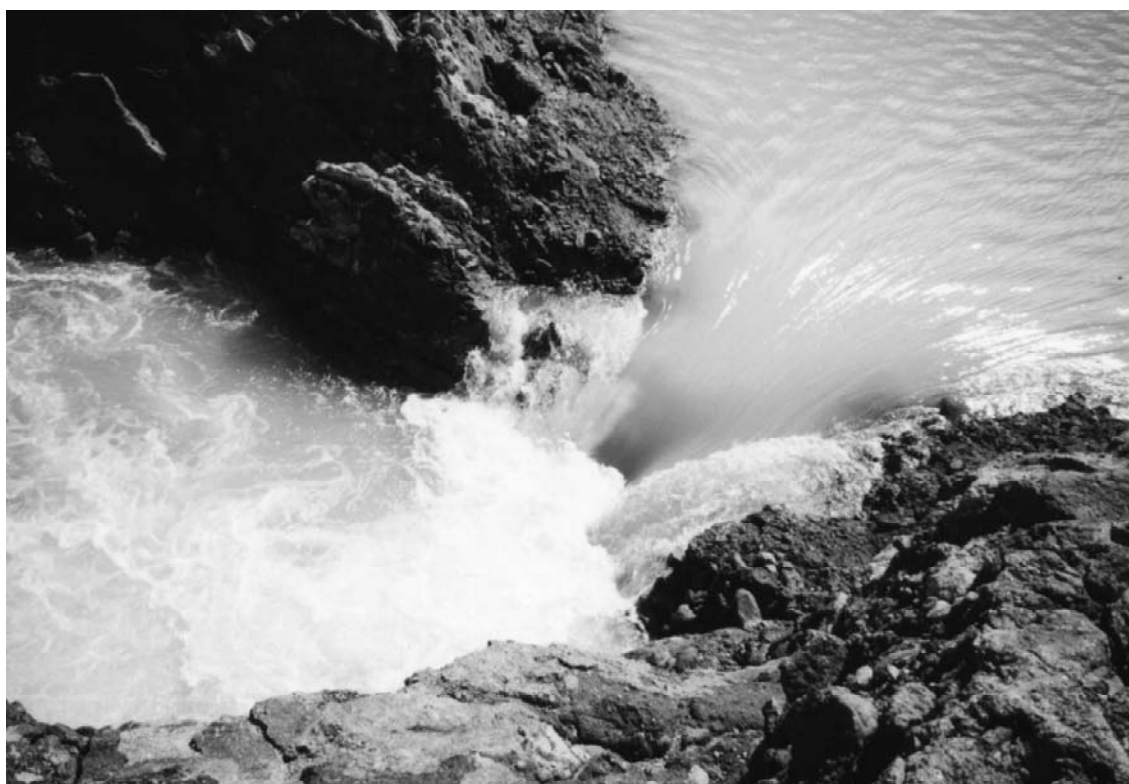
Figure 8.8.4

**The Condition of Maraunot Notch and Close
Up of Notch (30 July 2002)**

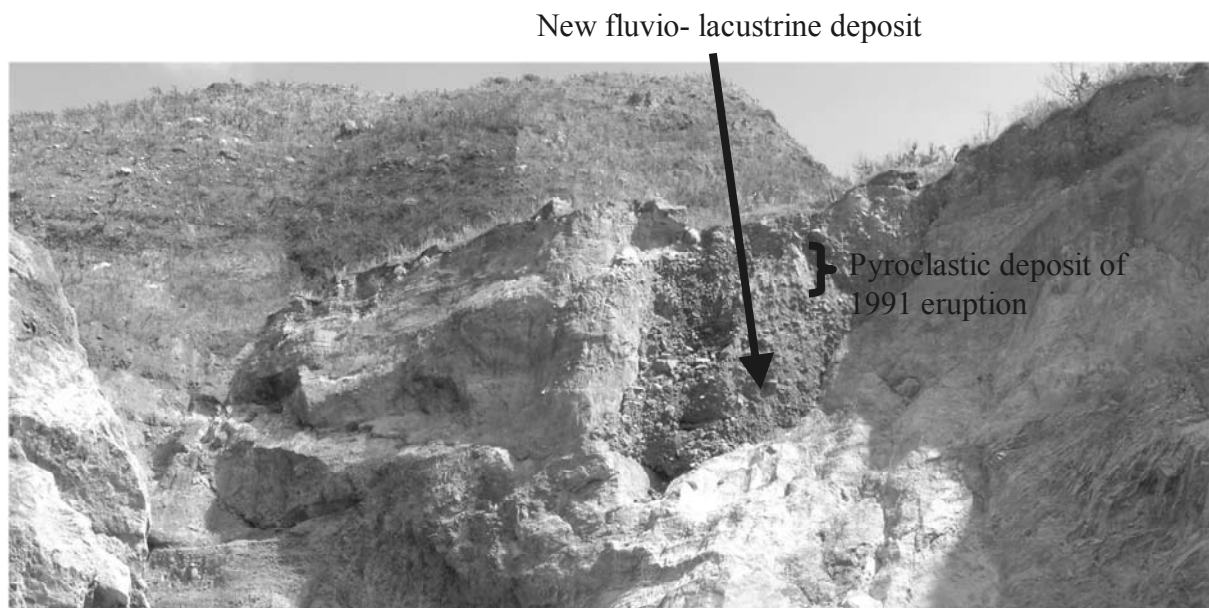
The upper side of the cave existing about 100 m downstream from the Notch

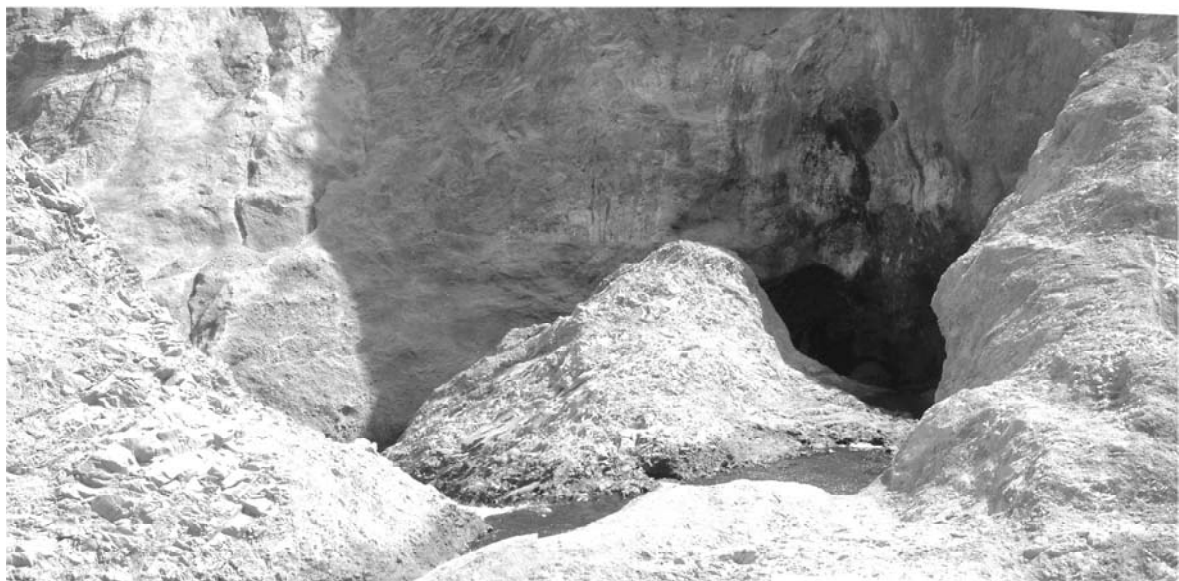
The cave existing about 100 m downstream from the Notch
