*The Study on Sabo and Flood Control for Western River Basins of Mount Pinatubo  
in the Republic of the Philippines  
Final Report  
Supporting Report*

**The Study on Sabo and Flood Control for  
Western River Basins of Mount Pinatubo in the  
Republic of the Philippines**

*JAPAN INTERNATIONAL COOPERATION AGENCY*

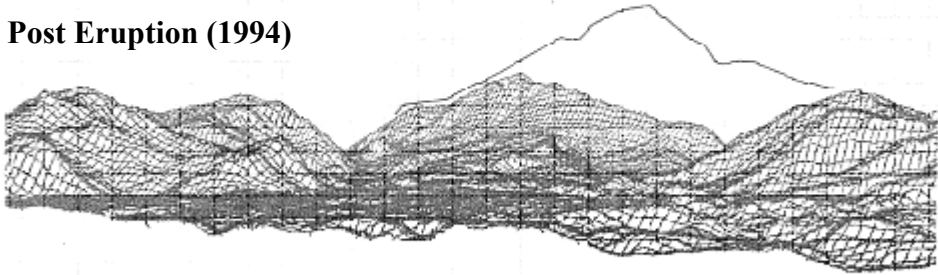
**Figure 1.1.2**

**a) View from Clark Field**

**b) View from Watch Point No.5 of the Pasig River**

**View of Mount Pinatubo before and after  
Eruption**
