Figure 2.4.2
**Geologic Map and Typical Photograph of
 Each Geology**

**The Study on Sabo and Flood Control for
 Western River Basins of Mount Pinatubo in the
 Republic of the Philippines**

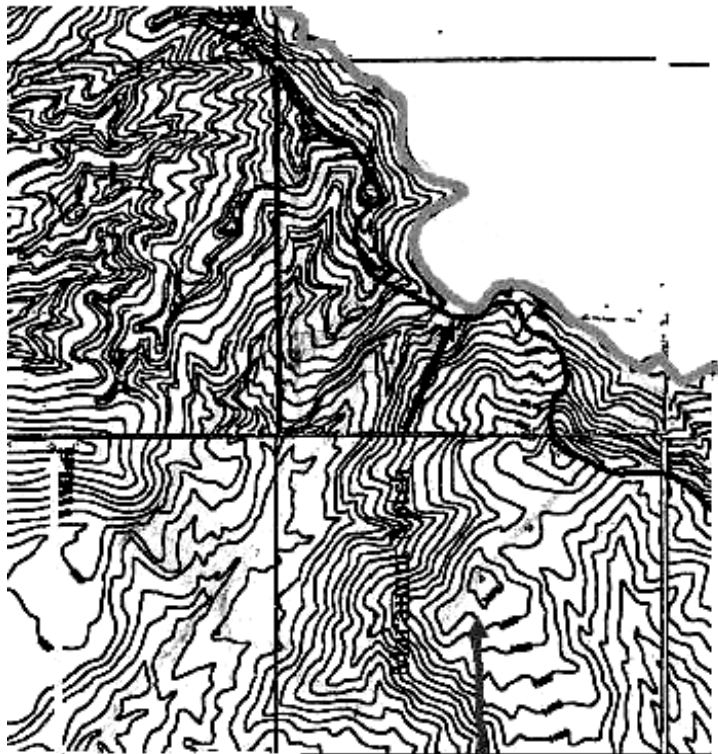
Figure 2.4.3

After Eruption
 (Topographic map prepared for
 this study based on aerial photos
 taken in May and June 2002.)

**Comparison of Topography of Maraunot
 Notch before and after Eruption**

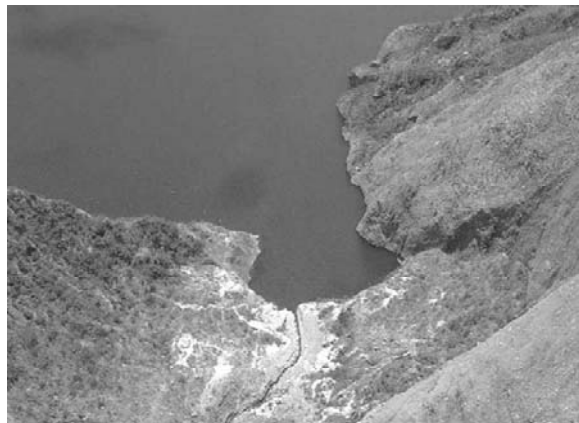
Figure 2.4.4

Before Breach

Aerial Photograph of Maraunot Notch

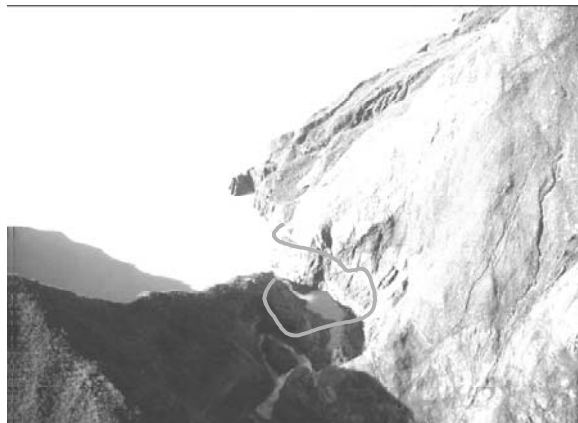
After Breach

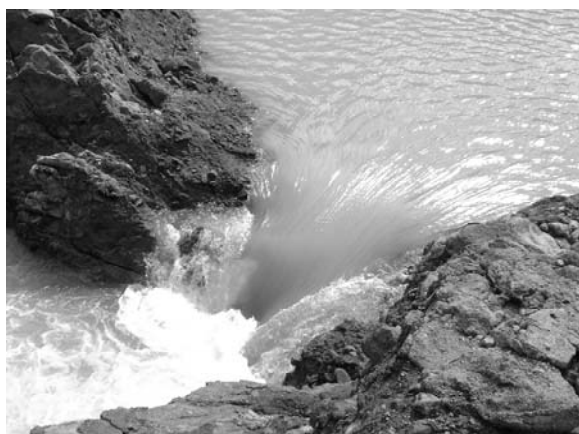
30 July 2002

Current Condition of Maraunot Notch
