THE GOVERNMENT OF THE PHILIPPINES
THE DEPARTMENT OF PUBLIC WORKS AND HIGHWAYS

**The Study on Sabo and Flood Control for
Western River Basins of Mount Pinatubo in the
Republic of the Philippines**

JAPAN INTERNATIONAL COOPERATION AGENCY

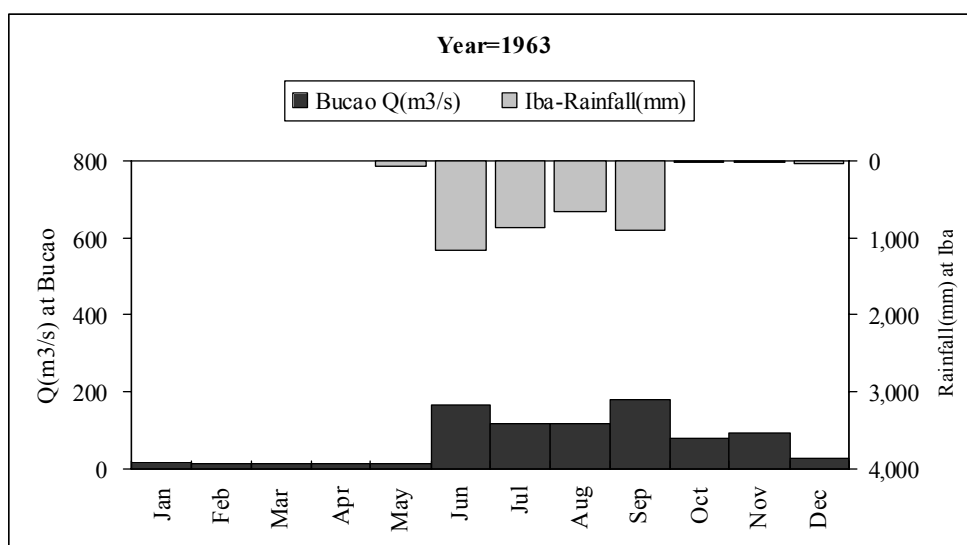
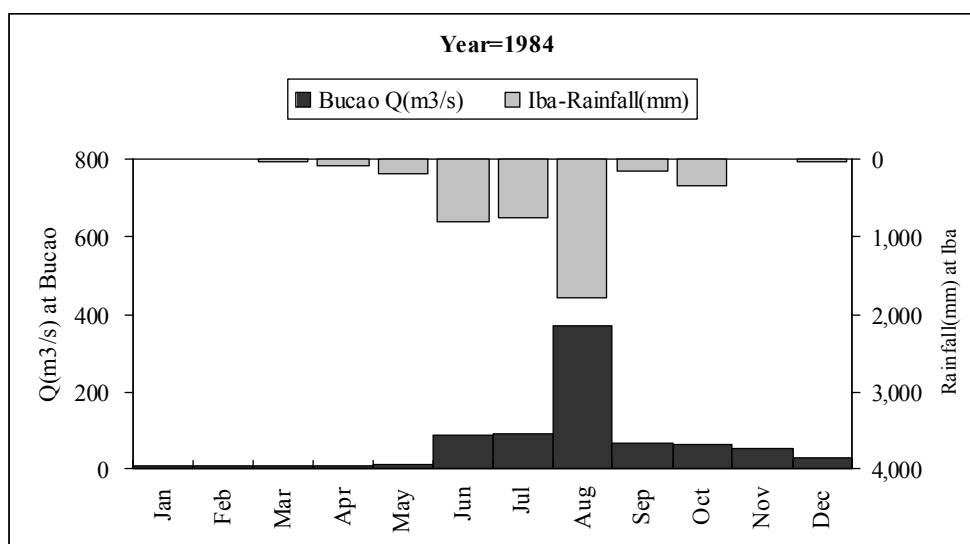
Figure 4.1.1

Month	1963		1984	
	Rainfall(Iba) (mm)	Discharge (m3/s)	Rainfall(Iba) (mm)	Discharge (m3/s)
Jan	0.0	15.2	0.0	9.3
Feb	1.1	13.4	0.0	9.1
Mar	0.0	12.4	16.7	9.1
Apr	1.5	11.3	75.7	9.0
May	69.3	13.5	195.1	11.0
Jun	1,166.0	167.7	801.8	86.2
Jul	880.3	118.4	738.4	91.2
Aug	673.2	116.8	1,787.6	369.4
Sep	891.0	180.7	135.0	67.1
Oct	30.6	77.3	326.5	62.0
Nov	20.3	93.3	10.0	53.8
Dec	50.8	23.6	20.4	28.1
Total	3,784.1		4,107.2	
Average		70.3		67.6

**Monthly Rainfall and Discharge in the Bucao
River in 1963 and 1984**

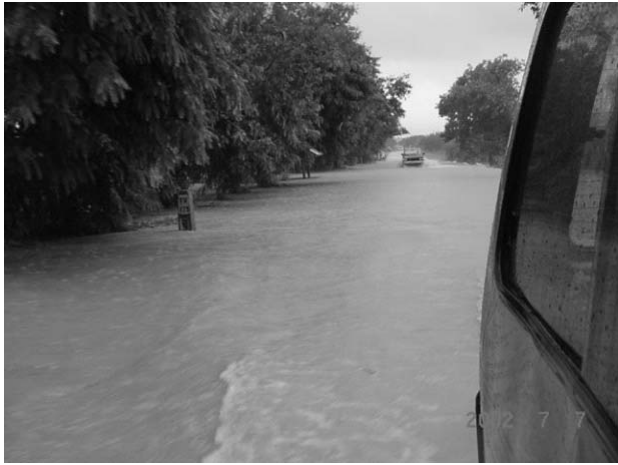
(1) Overflow from Maloma River to No.7 National Highway (on Right Side)

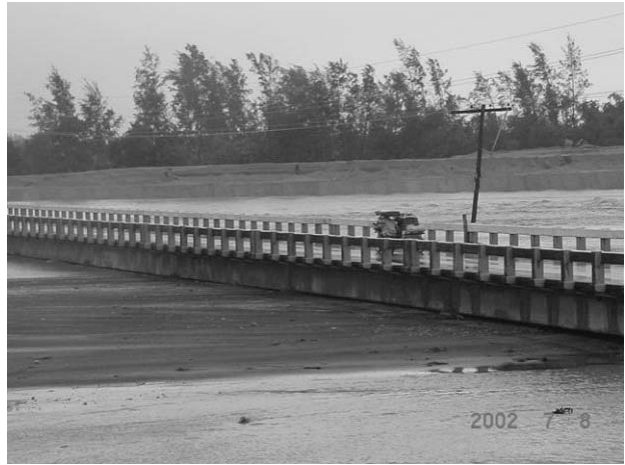
(2) Maculcol Bridge on July 8, 2002

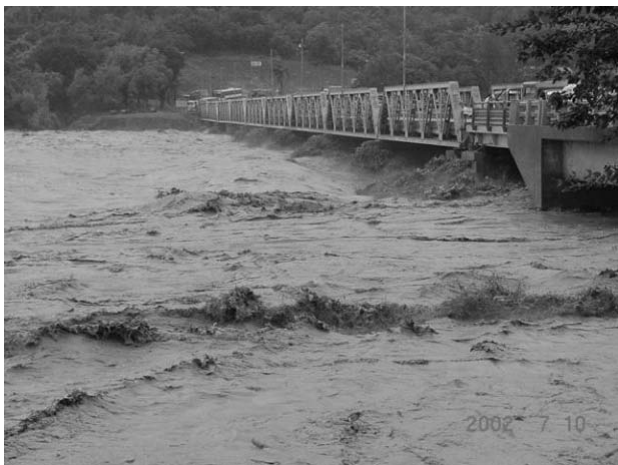
(3) Lahar at the Bucao Bridge (2 Hours after Peak of Lahar Flow)

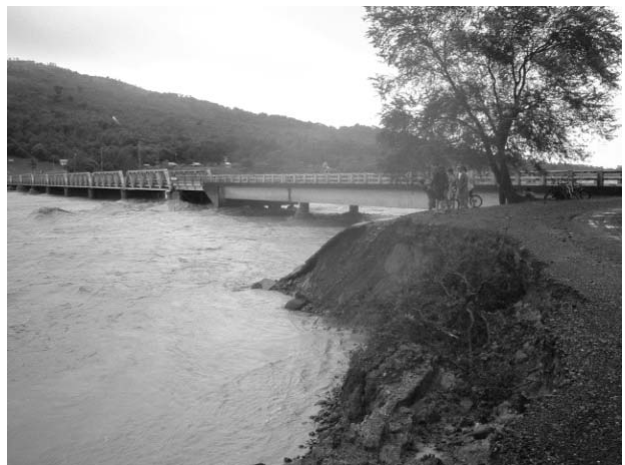
(4) Erosion of Dike at the Bucao Bridge on July 13, 2002 (Right Bank)

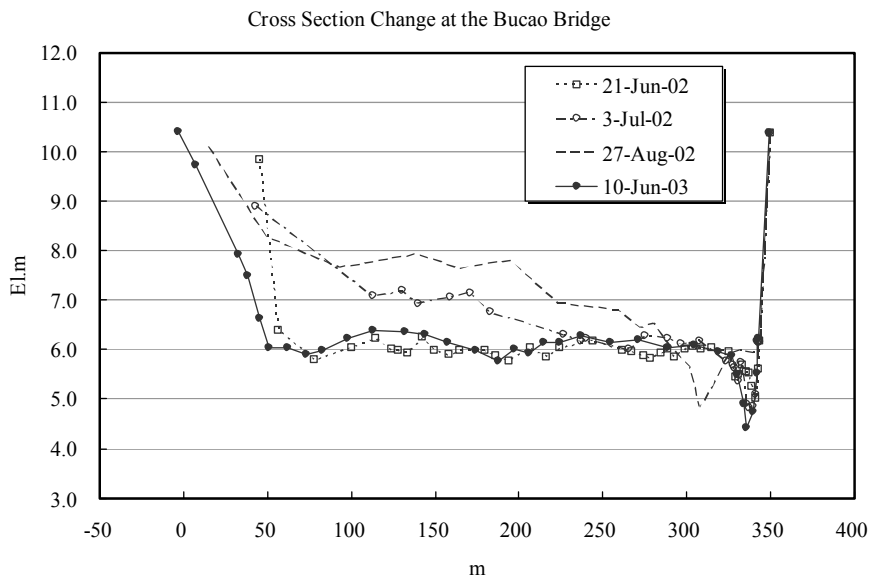
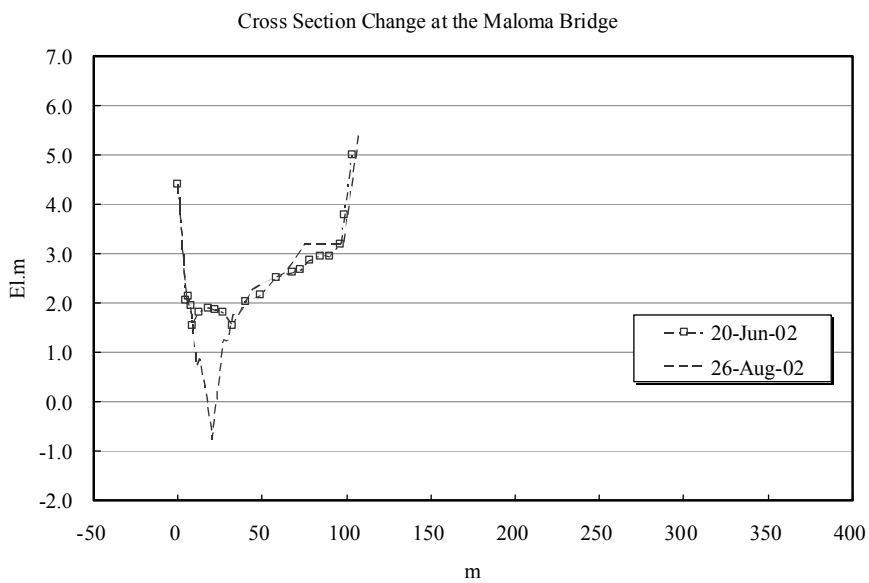
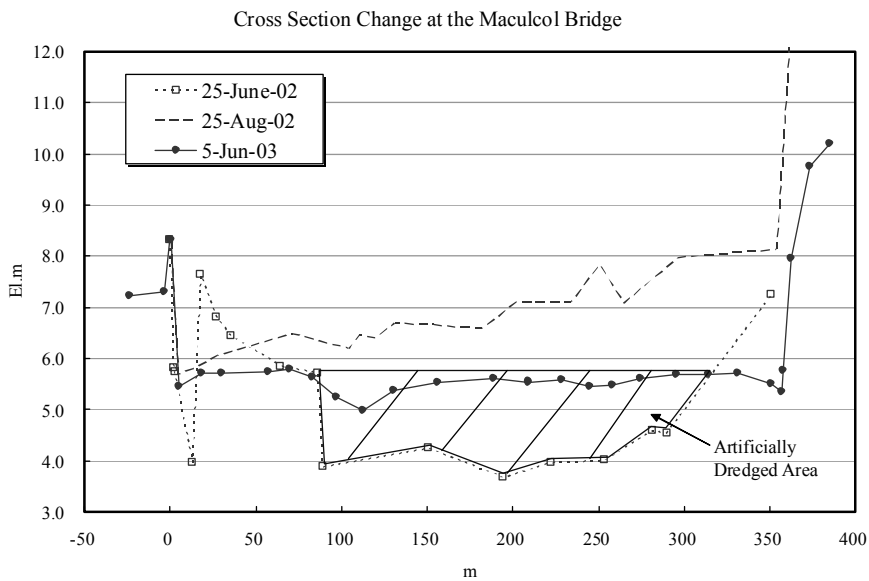
Figure 5.3.2

**Cross Section Change at the Bucao, Maloma
and Maculcol Bridges**

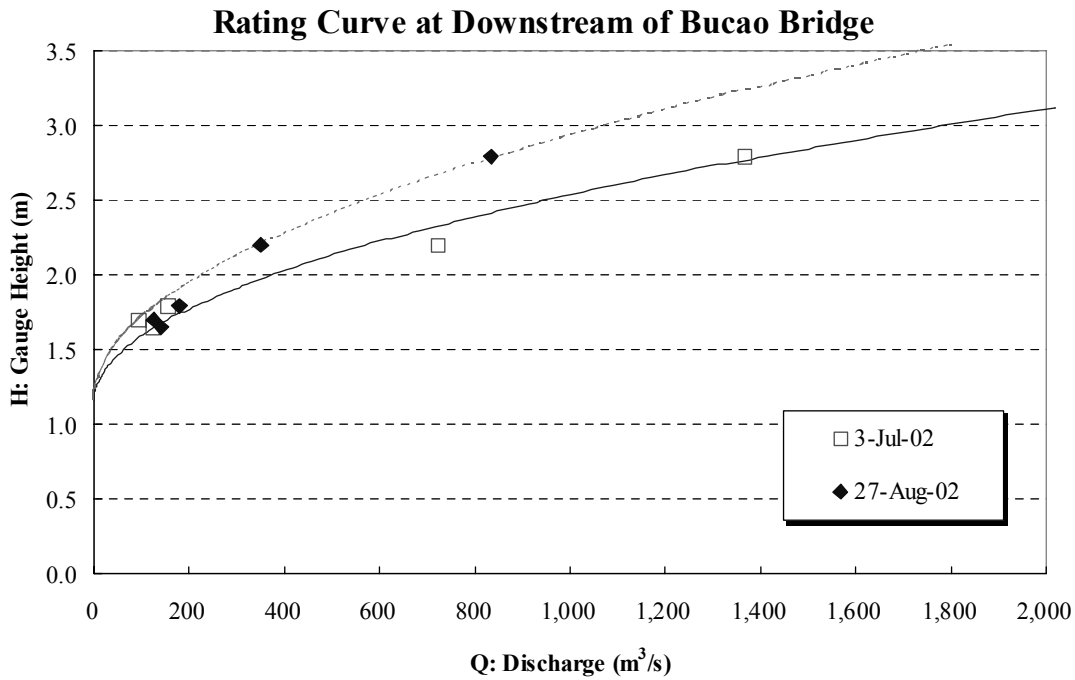
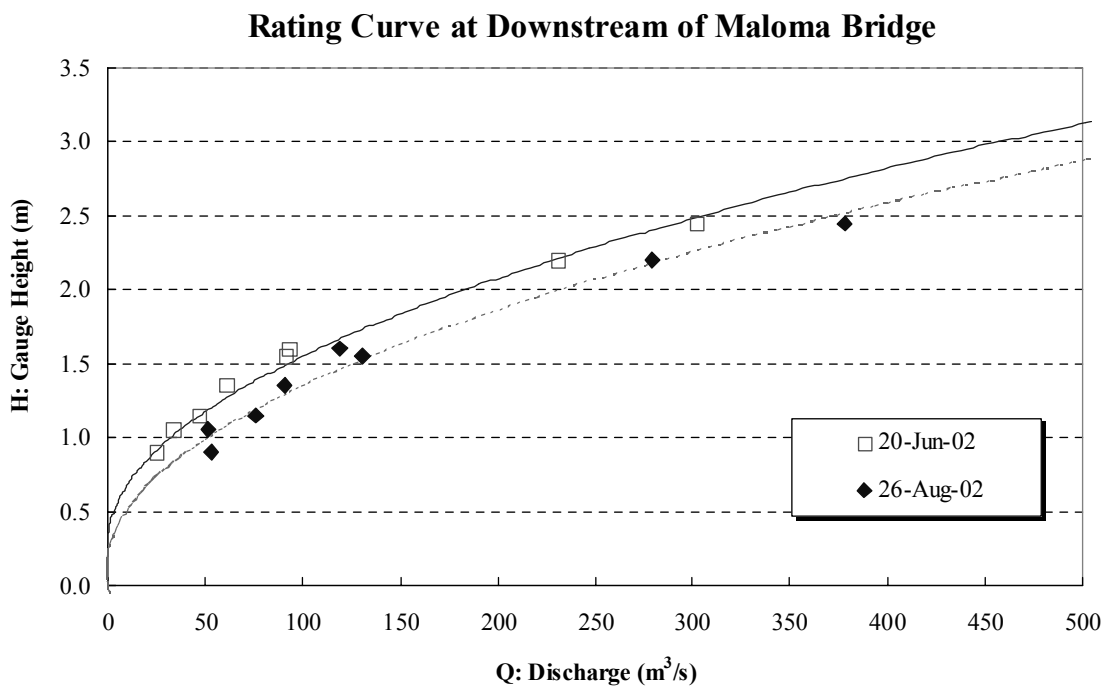
Figure 5.3.3

**Rating Curve at the Bucao and Maloma
Bridges**

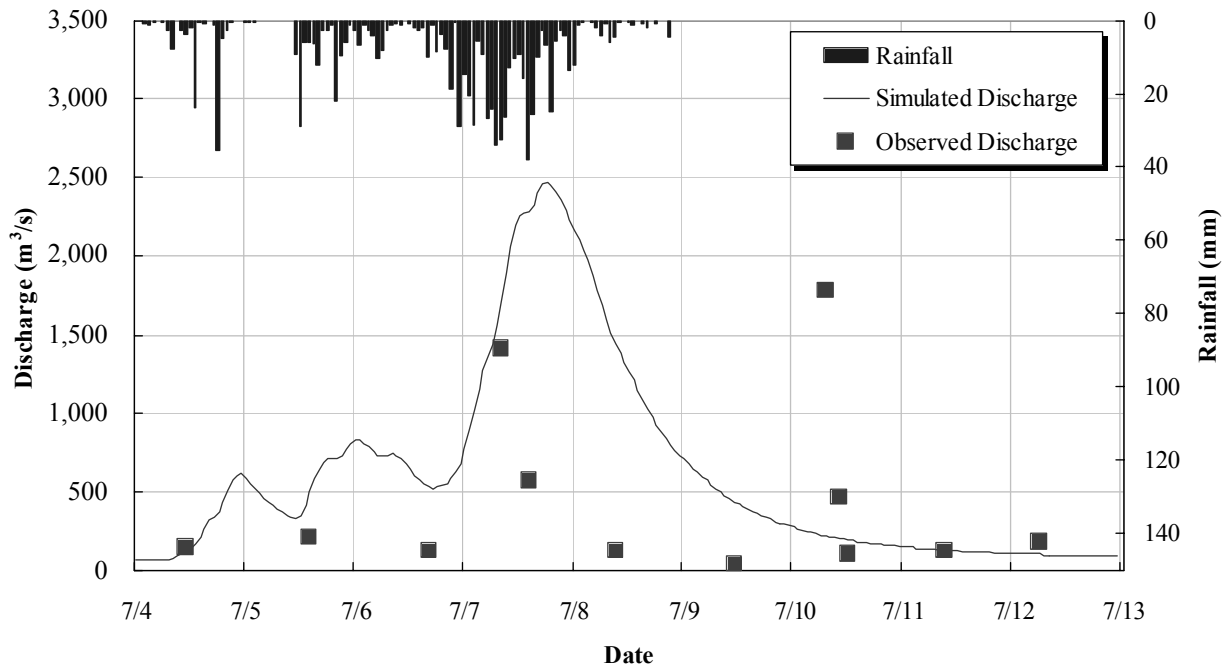
Simulated and Measured Discharge at Bucao Bridge

**Observed and Simulated Discharge during
Flood in July 2002**

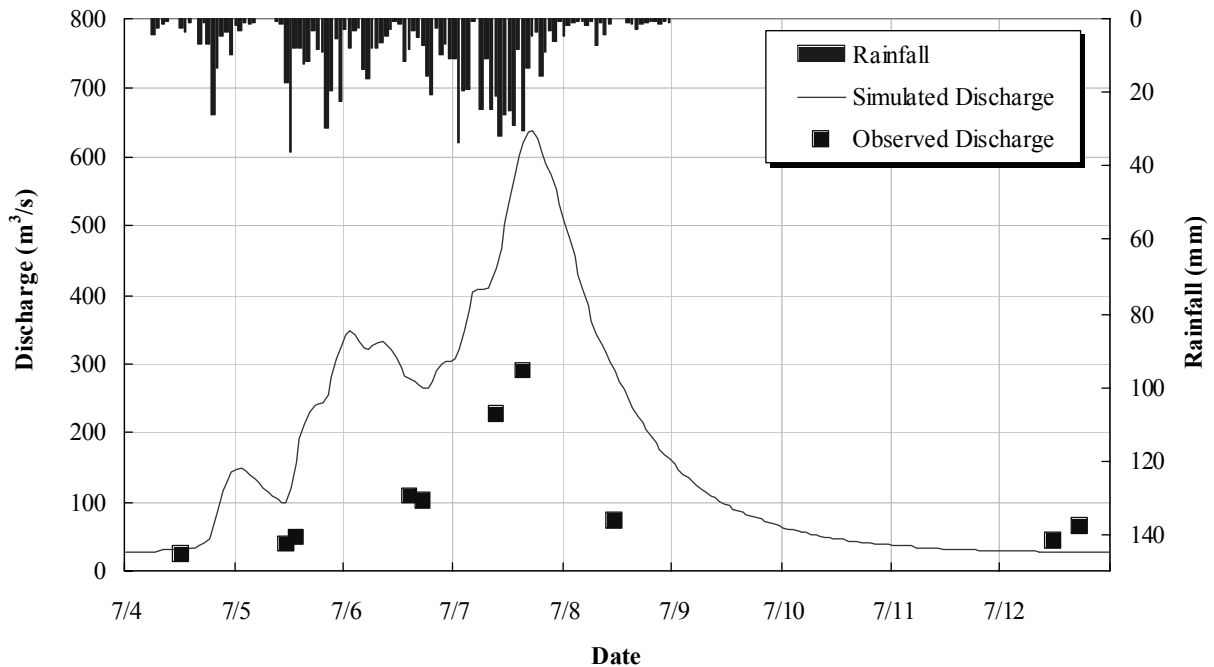
Simulated and Measured Discharge at Maloma Bridge

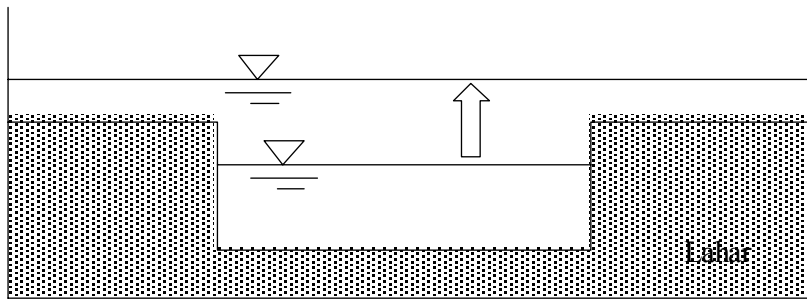
Discharge Measurement during Flood in July 2002

River Cross Section

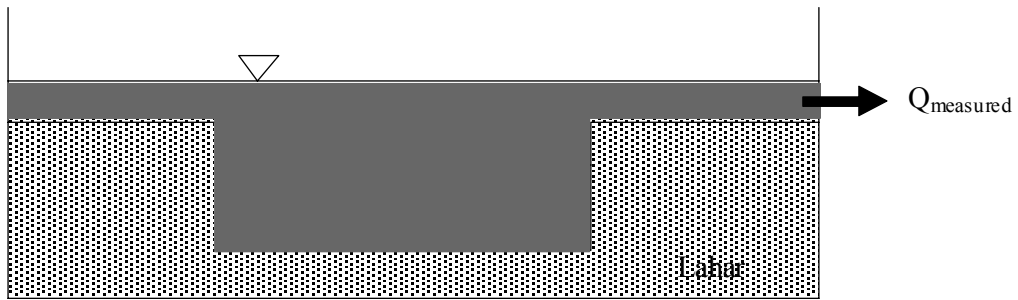
a) Without Considering Seepage into Lahar Deposits

$$Q_{\text{actual}} > Q_{\text{measured}}$$

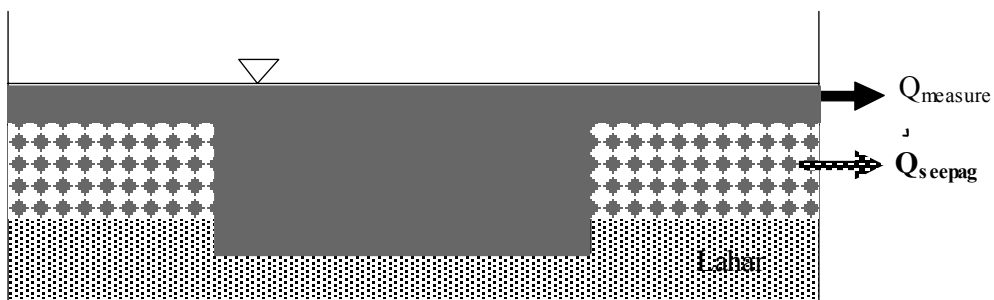
Figure 5.3.5

b) With Seepage into Lahar Deposits (Storage Effect of Lahar Deposits)

$$Q_{\text{actual}} = Q_{\text{measured}} + Q_{\text{seepage}}$$

Assumed Storage Effect of Lahar Deposits

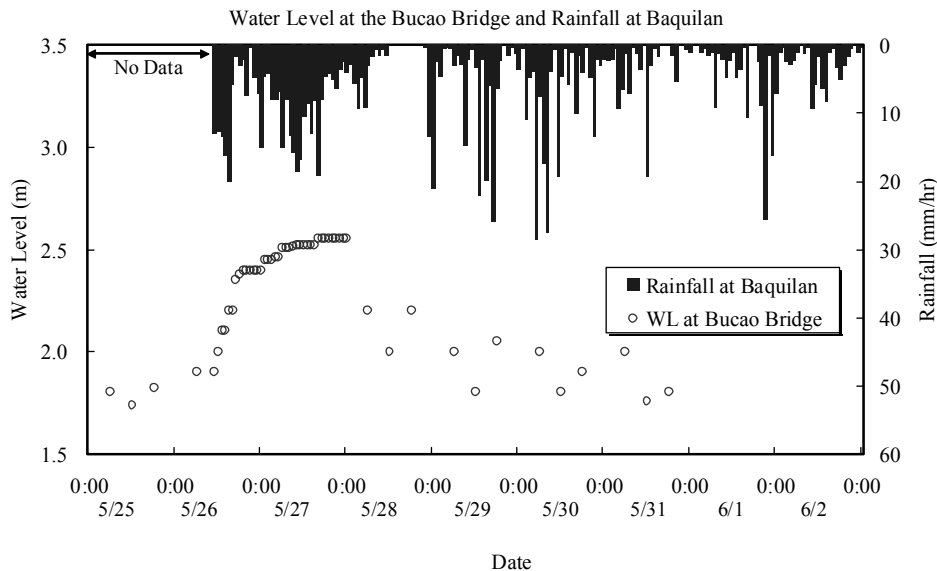
Baquilan	
Date	mm/day
5/27	216.1
5/28	75.9
5/29	127.8
5/30	178.0
5/31	67.6
6/1	105.9
6/2	59.7
Accumulated	831.1

**Relationship between Water Level and
Rainfall during Flood in May 2003**

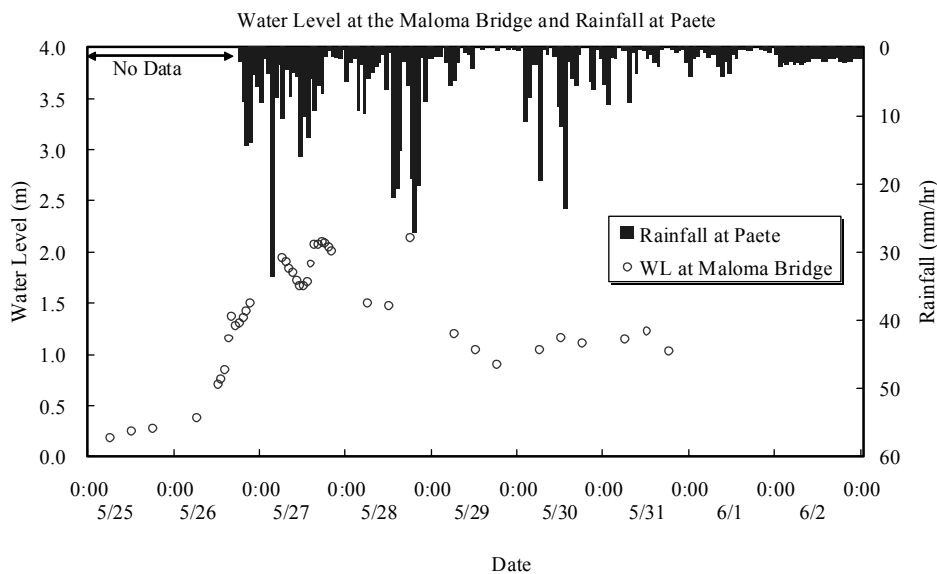
Paete	
Date	mm/day
5/27	155.2
5/28	192.0
5/29	24.1
5/30	121.2
5/31	42.7
6/1	27.4
6/2	49.5
Accumulated	612.2

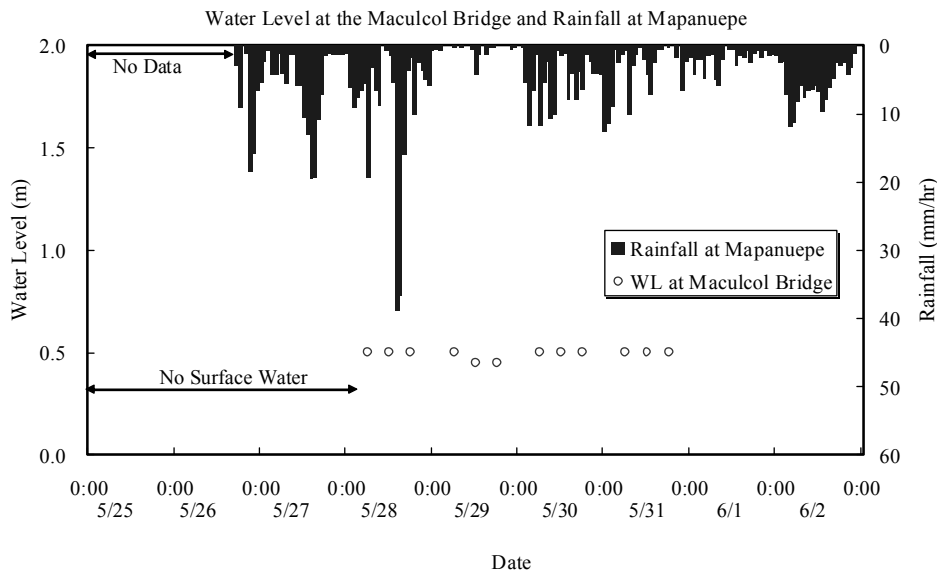
Mapanuepe	
Date	mm/day
5/27	125.5
5/28	205.2
5/29	10.4
5/30	127.2
5/31	69.6
6/1	48.0
6/2	127.3
Accumulated	713.2

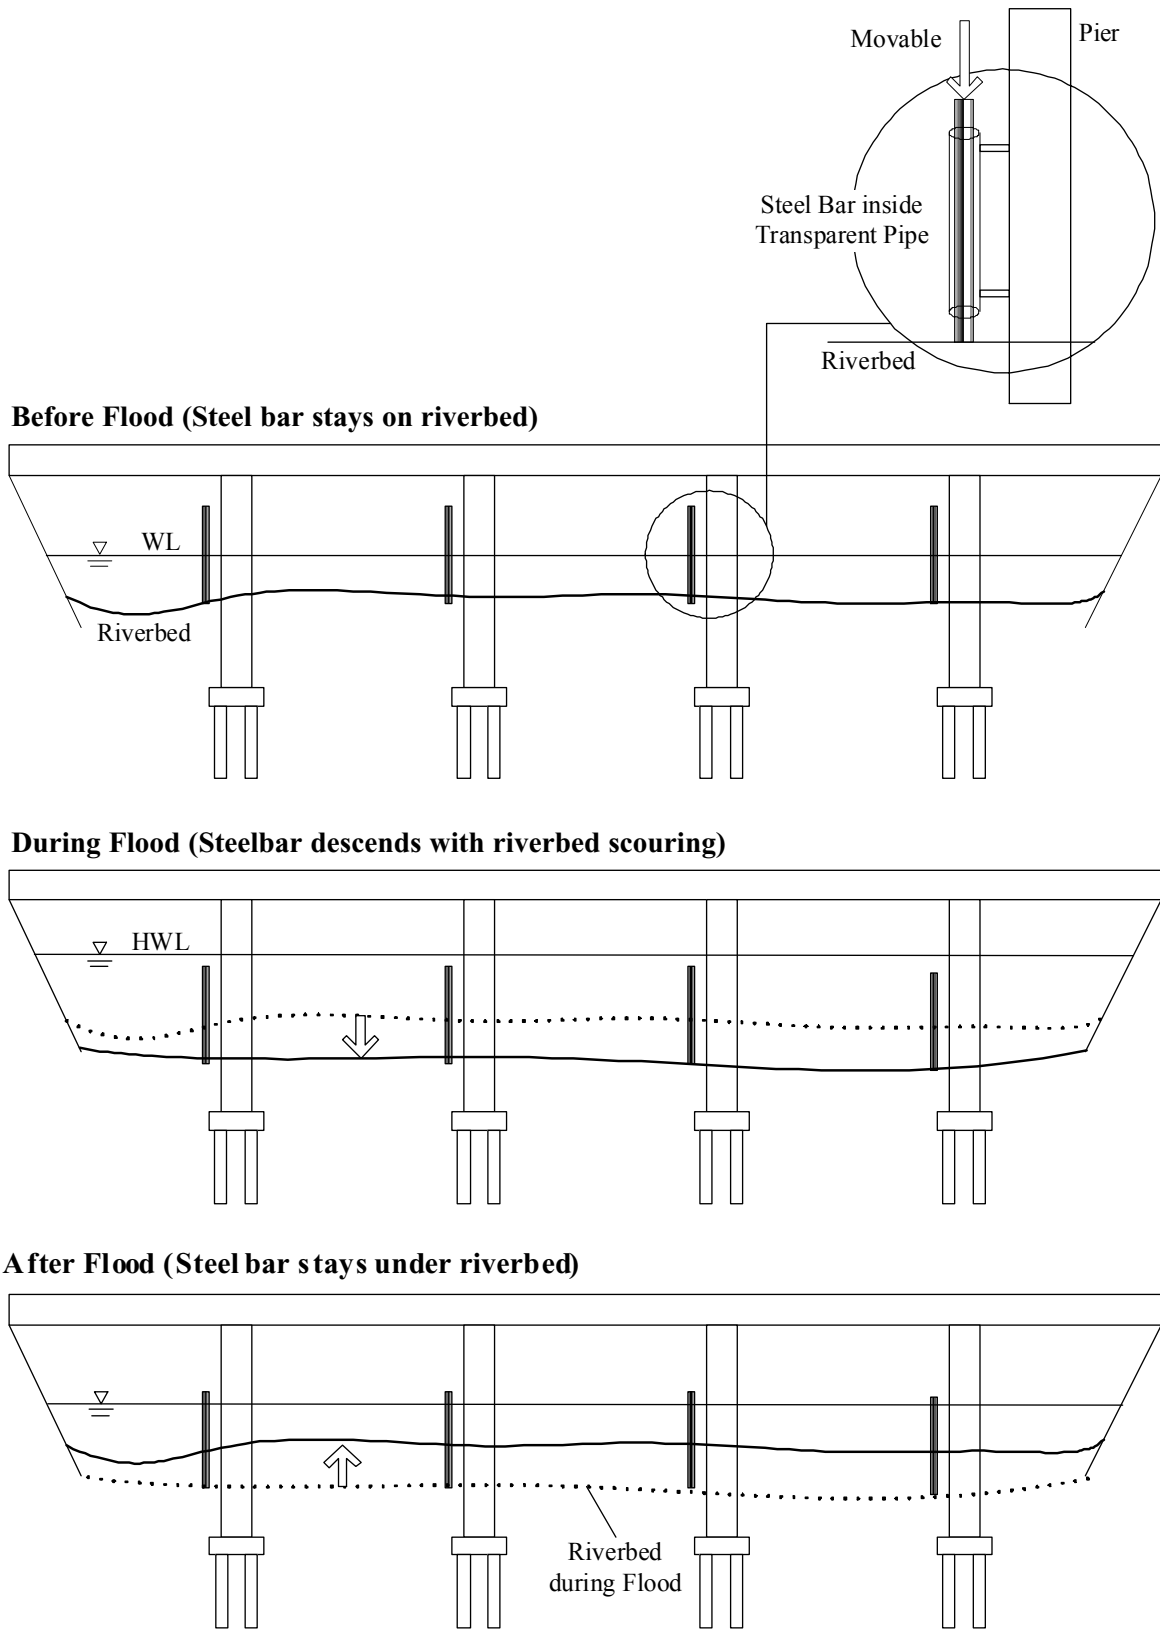
Figure 5.5.1

**Measurement System for Riverbed Scouring
at Bridge during Floods**
