The Study on Sabo and Flood Control for Western River Basins of Mount Pinatubo in the Republic of the Philippines

JAPAN INTERNATIONAL COOPERATION AGENCY

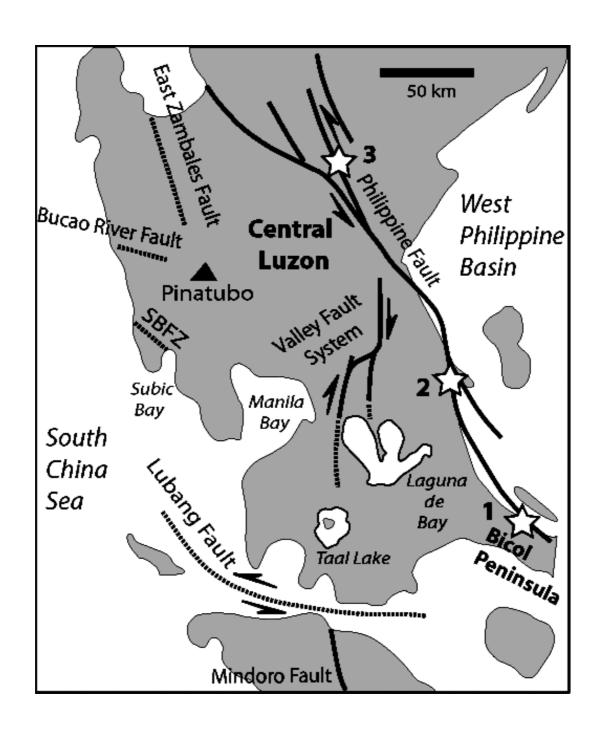
Figure 3.1.4

Principal Faults in the Vicinity of Mount Pinatubo

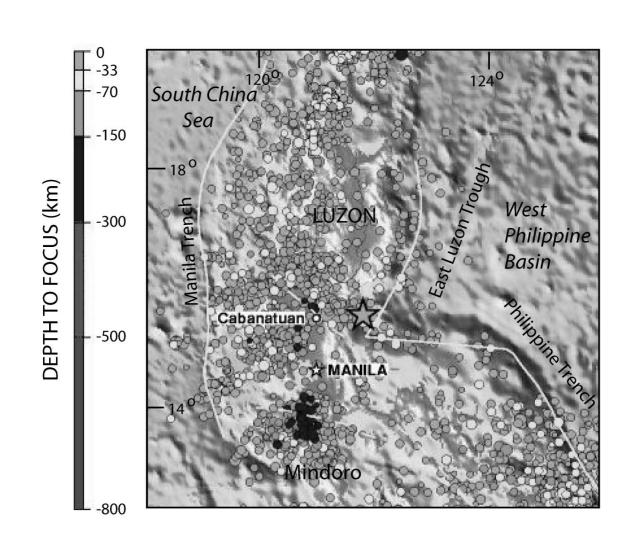
Figure 3.1.5 Seismicity in Luzon from 1990 to March 2, 2003

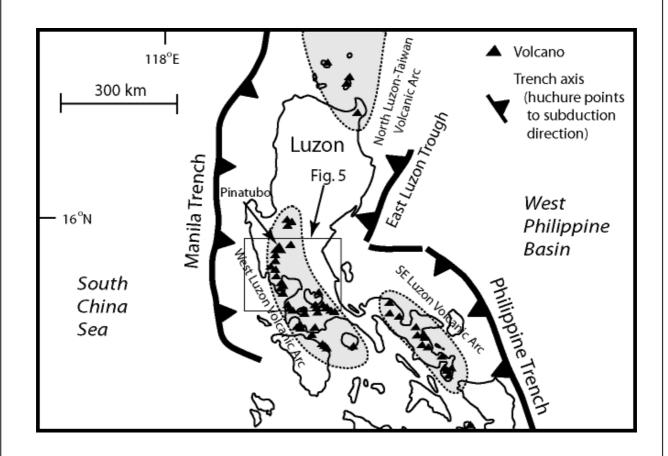
**Figure 3.1.6**

Map showing the Three Magmatic Arcs in Luzon that Host Active Volcanoes

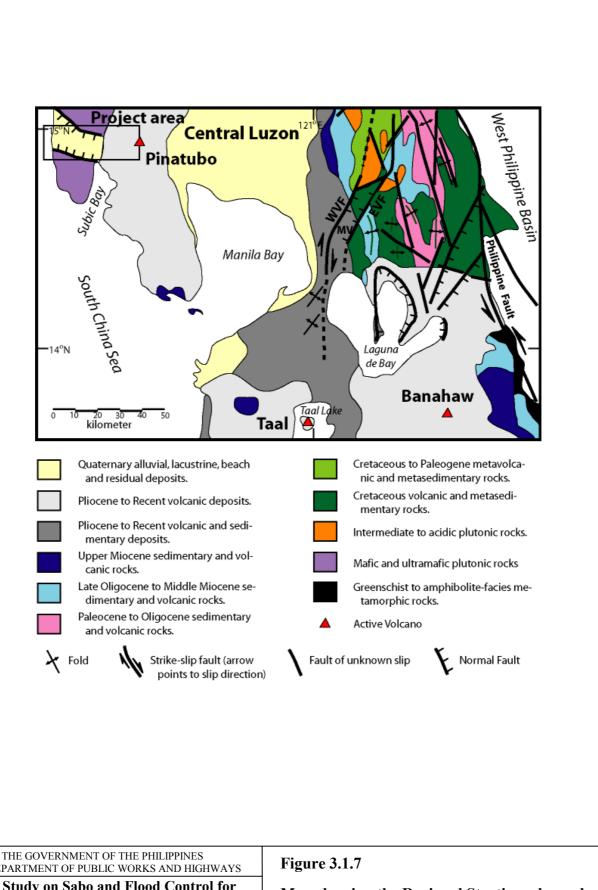
Map showing the Regional Stratigraphy and **Principal Geologic Structures in Central** Luzon

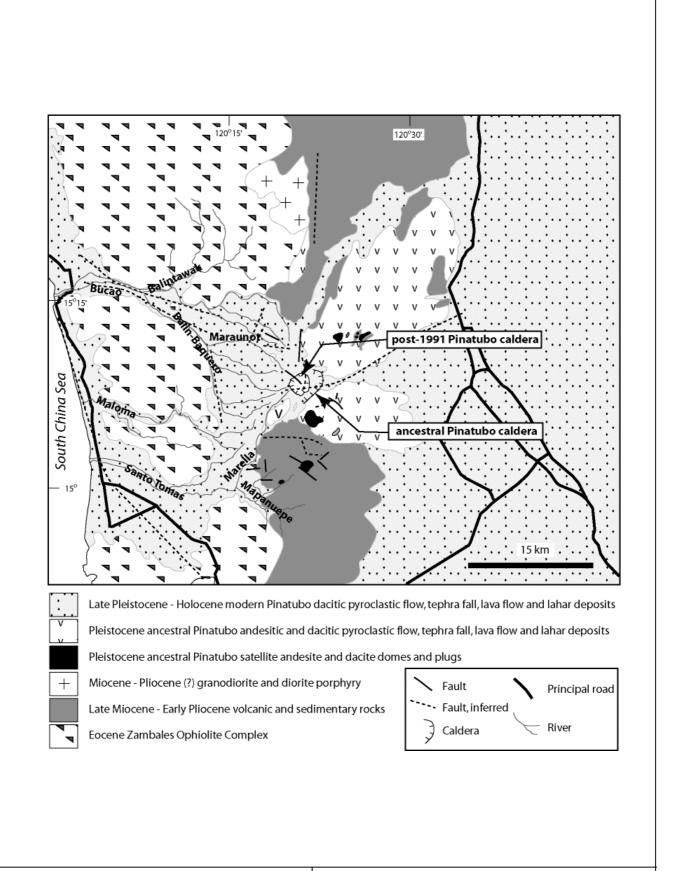
**Figure 3.1.8**

Map showing the Geology of Mt. Pinatubo and Surroundings Areas

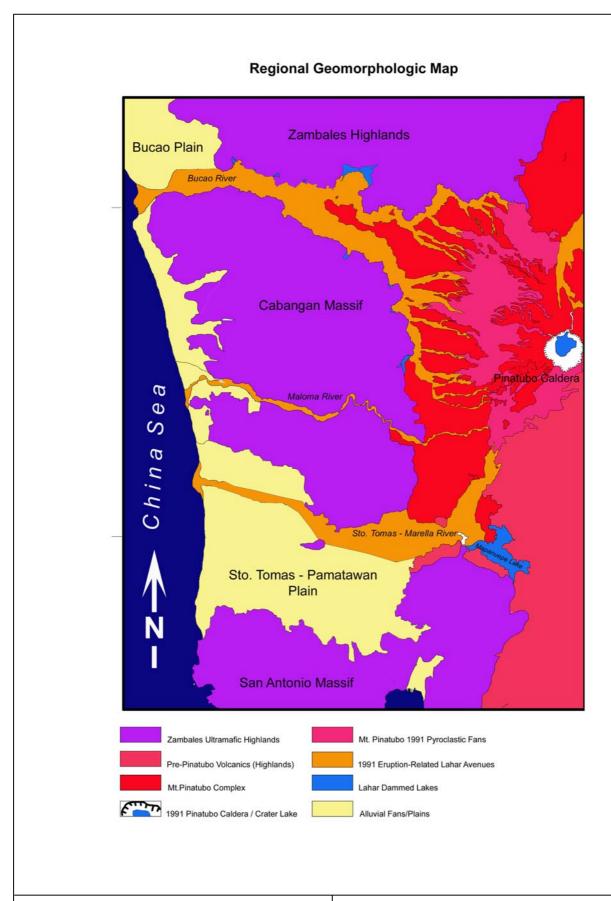
**Figure 3.1.9**

Map Showing the Principal Morphologic Units around Mt. Pinatubo

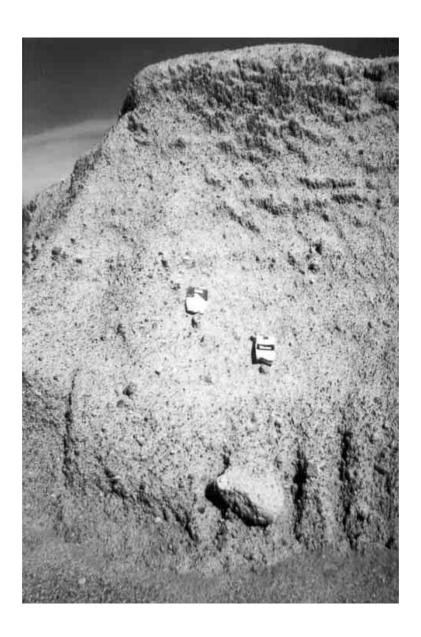
**Figure 3.1.11**

Photo Shows Poorly Sorted, Sand Rich Lahar Deposits Located near the Confluence of the Maraunot Notch and the Balin Baquero River

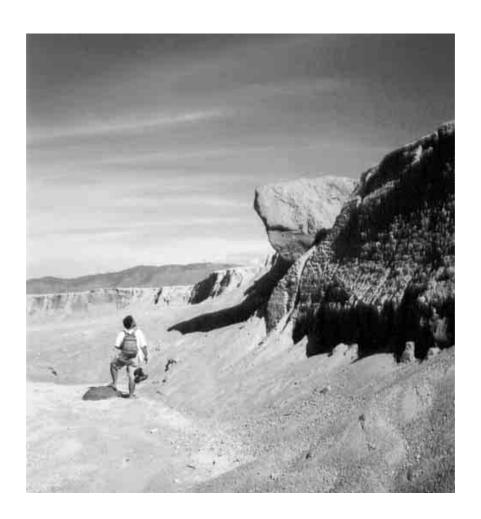
Figure 3.1.12
Photo Shows a Large Clast, Several Meters in Diameter, Jutting out of a Thick Lahar Deposit Located near the Confluence of Maraunot and Balin-Baquero, Zambales

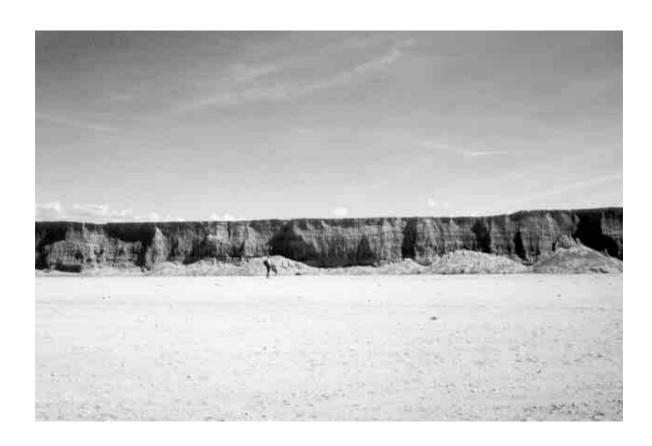
**Figure 3.1.13**

**Photo Shows a Thick Lahar Deposit with Crude Internal Stratifications**
