資料 8 その他の資料・情報

資料 8-1	路線測量
資料 8-2	地質調査
資料 8-3	交通量調査
資料 8-4	既存橋梁損傷調査

資料8-4 既存橋梁損傷調査

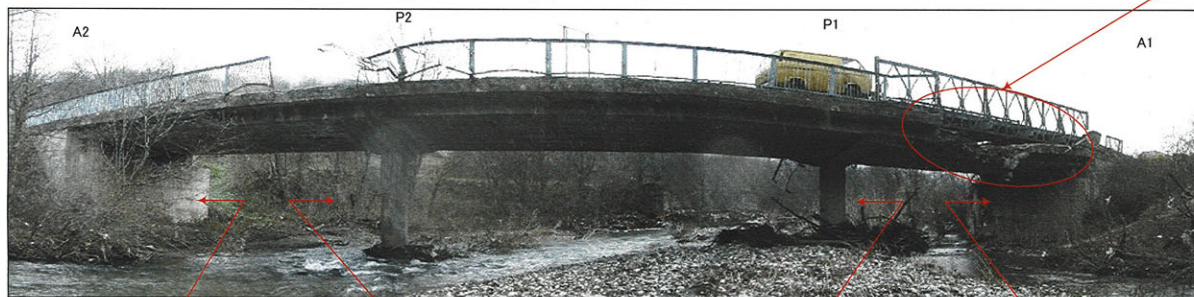
ボガティチ橋 橋梁調査写真

橋名		ボガティチ橋		
橋梁諸元	橋梁形式	RC3径間連続床版桁		
	橋長	43,250		
	支間長	(13,000+16,250+13,000)		
	幅員	全幅	8,300	
		車道	6,000	
		歩道	1,150(有効幅員:750)×2	
	橋台	逆T式橋台(推定)		
	橋脚	柱式橋脚		
基礎	不明			
損傷状況	上部工	<ul style="list-style-type: none"> 空爆によって第1径間および第3径間の床版橋は著しく破壊されており、爆撃後に桁の補修・維持管理がされないこともあり、床版コンクリートのひび割れに水が浸透し著しい遊離石灰が認められるなど、鉄筋腐食は顕著であり上部工全体の劣化は著しい。 		
	橋台	<ul style="list-style-type: none"> 橋台の基礎形式は直接基礎が想定されるが、フォッチャ側のA2橋台は洗掘により基礎下面が露出し、さらに爆撃の影響により橋座および縦壁は一部破損している。 		
	橋脚	<ul style="list-style-type: none"> 橋脚に爆撃の影響によるものと思われる表面コンクリートの剥落が認められるものの、大きな損傷は見られない。ただし、上部工と一体の円柱式構造(ピルツ形式)のため橋脚のみ上部工から切り離れた再利用は困難である。 		
	基礎	不明		
試験	シュミットハンマーによる圧縮試験	上部工	床版：370kgf/cm ²	
		下部工	柱式橋脚：400kgf/cm ² 橋台：480kgf/cm ²	
	中性化試験	供用中であり、実施せず。		
耐久性評価*	ランク：D (損傷が大きい)
