## 4.2 Production of 1/10.000-scale Orthophoto Maps

### 4.2.1 Ground control point survey (in technical cooperation with IGN)

## 4.3 Hazard mapping

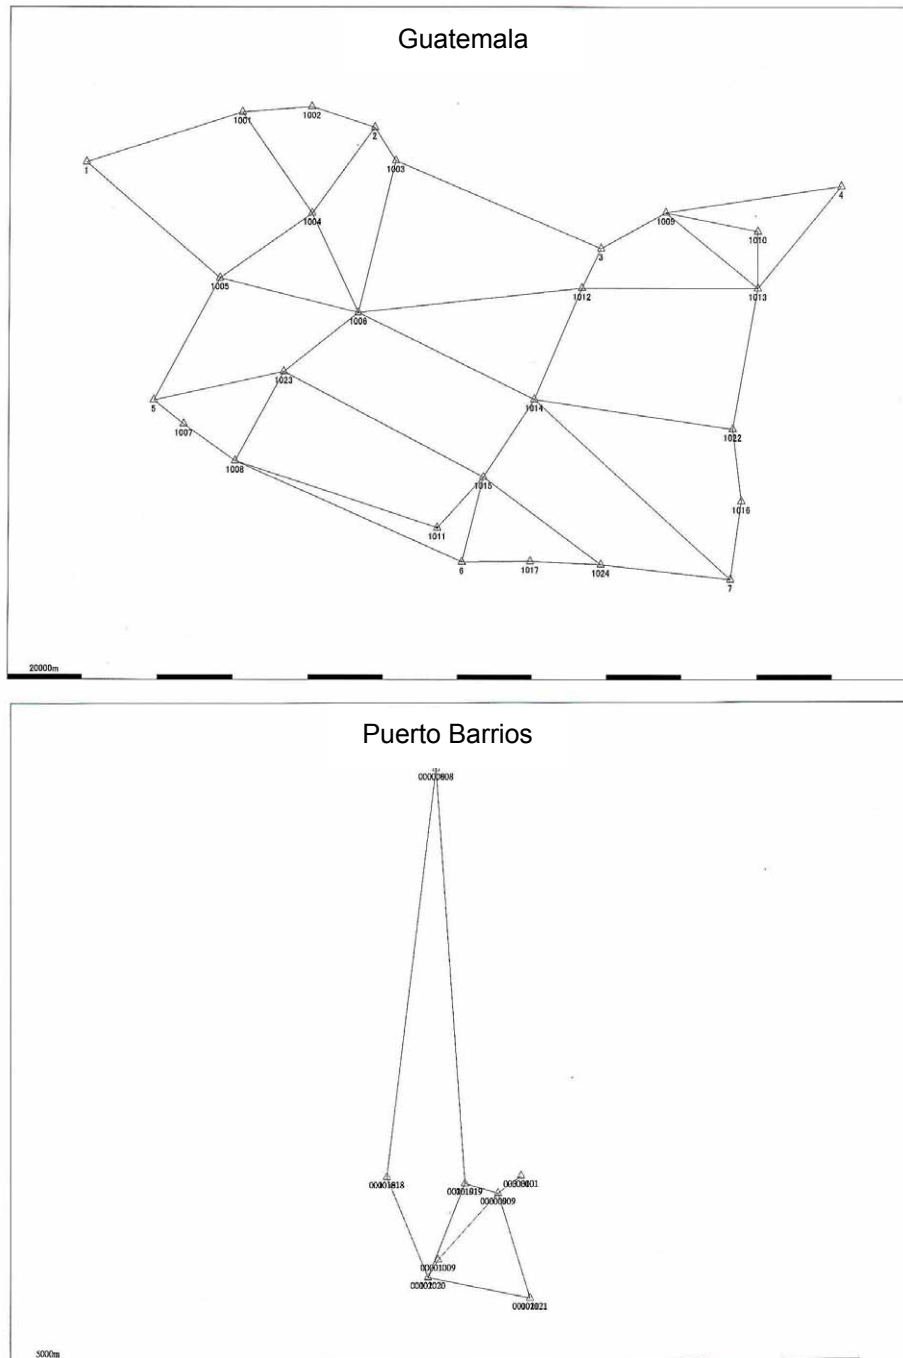
Figure 4.2-1 Control point survey

The control point survey was conducted using GPS, including area triangulation, and 25 new control points were created. Eight existing control points in Guatemala were used as existing points. The survey was implemented by following the survey specifications decided in “Discussions on GIS specifications”. The control point survey plan is shown in Figure 4.2-1.

The results of analysis are as follows and are within the horizontal accuracy limit of 150mm and the vertical accuracy limit of 300mm.

Maximum error is:

Guatemala area:                    B(X)=24mm,        L(Y)=29mm,        H=200mm

Puerto Barrios area:                B(X)= 3mm,        L(Y)= 4mm,        H=18mm

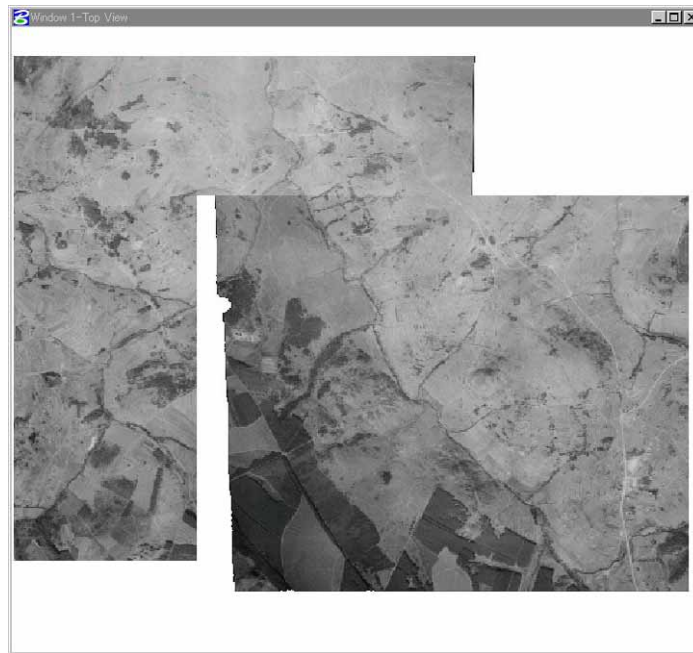
**Figure 4.2-2 Mosaic Processing**

The Study Team selected the joining line of the created orthophoto with the adjacent photo within the overlap range to set a tie line manually and create a mosaic image. The mosaic image was then subjected to cut-out processing for each 1/10,000 map sheet.

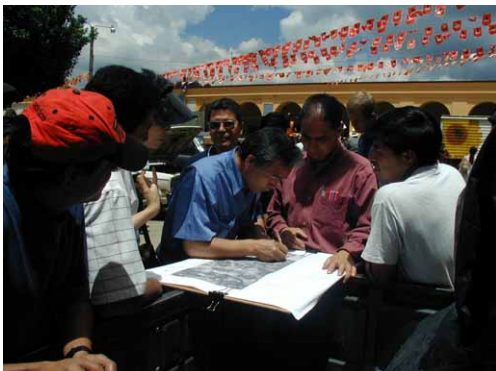
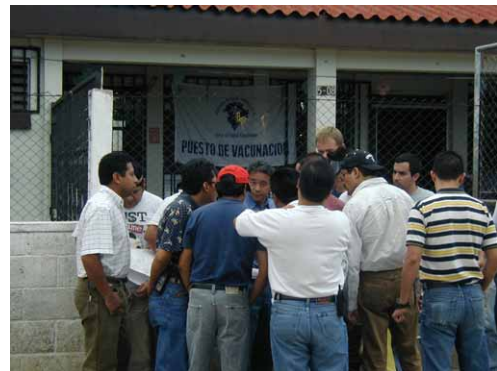
Photo 4.2-1 Field survey and OJT

The positions of schools, churches, hospitals, police stations, military bases and public offices were checked accurately in the field. These facilities are public and medical institutions that at time of disaster would be designated as rescue and relief facilities and places of refuge.

These facilities were not entered as symbols, but as annotations such as “Escuela”, “Iglesia”, “Hospital”, “Policia”, “Militar” and “Municipalidad”, and the buildings were marked.

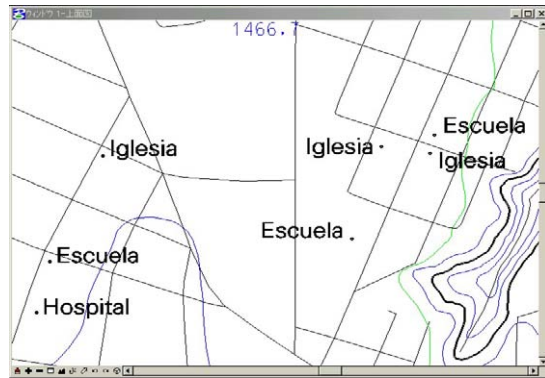
Figure 4.2-5 Input of schools and churches

As a rule for the annotations on orthophoto maps the data created in preparing the 1:50,000-scale national base maps were input at reduced size. This means that some objects indicated by the annotations were unclear, but their positions were rectified on the basis of survey results (see Figure 4.2-5.).

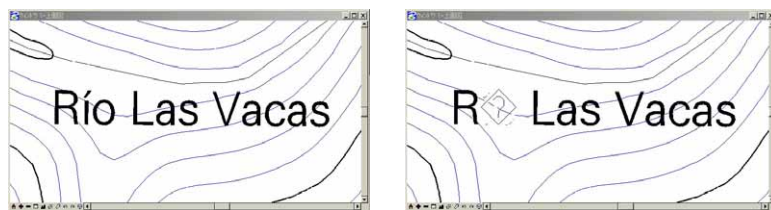
Figure 4.2-6 Normal and garbled character lines

Something that caused problems during the work of annotation input was notations unique to the Spanish language. When Spanish words are input into MicroStation, if the operating system and MicroStation are non-English versions, characters become garbled and do not show up correctly.

Although the study equipment provided to Guatemala had English-language versions of both the operating system and the software, on

the equipment that the Study Team used both were Japanese-language versions. Therefore, as a temporary measure the Study Team replaced accents and other marks with other characters

when editing the annotations. When all the work was completed, the Study Team carried out a batch conversion of the annotations in Microstation on the study equipment, to reproduce the correct representations.

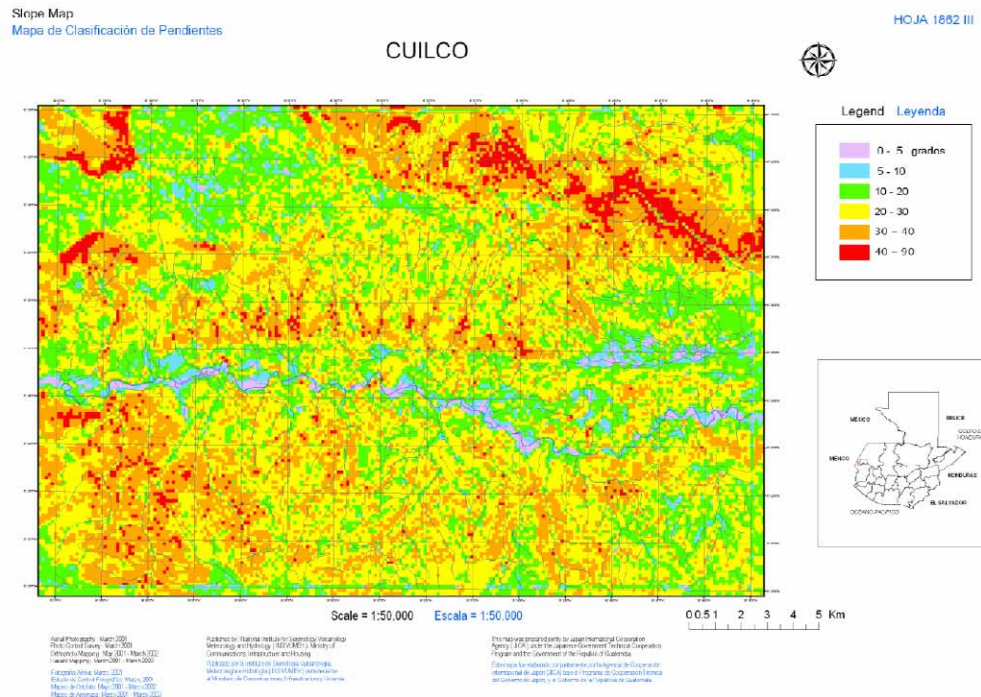
Figure 4.3-5 Sample slope angle classification map

For the northwestern and central areas in the landslide study area, we created slope angle classification maps as one of the elements of landslide evaluation. Furthermore, we identified through the interpretation of photographs and supplementary field survey, then digitized the areas with concentrated landslides, slope collapses, and gullies and major roads vulnerable to sediment disasters.
