(2) Earthquake Disaster(1976 Guatemala Earthquake)

(3) Volcanic Disasters

2.3 Hazard mapping

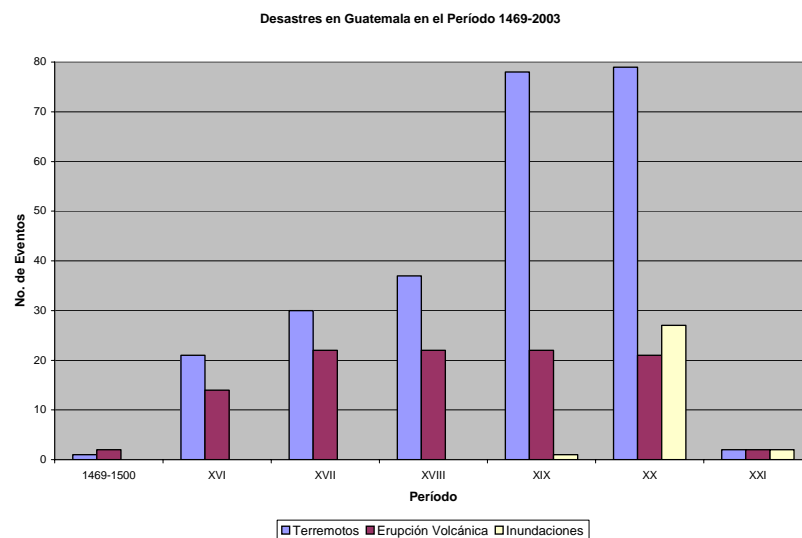
Figure 2.3.3-1 Number of historical disaster in Guatemala (as of May 2003)

According to the registers of disasters in Guatemala, we have obtained an account of 383 events in the period 1469 through May 2003 as shown in Table 2.3.3-1. Among them 60% correspond to earthquakes, 27% to volcanic eruptions and 13% Hurricanes or heavy rainfalls. This register does not classify the severity of these events, it is a compilation of the historical account found in several sources. However, it gives to a certain degree, a trend of the more catastrophic disasters in this period especially for those that are recorded in several sources, and they are well referenced.
