5.1.7 Evaluation of Current Conditions

a. Existing Power Plant as a Whole

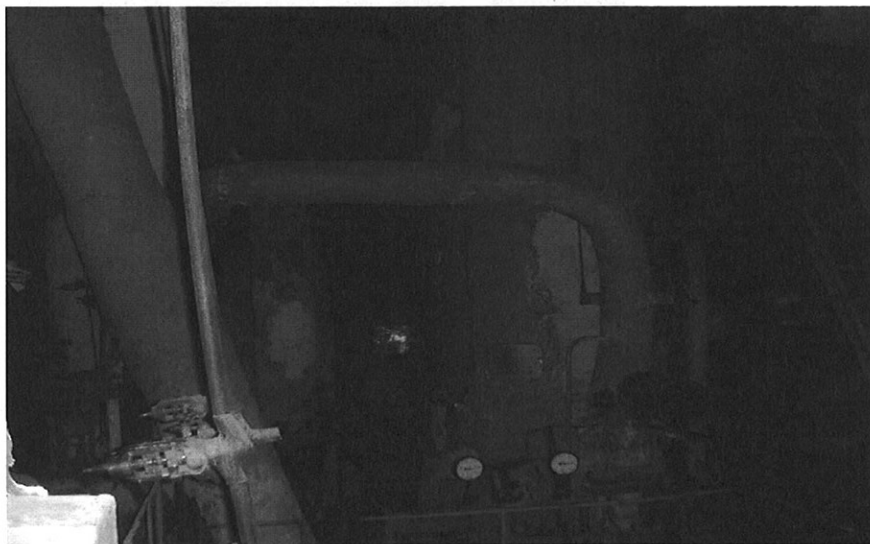
Picture 5.1-11 Inside the Turbine Auxiliaries Building

As shown in Picture 5.1-11, the inside of the turbine auxiliaries building is dimly lit, even during the day on sunny days. There are many places where the lighting is insufficient in the grounds of the power plant and especially in the turbine auxiliaries building. There are even places where it is impossible to see one's feet for the pitch darkness, even in the daytime. It is very dangerous, as one must walk without being able to see what is at one's feet, and urgent improvement is needed.

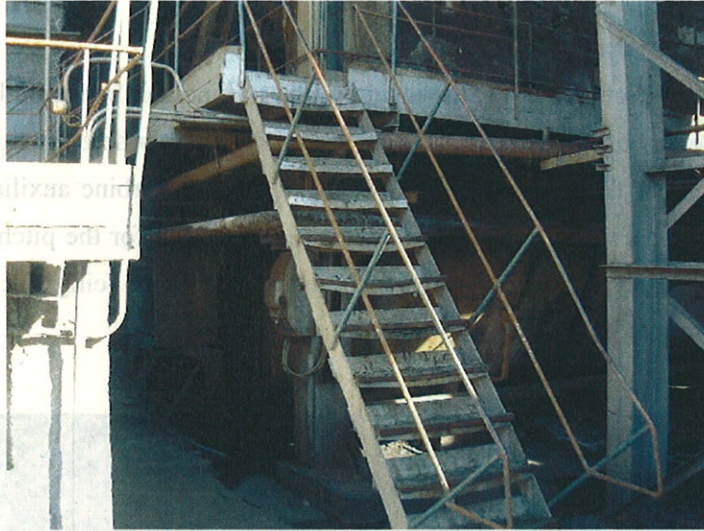
Picture 5.1-12 Stairs and Walkway Handrails

Another point of safety is shown in Picture 5.1-12. The grating floors, walkways, stairs, and handrails around the boilers are of weak construction, and walking around the site is a frightening experience for those who used to equipment in Japan. Further, although there are as many as twelve units, there is no method of identifying them, so there is the likelihood of mistaken operation.

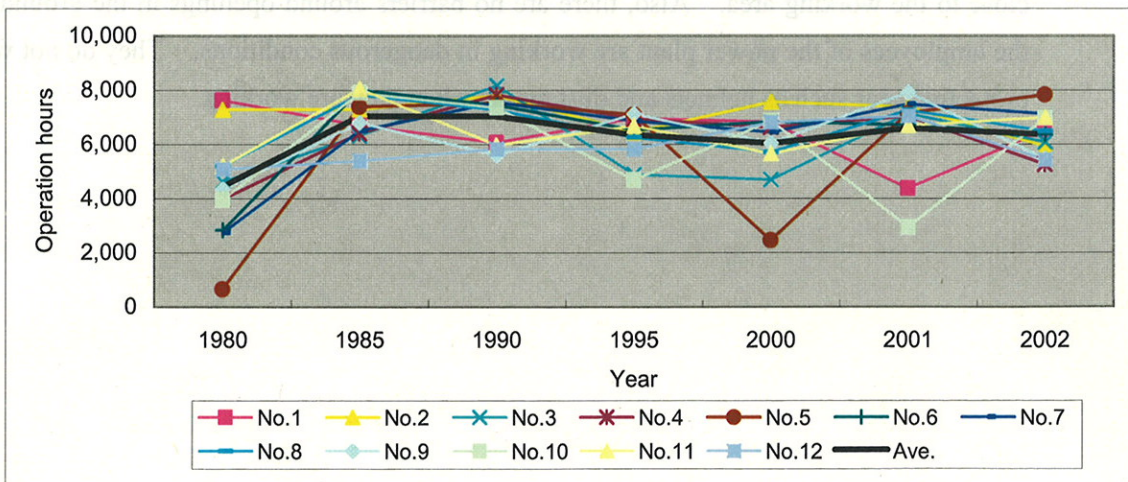
Figure 5.1-7 Unit Operating Hours

Even though all the units have been operating for over thirty years and over 200,000 hours, the average number of operating hours per year is over 6,000 hours, as shown in Figure 5.1-7.
