THE MASTER PLAN STUDY ON
FLOOD FORECASTING AND WARNING SYSTEM
FOR ATLAS REGION IN THE KINGDOM OF MOROCCO

APPENDIX G

ENVIRONMENTAL CONSIDERATIONS

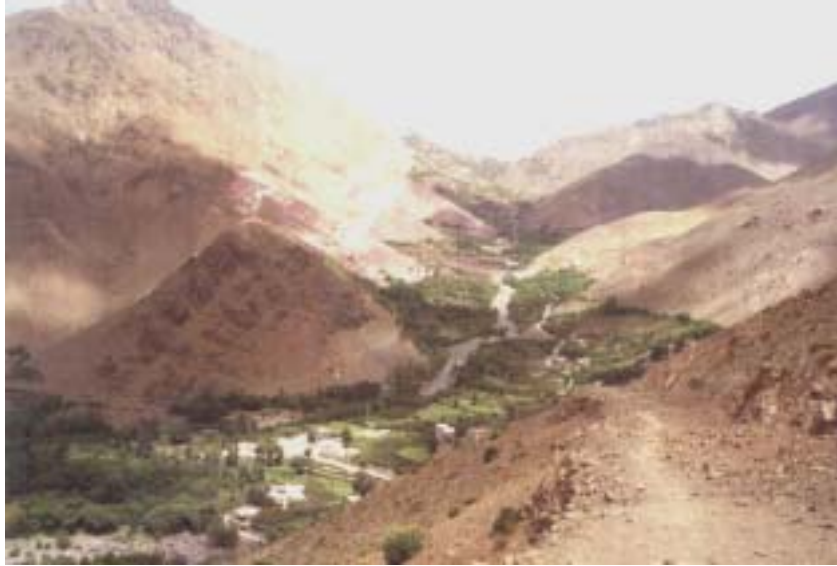
PHOTOGRAPH 1 AGRICULTURE AND HOUSING ALONG THE FLOOD PLAIN

A. LANDUSE ALONG THE FLOOD PLAIN EXASPERATES DANGEROUS SITUATION

The land use issue is very important because of the nature of the Study Area, being floodplains. The intervention of development in the floodplain is the best guarantee to increase damages and casualties during floods. In that sense the danger from floods is multiplied in the Study area.

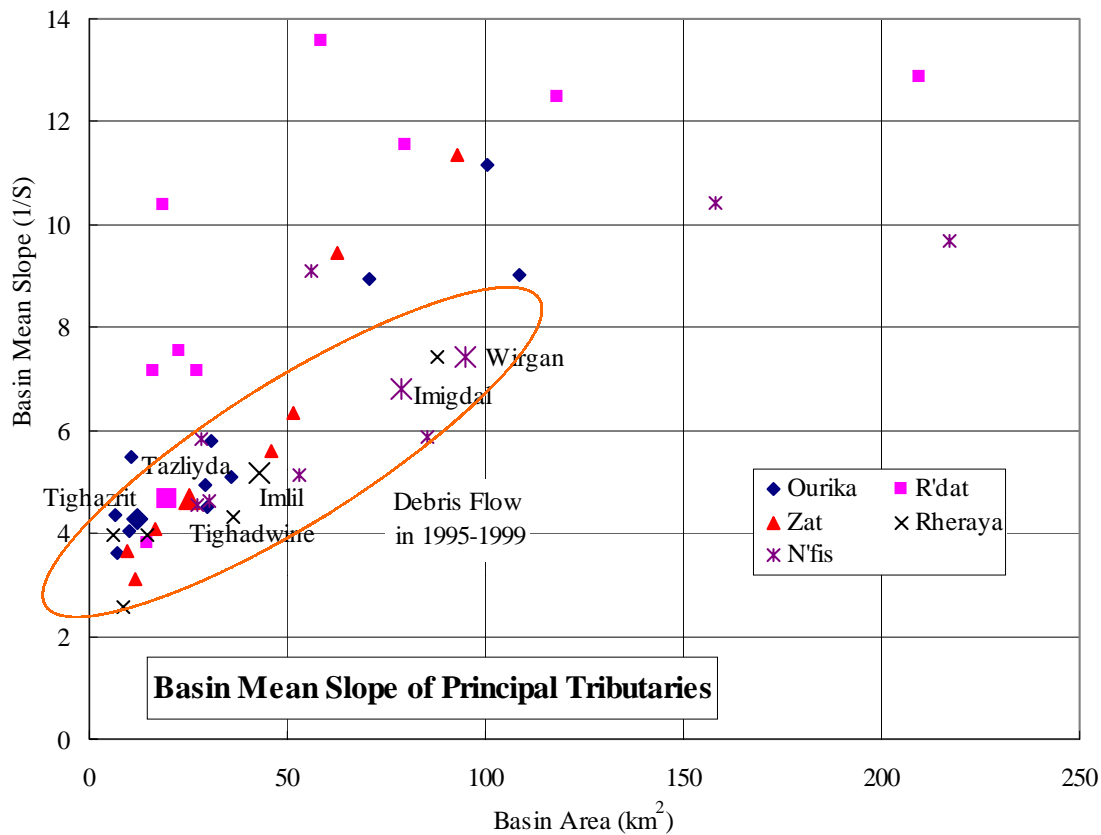
Basin mean slope of the principal tributaries becomes larger according to the increase of basin area. The basin mean slope shows $1/4 - 1/6$ under the basin area of 50 km^2 , $1/6 - 1/10$ within that of $50 - 100 \text{ km}^2$ and less than $1/10$ over that of 100 km^2 . It is recognized that the basin mean slope of the tributaries of the R'dat River is relatively gentler than the others but the basin mean slope in the other tributaries is almost the same each other.

The tributaries where debris flow happened in 1995, 1997 or 1999 are pointed in the following figure. It shows that in the tributaries with steep slope, debris flow happened in the wide range of basin areas.
