CHAPTER 4

ENVIRONMENTAL DESCRIPTION

The Project is located in the lower part of the Torola river basin. The area of the Project include land from the Municipalities of San Luis-La Reina, Carolina, and San Antonio del Mosco, all pertaining to the department of San Miguel". The river basin is located on the Northeast part of El Salvador. The river basin is enclosed on the North latitude between the parallels 13° 42' and 14° 05' and on the West longitude between the meridians 87° 47' and 88° 29'. The layout of the project at a scale of 1:25,000 is shown in Figure 4.1.

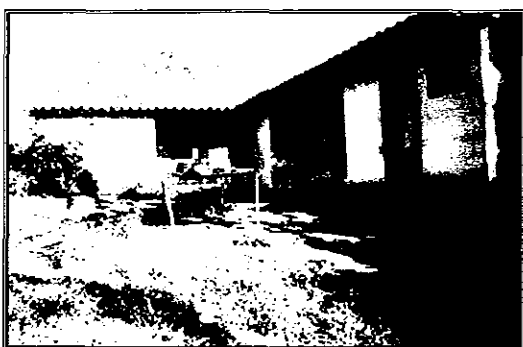
Photo 4.20 House made of cement blocks

In relation to the construction materials of the houses, 12% are made with walls of cement blocks, 42% walls are made of unburned bricks. 40% are made of bahareque, 6% are elaborated with rustic wood. Figures A4.22 to 4.25 models of houses located in the zone are shown. Figures A6.1 of Annex 6 shows a list of family chief, grouped by houses which include two churches and a school.

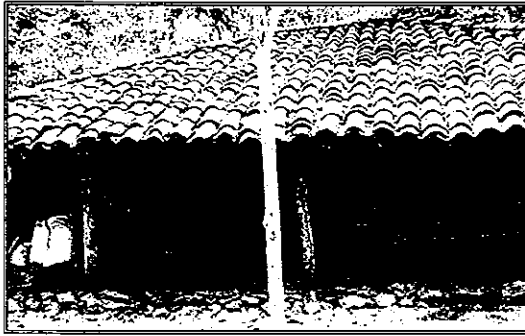
Photo 4.22 House made of bahareque

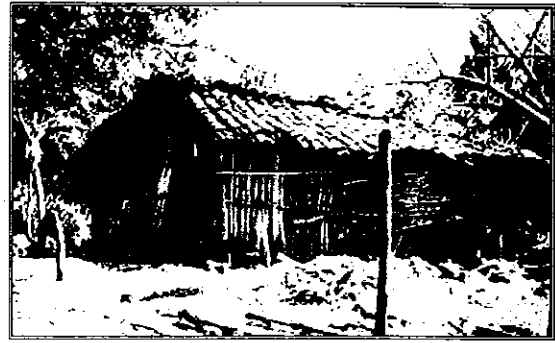
Photo 4.23 House made of rustic wood
