ANNEX C IMPROVEMENT OF WATERING

C.1 Watering using Small Pumps in Groups

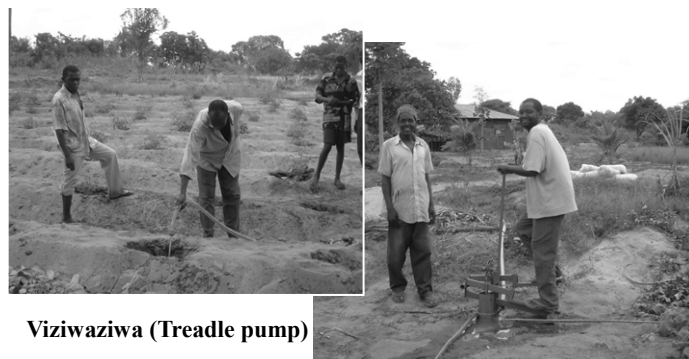
Viziwaziwa (Treadle pump)

because of water source. And efficiency of watering by plastic container is considered to be the best. Therefore, an area might be reduced when using pump because of low efficiency. Therefore, treadle pumps were chosen in Viziwaziwa.

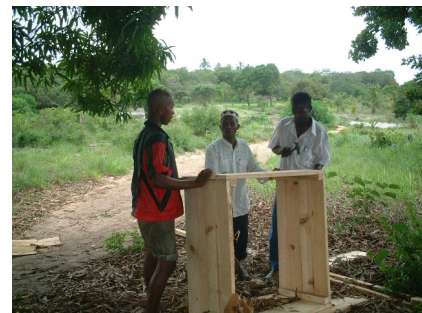
Improvement of kisima involves earth retaining with wooden frame, which is shown in the picture, and it can perform comparatively easily by increasing the depth of the existing kisima by about 50 cm more. The size of frame was set to 1.0 x 1.0 x 0.5 m (height).

The farmers dug a hole bigger than frame on the bottom of kisima, and frame was made to be settled. The depth was made shallower several centimeters than the height of frame, and when the frame was installed, the frame made it higher than the hole so that mud might not flow in.

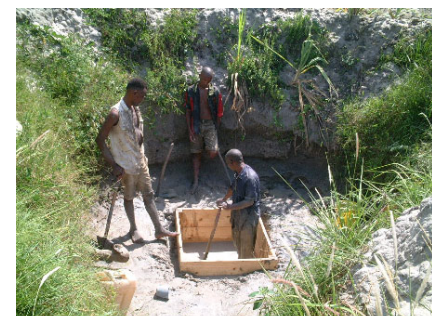
Digging the works had to begin eliminating water in kisima first. Although there was yearly difference, the water level at beginning of short rainy season rain was lower than the optimum. This time, since digging was carried out after big rain in mid-January, the water level was high and drain work of water was cumbersome.

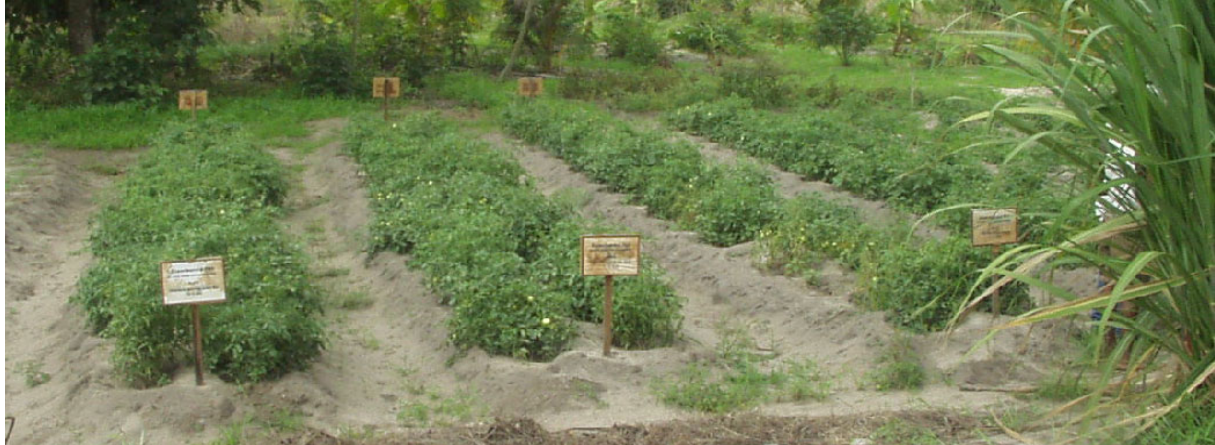
The growing situation on January 18 2002 is shown below.

The growing situation observed in early January showed that plot 1 (everyday watering) was better than the other two. However, in the observation of the late January, the plot 3 (watering every three days) being the worst of all, the difference between the plot 1 and the plot 2 was not significant. A comparatively big rainfall fell in the meantime, and the plot 2 recovered in response to this rain.

In the observation of the late January, high temperature constraints were observed in every plot especially in the plot 2. In the observation of mid-February, these constraints were spread to all plots.

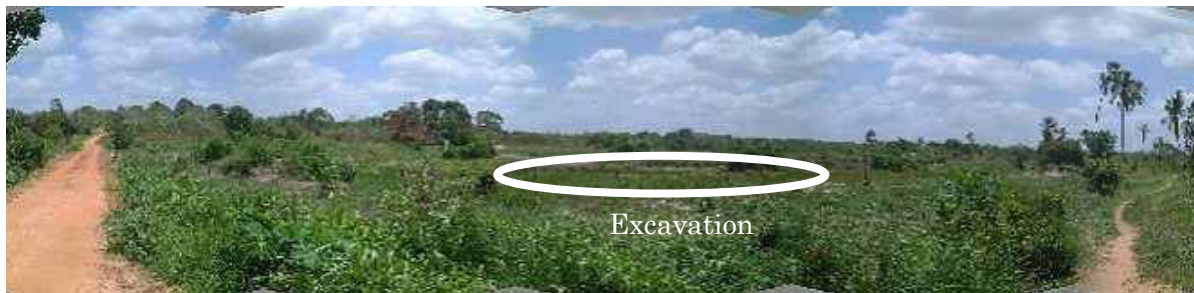
The use situation of the present pond considers a part used as farmland, and a part used for kisima, as shown in the following figure. As shown in figure, it is better to avoid excavation between for farmland or near kisima. In addition, since the digging range is 100mx50m, a depth of 40 cm is considered.

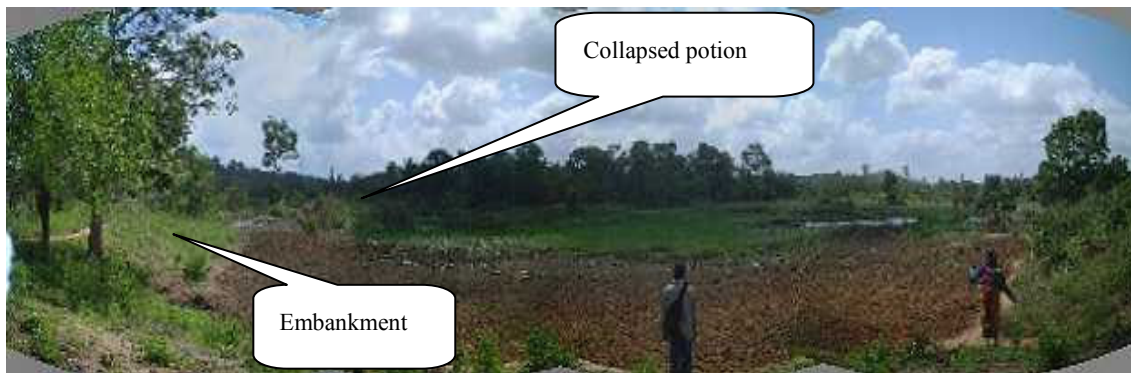
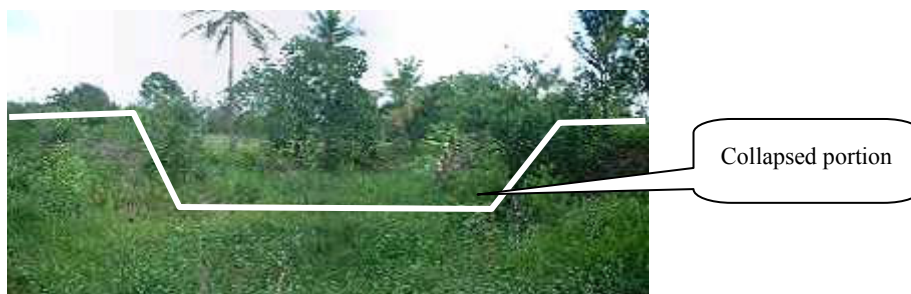
The embankment is washed away is a portion which touches the natural ground on the right bank. Grass has grown thick now on the site since about 20 years or more have passed. However most of the embankment has not collapsed and is not damaged.

Therefore, the irrigation pond can recover its original function by repairing the collapsed part. Other structures, such as spill way and intake works, have not been observed. Therefore, it is guessed that spillway was installed in the collapsed place.
