**THE STUDY ON
HYDRO-METEOROLOGICAL MONITORING
FOR WATER QUANTITY RULES
IN MEKONG RIVER BASIN**

FINAL REPORT

VOLUME II SUPPORTING REPORT (1/2)

**IMPROVEMENT OF
HYDROLOGICAL STATIONS**

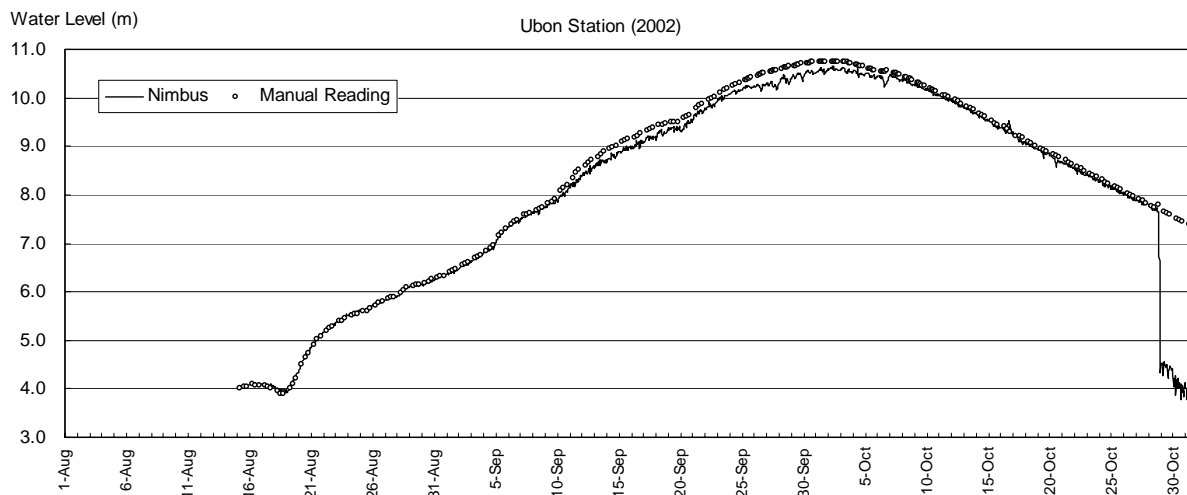
Fig. 2.4(1/2) Measured Data of Ubon Station

Ubon Station: Nimbus has been installed at the station and measurement was started on 15 August 2002. For a while after the installation, the Nimbus data in the middle range (4.0 to 8.0m) fitted with the manual reading data. When it was over 8.0m in gauge height, however, the fluctuation and the gap between the manual reading value became remarkable and wider until it reached approximately 20cm. At the falling stage and lower than 10m in gauge height, the Nimbus data fit again with the manual data.

On 29 October 2002 during the 2002 flood season, the base supporting the measuring tube was washed away. Comparing the measurement results with those before the base was washed away, there may have been some problem with the fixing of the tube outlet because when the water level exceeded 8m in gauge height, the gap and fluctuation became suddenly remarkable. It seems that the fixing of the bottom parts were loosened by debris, moved by the current, and then finally washed away.

Thereafter, staffs of DWR repaired the loosened end of the measuring tube by themselves in accordance with the advice of the WUP-JICA Team at the end of April 2003. The following figure shows the measurement just after the reinstatement of bottom parts at the end of 2003.

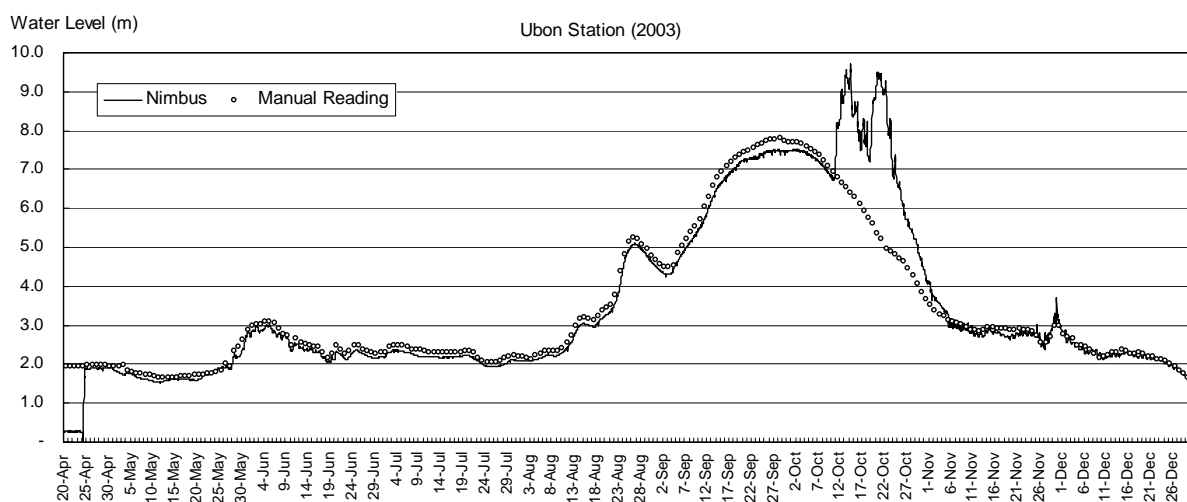
Fig. 2.4(2/2) Measured Data of Ubon Station

In the middle of October up to the beginning of November 2003, the Nimbus data was plotted as remarkably different from the manual reading data. The cause may be the choking of the outlet of the measuring tube with sediment or debris. Thereafter, the Nimbus data gradually turned to be in agreement with the manual reading because the obstruction may have been washed away naturally.

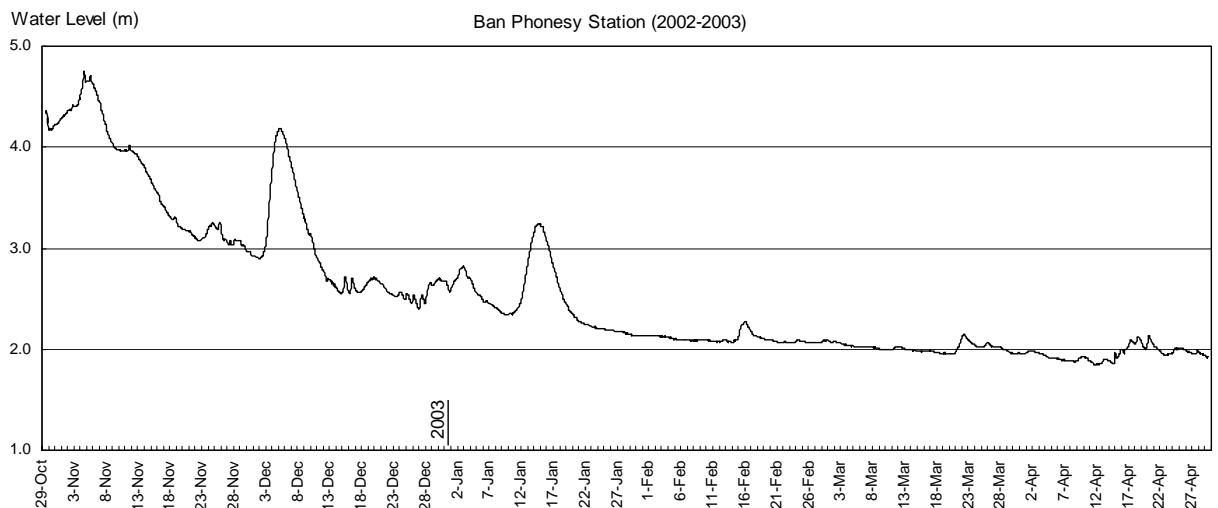
Fig. 2.5 Measured Data of Ban Phonesy Station

Ban Phonesy Station: The following figure was recorded right after the installation of measuring equipment in 2002 up to the end of April 2003. The verification by comparison with the manual reading data has been impossible because the manual reading data could not be obtained.

As can be seen from this figure, the measuring equipment of this station has been functioning well because there are no missing and abnormal data. The equipment had functioned well at the time of site inspection in September 2003 as well. However, the value of Nimbus had been readjusted at the time because there were small gaps between the water level of the manual gauge and the equipment. Unfortunately, the latest data has not yet been obtained.

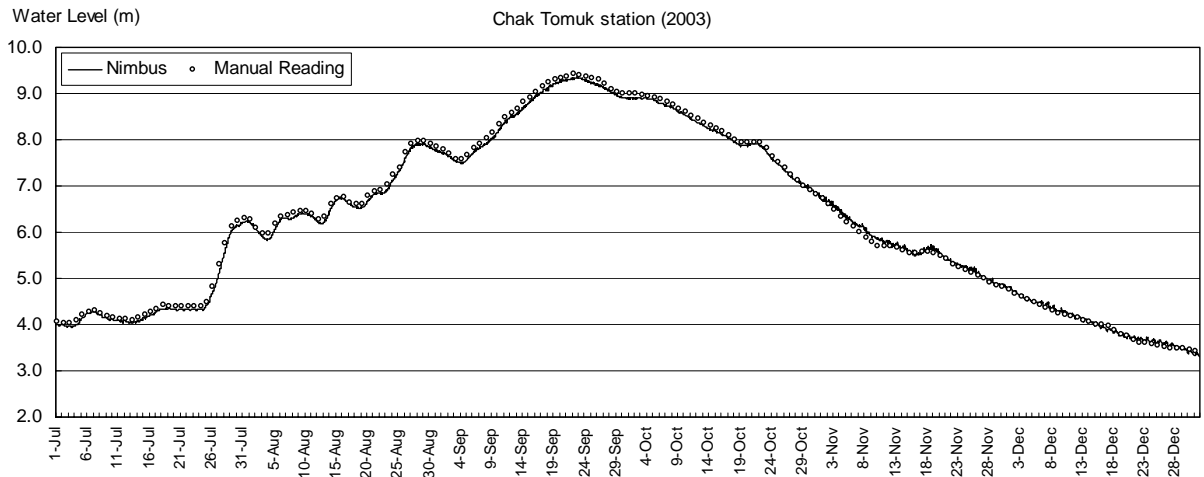
Fig. 2.8(2/2) Measured Data of Chak Tomuk Station

Chak Tomuk Station is highlighted because the elevation of zero gauge might have been incorrect. Usually, the difference of water levels between Chruï Changvar and Chak Tomuk are found to be 20 to 30cm. The difference should be around 0 because they are very closely located. In the WUP-JICA improvement work, the zero gauge was kept at the former value. Therefore, there are no gaps between before and after the improvement.

When the leveling survey was conducted by DHRW from the National Bench Mark in the Parliament to the TBM of the station in October 2003, the elevation of zero gauge was 0.232m and it was 1.3m higher than the former zero gauge, which is minus 1.02m. If the new value were assumed to be correct, the relation among the surrounding stations such as Chruï Changvar and Phnom Penh Port would be incoherent because the differences were found in only 20 to 30cm. The difference of 1.3m is too big. The situation of datum in Cambodia is now complicated. This issue should continue to be investigated after this study.

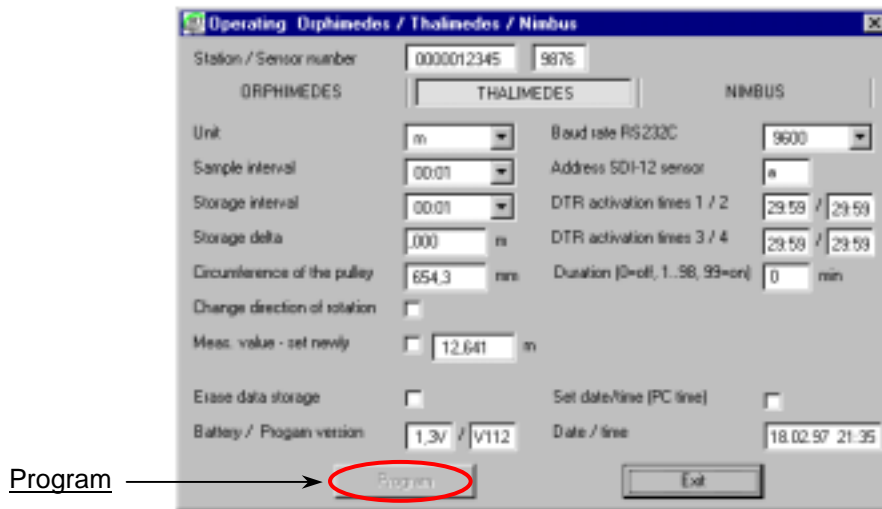
Example of Configuring OTT Device

The set of parameters is immediately input and displayed in the following dialog box (the example illustrates Thalimedes, one of the OTT devices, and it is a close resemblance to Nimbus).

You can now adjust the individual parameters and transfer them to Nimbus by clicking the "Program" button. Load and display the parameter set immediately afterwards to check the data.
