20.3 PRELIMINARY DESIGN AND COST ESTIMATE

20.3.1 Rehabilitation Design

(1) Bridge Design

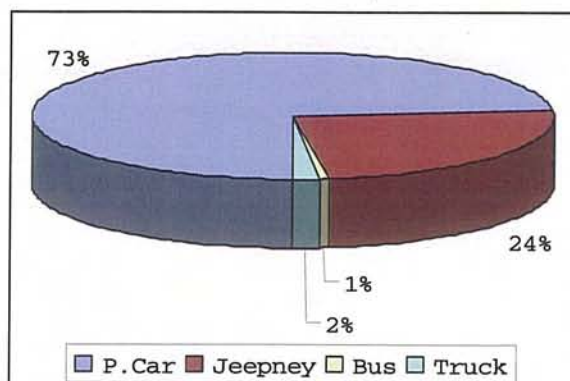
Figure 20.4.1-1 Vehicle Composition of Jones Bridge (PCU)

Figure 20.4.1-1 shows the vehicle composition of Jones Bridge. According to this figure, the share of heavy vehicles consisting of large busses and trucks to total traffic is only 3%.

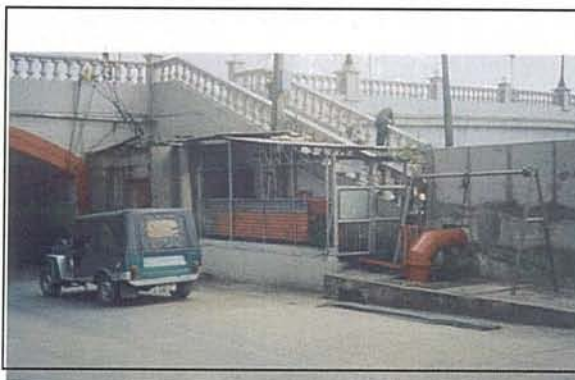
Photo 20.5-1 Photograph showing that there are no Encroachments at the Site of the Jones Bridge

It is important to note that there are **NO persons that will be displaced** during the rehabilitation of Jones Bridge because within the study period, there were no settlers within the immediate vicinity of the bridge (Please see **Photo 20.5-1** and **20.5-2**). As such, consultation meeting was confined to the barangay officials who have jurisdiction over Jones Bridge and its immediate vicinities (Please see **Photo 20.5-3** and **20.5-4**).

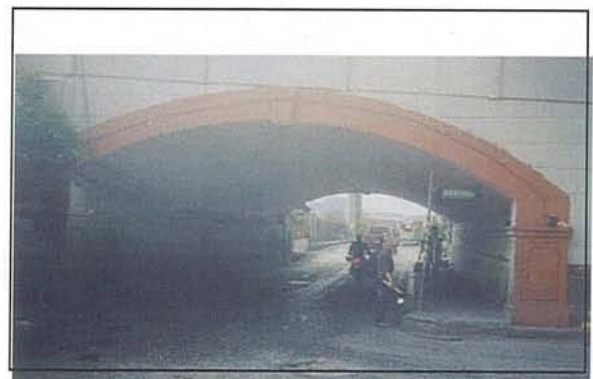
Photo 20.5-2 The only structure in the immediate vicinity of the Jones Bridge is pumping station of the Metro Manila Development Authority (MMDA)
