22.3 PRELIMINARY DESIGN AND COST ESTIMATE

22.3.1 Rehabilitation Design

(1) Bridge Design

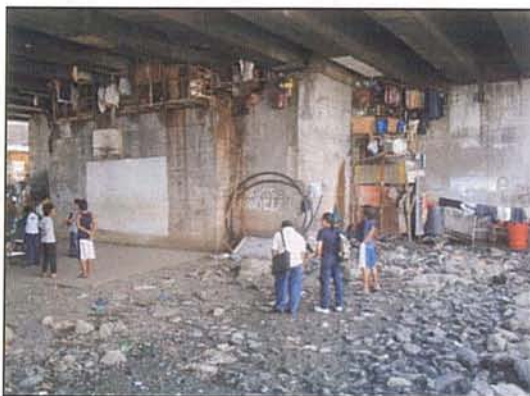
There are two (2) main types of dwellings/structures occupied by the PAFs. These are the apartment and shanty types of dwelling. The apartments are structures made of wood and light materials, have common roofing, and are composed of several units. The shanties are made of light materials such as second hand roofing with worn materials in place, old plywood, and other small pieces of used lumber. Most of the time, the informal settlers make use of the bridge as roofing. Please see Photo 22.5.3-1 and 22.5.3-2.

Photo 22.5.3-1 Photos showing the informal settlers' dwellings below the Lambingan Bridge columns and between the girders

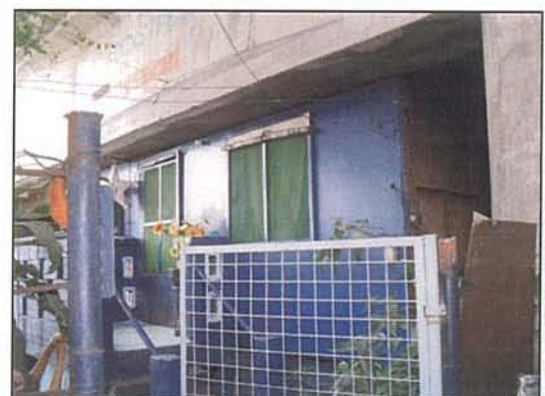
Photo 22.5.3-2 Sample dwelling under the bridge at Barangay 892
