## 23.3 PRELIMINARY DESIGN AND COST ESTIMATE

### 23.3.1 Rehabilitation Design

#### (1) Bridge Design

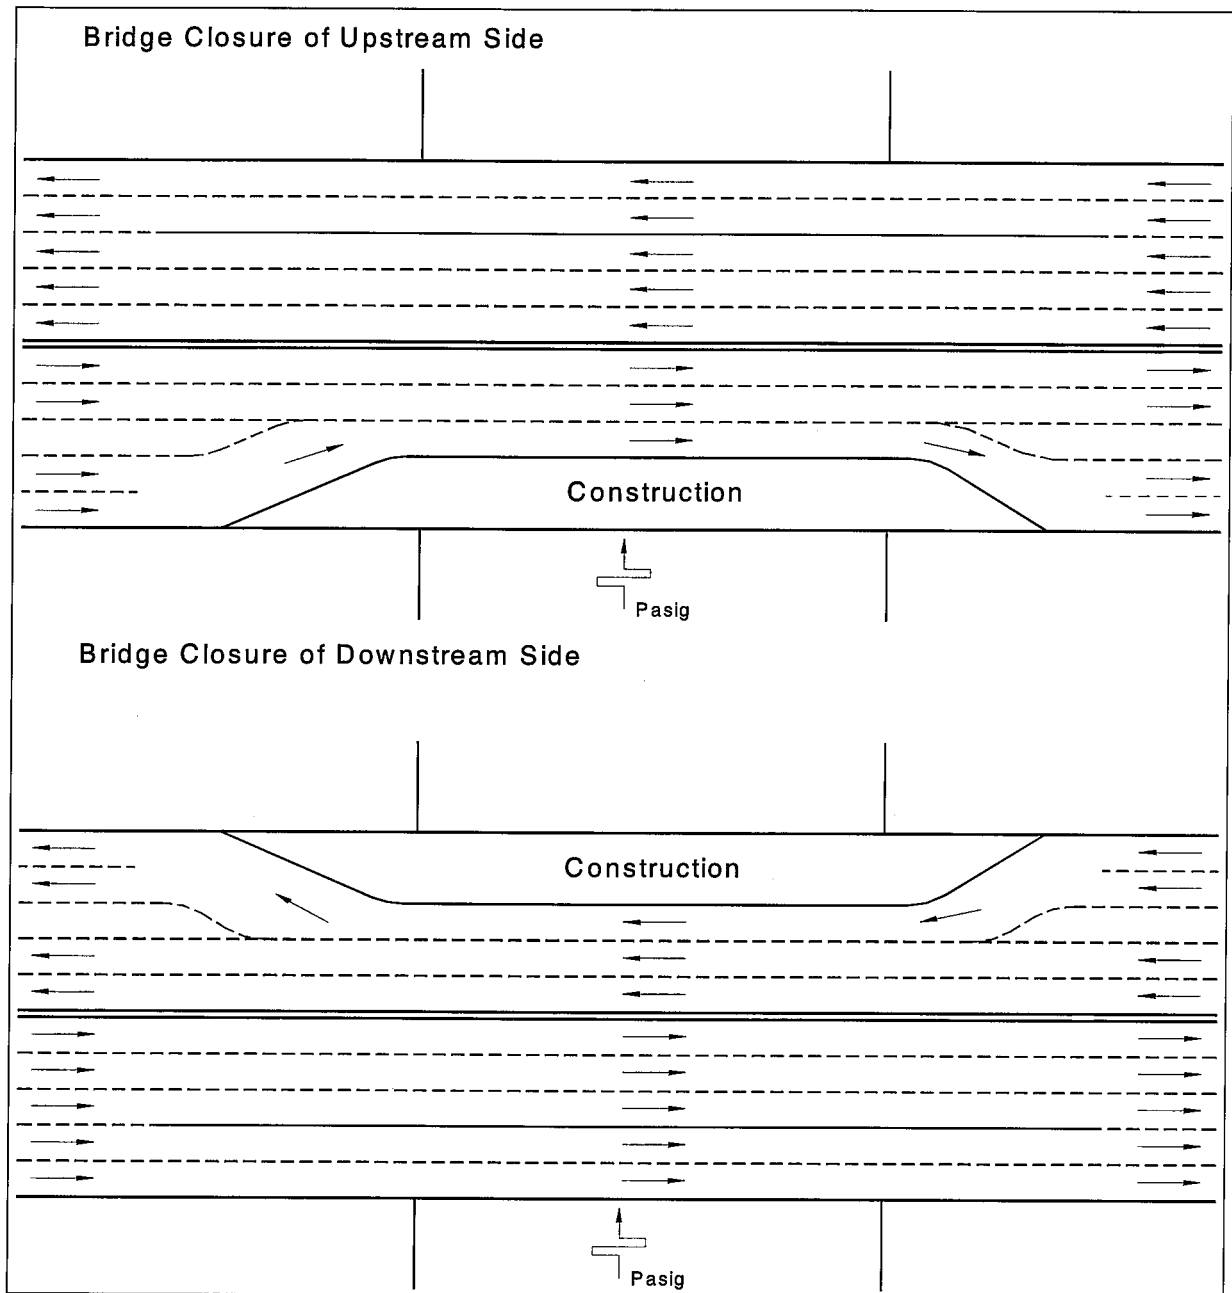
Figure 23.3.2-3 Traffic Lane Control

The traffic lanes will be controlled as shown in **Figure 23.3.2-3** during construction work.

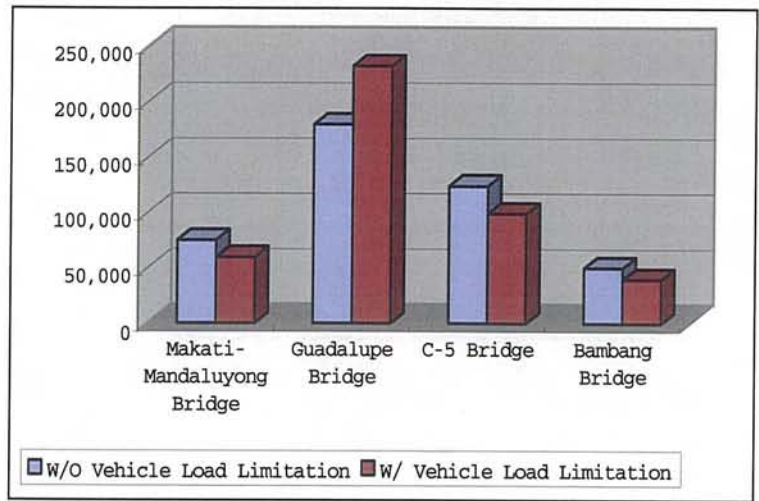
Figure 23.4.1-1 Comparison of Traffic Volume with and without Vehicle Load Limitation in 2010

Based on this table, comparison of future traffic demand with and without vehicle load limitation is made and shown in **Figure 23.4.1-1**. **Figure 23.4.1-2** and **Table 23.4.1-3** shows the vehicle composition by vehicle type of the traffic demand on Guadalupe Bridge. It is noted that share of bus traffic is comparatively large.
