## 24.3 PRELIMINARY DESIGN AND COST ESTIMATE

### 24.3.1 Rehabilitation Design

#### (1) Bridge Design

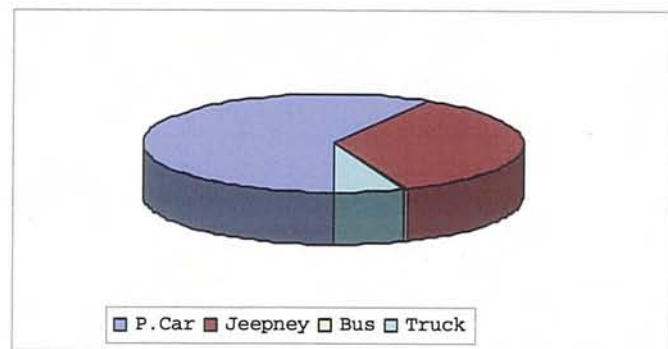
Figure 24.4.1-1 Traffic Volume and its Composition on Vargas Bridge

AADT	Composition (%)
P.Car	31,800	58.2
Jeepney	19,400	35.5
Bus	100	0.1
Truck	3,400	6.2
Total	54,700	100.0
