# **CHAPTER 22**

## **FEASIBILITY STUDY OF LAMBINGAN BRIDGE REHABILITATION PLAN**

CLOSE-UP VISUAL INSPECTION OF DAMAGE (LAMBINGAN BRIDGE)

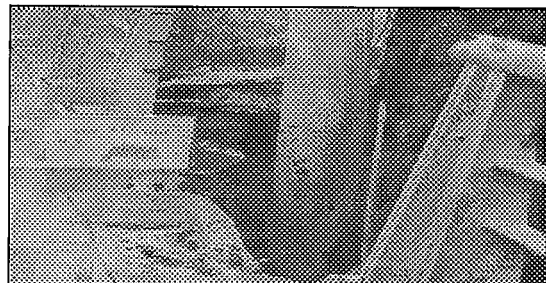
DAMAGE	TYPE	MISSING	
	EVALUATION	X	-
		Y	HIGH
		Z	-
RATING	II		
DAMAGE CONDITION	DUE TO VEHICLE COLLISION		
RAILING	VIEW	PHOTO FILENAME	
APPROACH SLAB @ RIGHT SIDE FACING NORTH	NORTH EAST	P19'

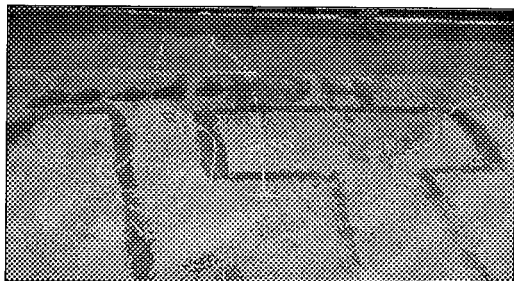
DAMAGE	TYPE	CRACK	
	EVALUATION	X	HIGH
		Y	MEDIUM
		Z	HIGH
	RATING	III	
DAMAGE CONDITION	t = 0.15 mm, spacing + 200 mm		
GIRDER	VIEW	PHOTO FILENAME	
DOWNSTREAM FACE OF G12 @ PIER 2	UPSTREAM	P2'

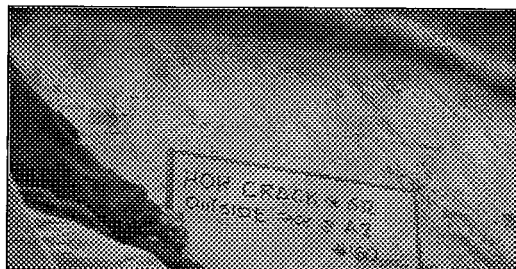
DAMAGE	TYPE	HORIZONTAL CRACKS	
	EVALUATION	X	HIGH
		Y	HIGH
		Z	HIGH
	RATING	II	
DAMAGE CONDITION	l=4300, t=2mm, d+<5 spacing = 150 mm		
GIRDER G12	VIEW	PHOTO FILENAME	
OUTSIDE FACE NEAR A2 (DUE TO ANCHORAGE)	EAST	P160

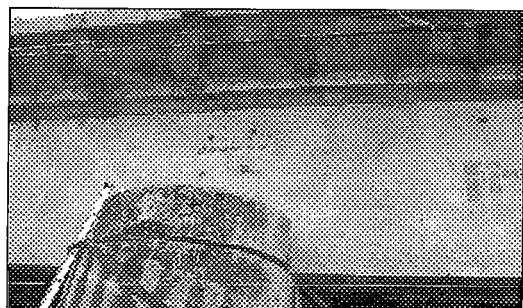
DAMAGE	TYPE	VERTICAL CRACK	
	EVALUATION	X	HIGH
		Y	HIGH
		Z	LOW
	RATING	II	
DAMAGE CONDITION	L=1600mm, w=0.3mm, d=134mm N = 1 (UPV 12)		
ABOVE PIER	VIEW	PHOTO FILENAME	
GIRDER G1 @ PIER 1	DOWNSTREAM	P312

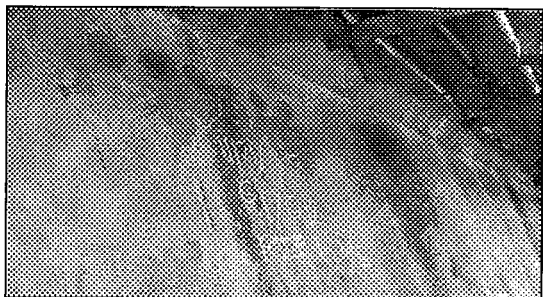
DAMAGE	TYPE	VERTICAL CRACK	
	EVALUATION	X	HIGH
		Y	HIGH
		Z	LOW
RATING	II		
DAMAGE CONDITION	L=1200mm,w=0.4mm,d=180mm, N=1 (UPV 7)		
ABOVE PIER	VIEW	PHOTO FILENAME	
GIRDER G12 @ PIER 1	UPSTREAM	P307

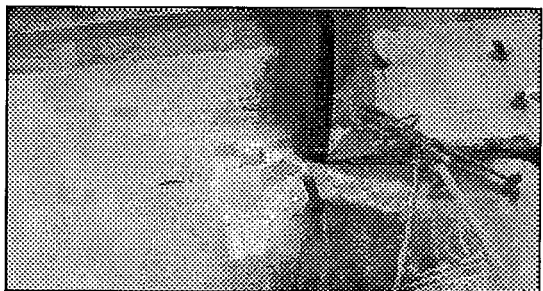
DAMAGE	TYPE	DIAGONAL CRACK	
	EVALUATION	X	HIGH
		Y	HIGH
		Z	LOW
RATING	II		
DAMAGE CONDITION	L+250mm,w+0.3mm,d=20mm, N=1 (UPV 11)		
GERBER HINGE	VIEW	PHOTO FILENAME	
GIRDER G1 @ GH1-L	DOWNSTREAM	P311

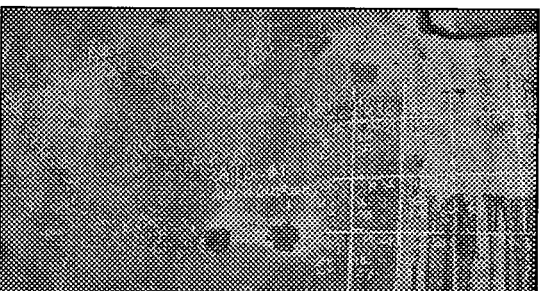
DAMAGE	TYPE	DIAGONAL CRACK	
	EVALUATION	X	HIGH
		Y	HIGH
		Z	LOW
RATING	II		
DAMAGE CONDITION	L=350mm,w=0.2mm,d=56mm N=1 (UPV 1)		
GERBER HINGE	VIEW	PHOTO FILENAME	
GIRDER G12 @ GH2-L	UPSTREAM	P301

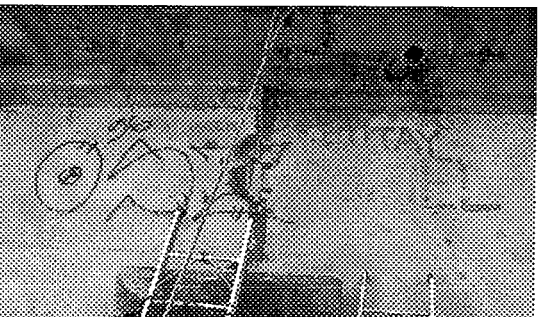
DAMAGE	TYPE	VERTICAL CRACK	
	EVALUATION	X	HIGH
		Y	HIGH
		Z	LOW
RATING	II		
DAMAGE CONDITION	L=1200mm,w=0.15mm,d=29mm N=1 (UPV 6)		
ABOVE PIER	VIEW	PHOTO FILENAME	
GIRDER G12 @ P2	DOWNSTREAM	P303

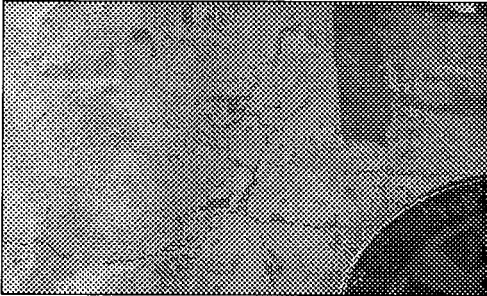
DAMAGE	TYPE	CRACKS	
	EVALUATION	X	LOW
		Y	HIGH
		Z	HIGH
RATING	II		
DAMAGE CONDITION	l <sub>max</sub> =1mm, spacing=200mm SURFACE CRACKS DUE TO SHRINKAGE & TEMPARATURE		
ABUTMENT WALL	VIEW	PHOTO FILENAME	
LEFT SIDE, ABUTMENT A1	SOUTH	P45

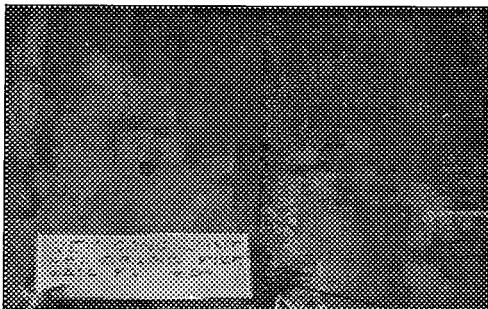
DAMAGE	TYPE	CRACK	
	EVALUATION	X	LOW
		Y	HIGH
		Z	LOW
RATING	III		
DAMAGE CONDITION	VERTICAL CONSTRUCTION JOINT (L=4800,t=10(max.),d=(THROUGH),spacing>500mm)		
PIER WALL (P1)	VIEW	PHOTO FILENAME	
BETWEEN G9-G10	MORTH	P89

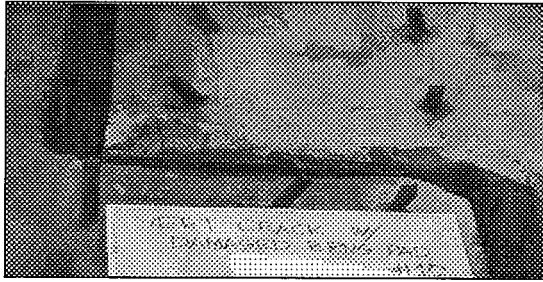
DAMAGE	TYPE	MOVEMENT	
		X	-
		Y	HIGH
	Z	-	
RATING	II		
DAMAGE CONDITION	ABNORMAL MOVEMENT OF BEARING		
BEARING PAD	VIEW	PHOTO FILENAME	
	OUTSIDE FACE G1, GERBER HINGE 1	WEST	P10

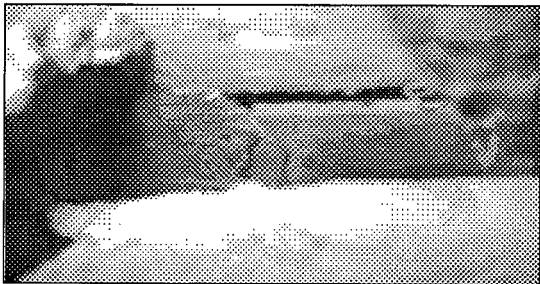
DAMAGE	TYPE	MISSING	
		X	-
		Y	LOW
	Z	-	
RATING	III		
DAMAGE CONDITION	ABNORMAL MOVEMENT OF BEARING		
BEARING PAD	VIEW	PHOTO FILENAME	
	GIRDER G2 @ GERBER HINGE 1		P98

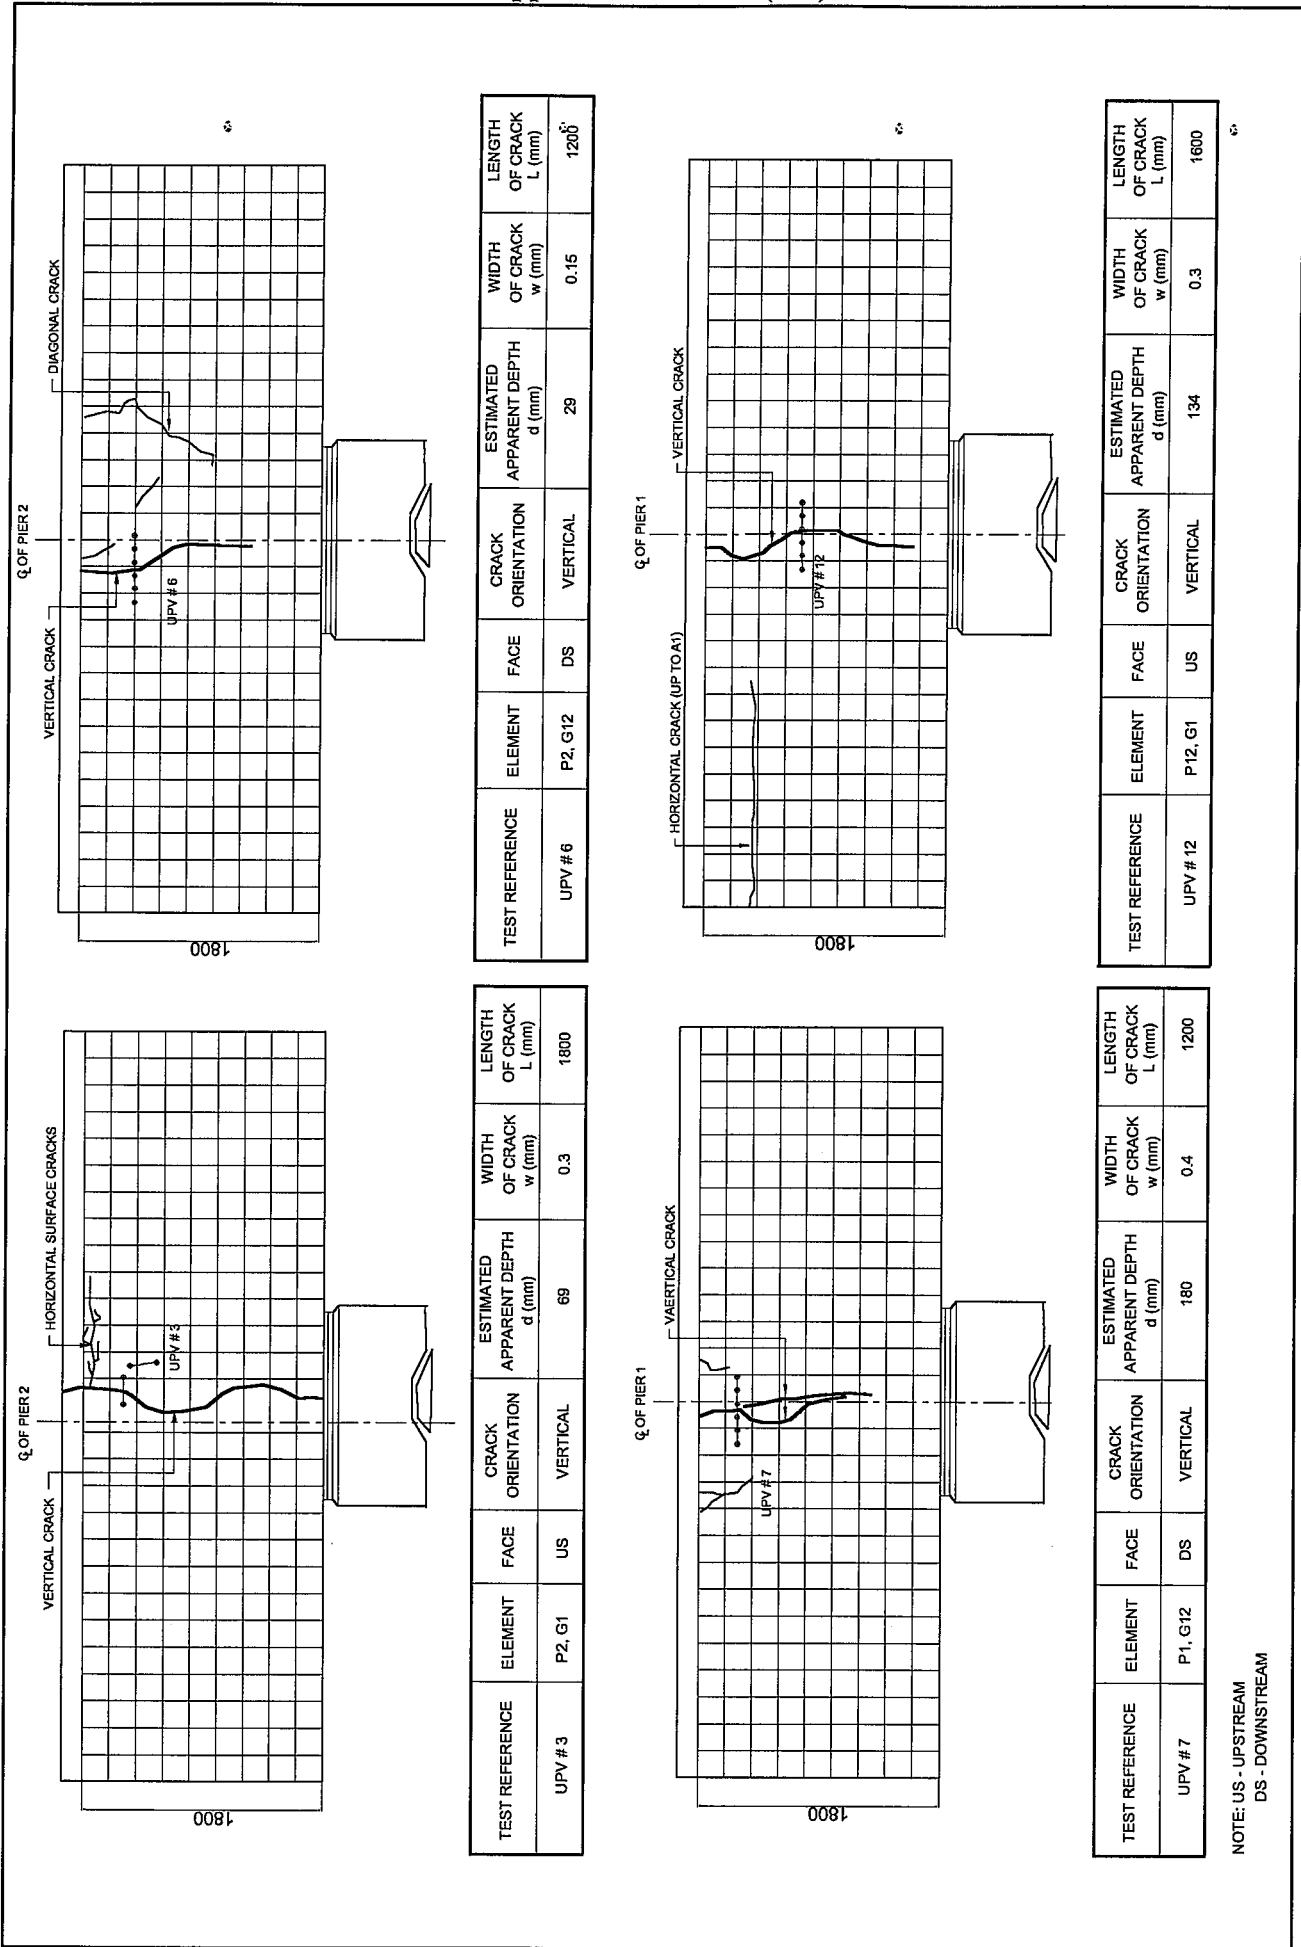
SUMMARY OF RESULTS FOR UPV ABOVE PIER

TEST REFERENCE	ELEMENT	FACE	CRACK ORIENTATION	ESTIMATED APPARENT DEPTH d (mm)	WIDTH OF CRACK w (mm)	LENGTH OF CRACK L (mm)
UPV # 6	P2, G12	DS	VERTICAL	29	0.15	1200

TEST REFERENCE	ELEMENT	FACE	CRACK ORIENTATION	ESTIMATED APPARENT DEPTH d (mm)	WIDTH OF CRACK w (mm)	LENGTH OF CRACK L (mm)
UPV # 12	P12, G1	US	VERTICAL	134	0.3	1600

TEST REFERENCE	ELEMENT	FACE	CRACK ORIENTATION	ESTIMATED APPARENT DEPTH d (mm)	WIDTH OF CRACK w (mm)	LENGTH OF CRACK L (mm)
UPV # 3	P2, G1	US	VERTICAL	69	0.3	1800

TEST REFERENCE	ELEMENT	FACE	CRACK ORIENTATION	ESTIMATED APPARENT DEPTH d (mm)	WIDTH OF CRACK w (mm)	LENGTH OF CRACK L (mm)
UPV # 7	P1, G12	DS	VERTICAL	180	0.4	1200
