BASIC DESIGN STUDY REPORT
ON
THE PROJECT FOR REHABILITATION
OF
BRIDGES ON THE HIGHLANDS HIGHWAY
IN
PAPUA NEW GUINEA

FINAL REPORT

July 2004

JAPAN INTERNATIONAL COOPERATION AGENCY
NIPPON KOEI CO., LTD.

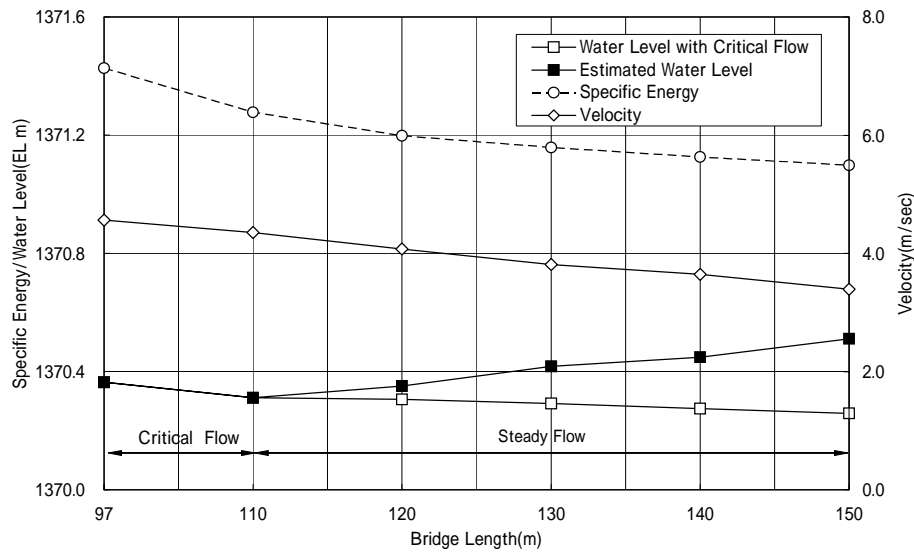
Figure 2-5 Relationship of Bridge Length and Water Level /Velocity

As such, the river flow condition with varying bridge length is assessed using a non-uniform flow calculation up to steady flood flow, which indicates the desirable bridge length. A result of the assessment is summarized in Figure 2-5.

According to the result, river flow was made steadier with a length of more than 110 m. Specific flow was also gentler with a length of more than 110-120 m. Consequently, the bridge length of the new Bena Bena Bridge was proposed as 120 m.

The existing Bena Bena bridge with a total span length of 100 m is located at a man made topographical bottleneck with a flood plain with more than 200 m wide upstream and downstream. Based on hydraulic analysis at the present situation, it has been revealed that critical flow with damming up phenomenon upstream and severe local scouring around the piers appear at the bridge crossing site. Extension of the bridge length therefore is required in order to mitigate such adverse effects.
