6.6 PILOT PROJECT - AMPANG JAYA LANDFILL SITE (SELANGOR)

6.6.1 Outline of the site

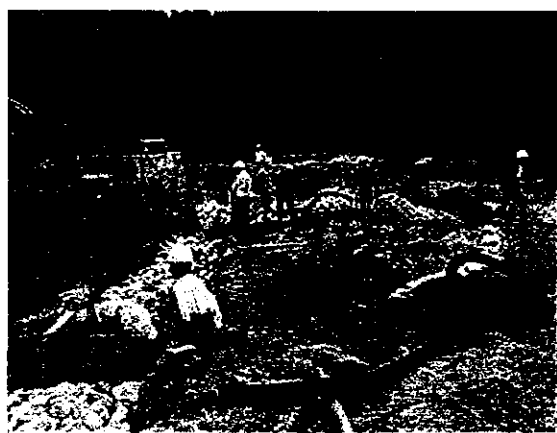
Installation of leachate collection pipe

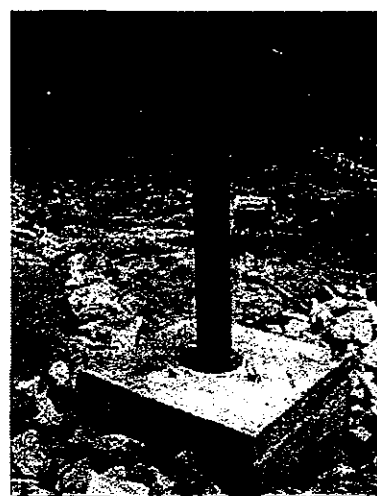
Gas ventilation pipe

The gas ventilation pipes act as the gas vents and also air supply pipes to supply oxygen to the waste layers and accelerate the waste degradation process. The gas ventilation pipes should be maintained over the long term and new ventilation pipes be installed where necessary.

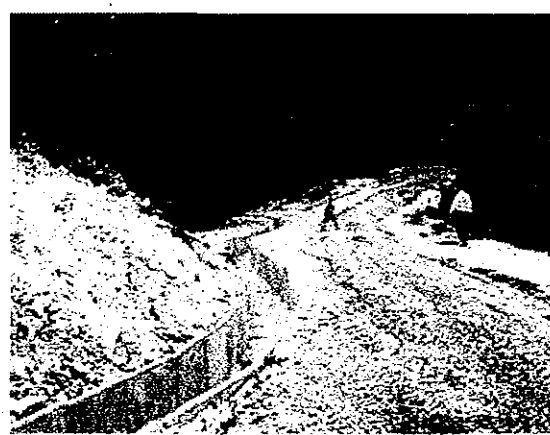
Improvement of access road and drain

Other supporting facilities like the access road and the vegetation growth on the top/slopes should be maintained where necessary for a long period of time. For the PP, a large portion of the works involved the repair and upgrading of the access road. This access road is the only access to the site and should be maintained properly. Furthermore, since the gradient of the access road is rather steep, and prone to erosion and wash out by heavy rain water, it is crucial that the road surface is constantly repaired and protected.

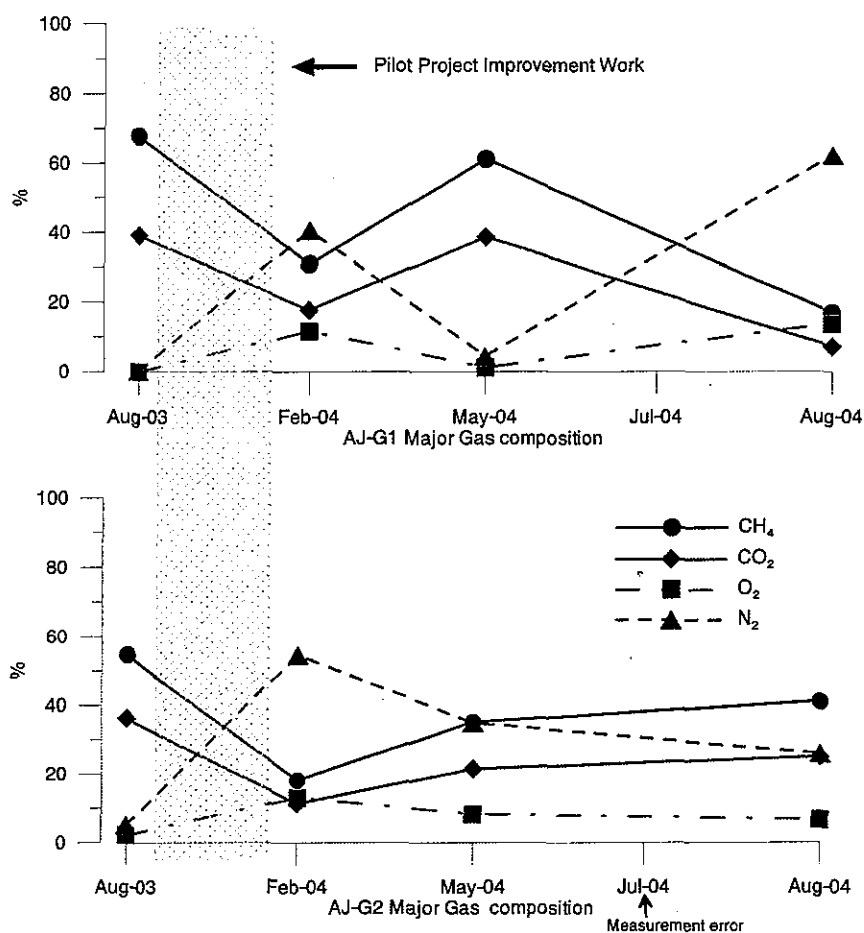
Figure 6.7.5 Ampang Jajar Landfill Gas Monitoring Results

Figure 6.7.5 shows the results of the monitoring for CH₄, CO₂, O₂ and N₂ of AJ-G1 and AJ-G2. It was found that the measurements taken in July, 2004 were not entirely correct due to some measurement error and therefore new measurements were taken in August, 2004.

The results for AJ-G1 showed fluctuated data for all the parameters. It seemed that the landfill gas generated by the organic decay, namely CH₄ and CO₂ tend to decrease after the PP works. The results for AJ-G2 also showed similar trends. It is premature at this early stage to conclude about the long-term effects of the PP improvement from the limited current data.

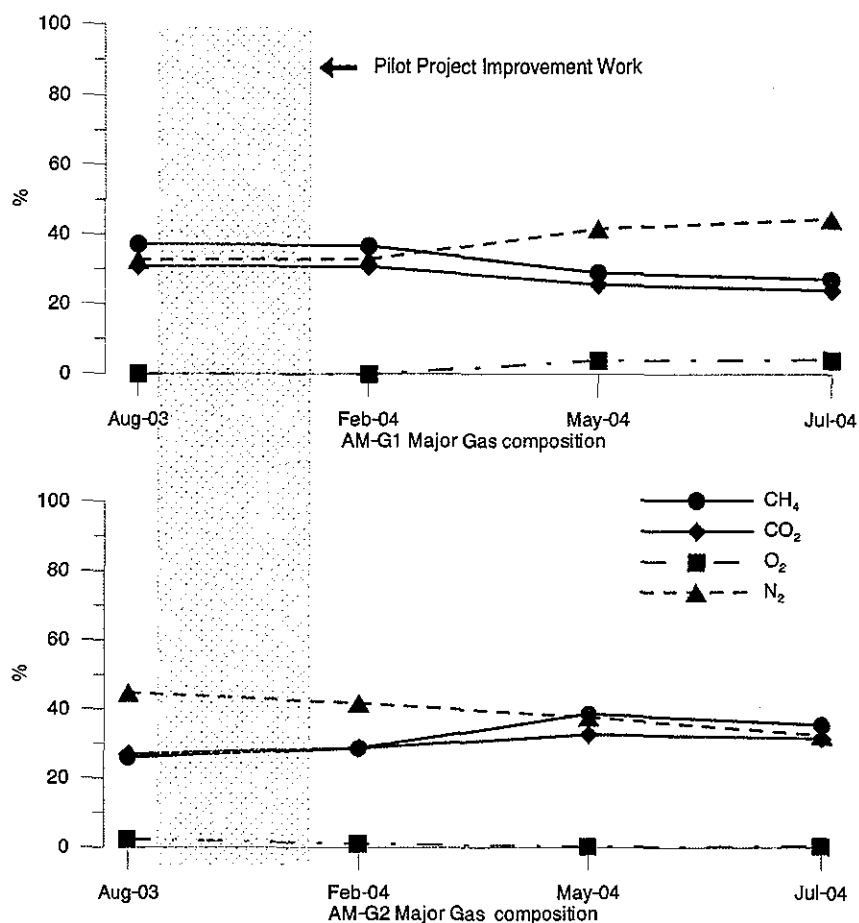
Figure 6.7.14 Ampang Jaya Landfill Gas Monitoring Results

Figure 6.7.14 shows the monitoring results of the landfill gas at AM-G1 and AM-G2. AM-G1 showed slight decrease in CH_4 and CO_2 and increase in N_2 . This may indicate better air circulation into the waste layers. On the other hand, AM-G2 showed the opposite tendency with slight increase in CH_4 and CO_2 and decrease in N_2 . In both points, the changes were not so significant and cannot be related definitely to the PP improvement works.
