## CHAPTER 7 PEKAN NENASI LANDFILL SITE (PAHANG)

### 7.2 THE SAFE CLOSURE PLAN

*The Study on The Safe Closure and Rehabilitation of Landfill Sites in Malaysia  
Final Report – Volume 4*

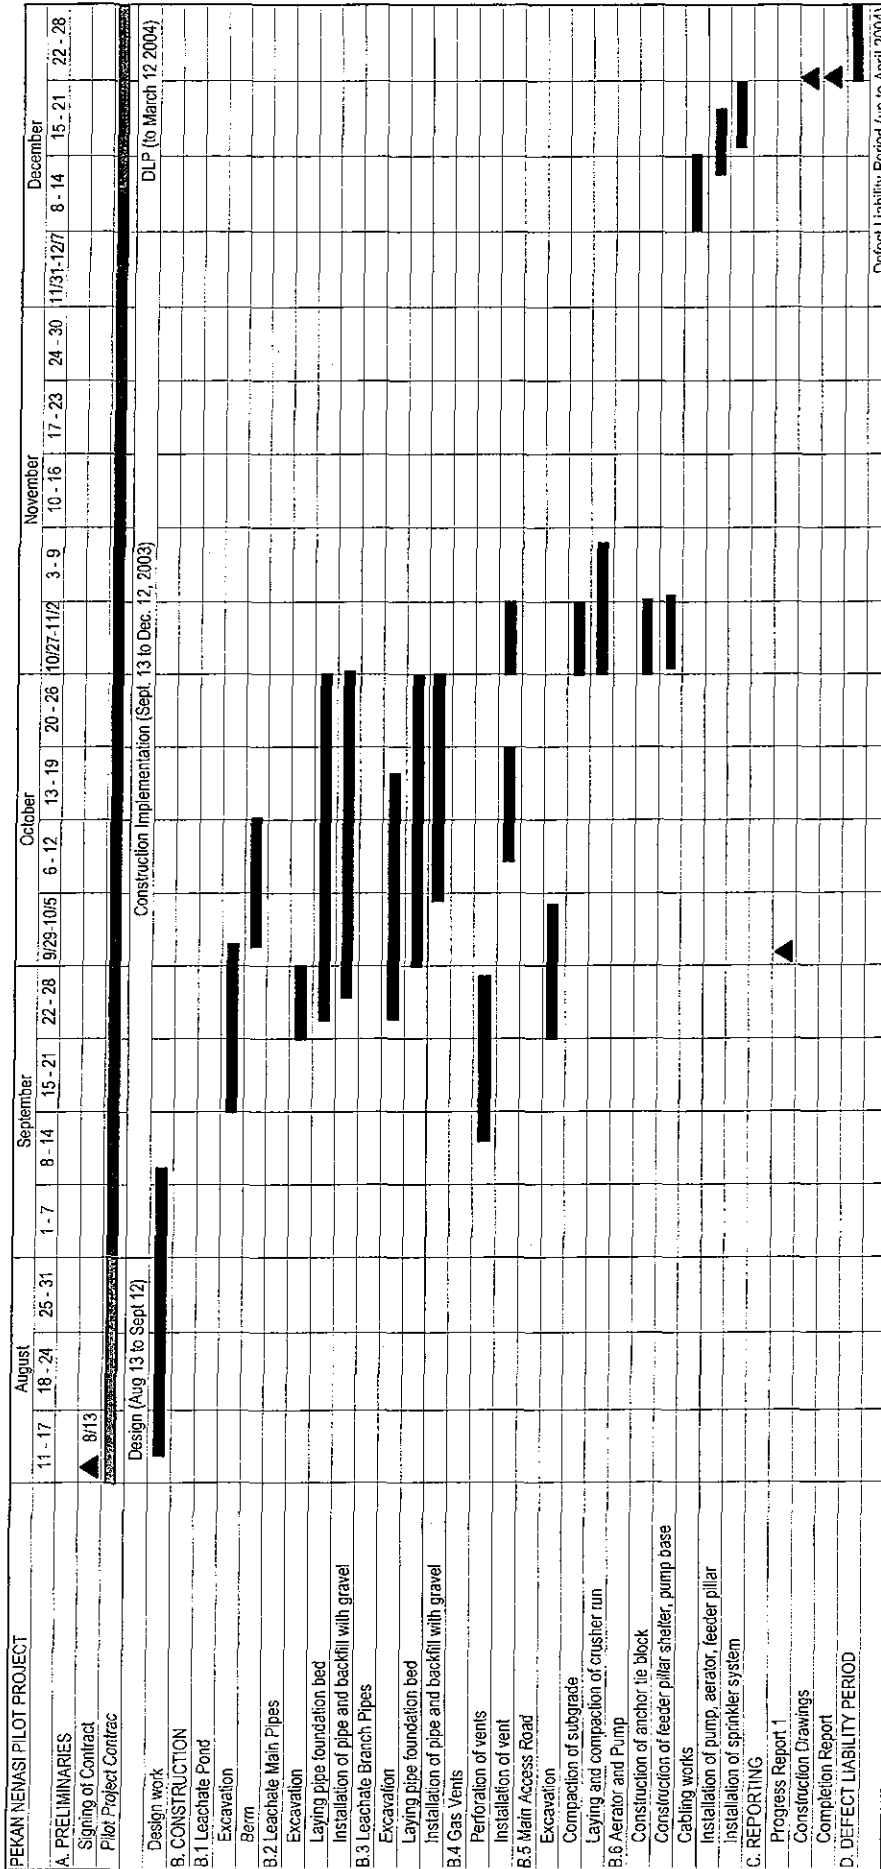
Figure 7.4.1 Project Implementation Schedule for Pekan Nenasi PP

Following the commencement of the project, as part of the deliverables, the contractor prepared and submitted the project implementation schedule as shown in **Figure 7.4.1**.

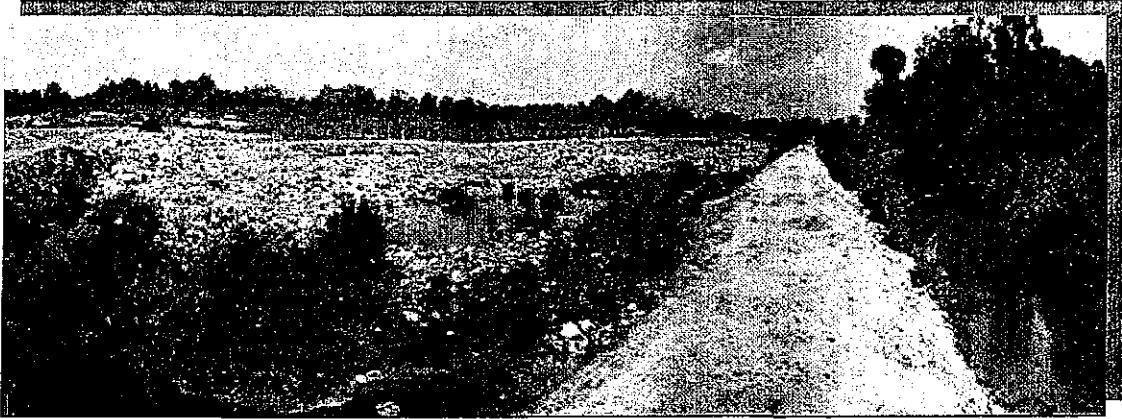
**Plate 7.4.1 Pekan Nenasi Pilot Project 1**

**Before pilot project (PP)**

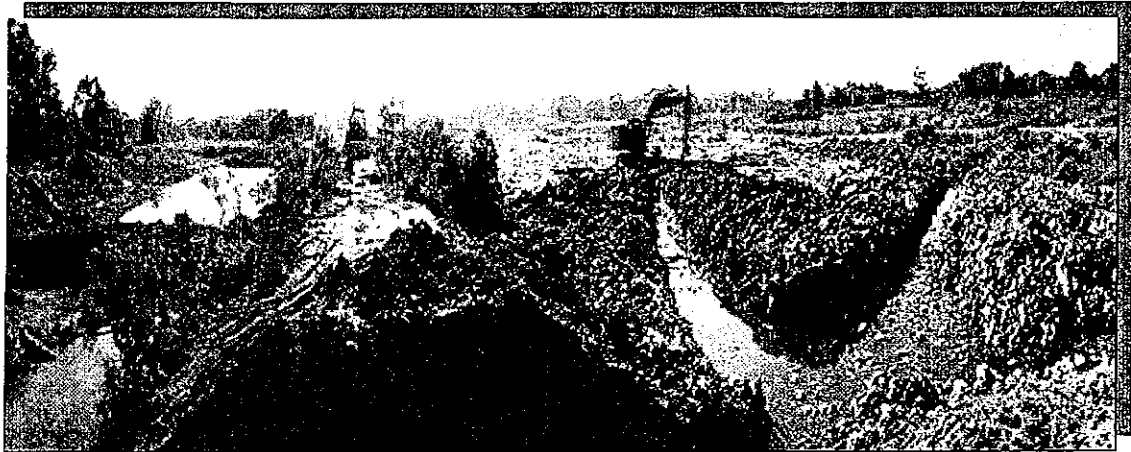
**During PP**

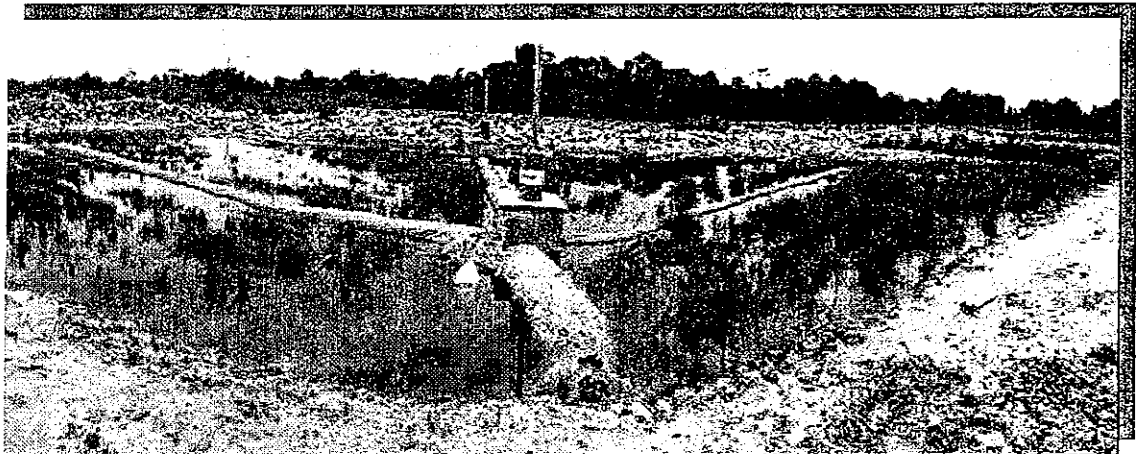
**After PP**

(Installation of leachate pipe & gas vent)

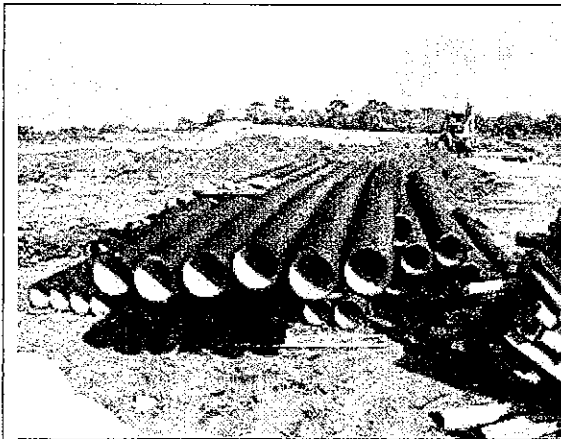
**Plate 7.4.2 Pekan Nenasi Pilot Project 2**

Leachate collection pipe  
(Branch pipe)

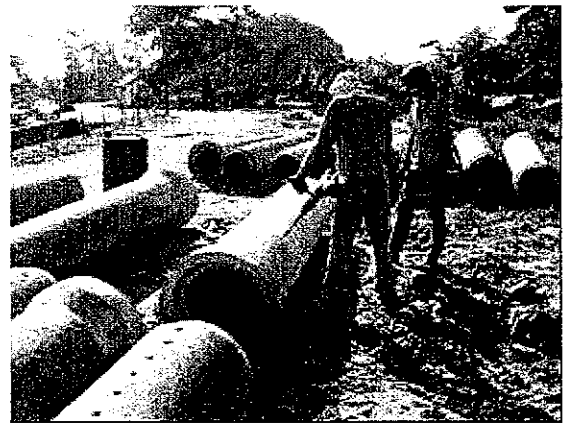
Leachate collection pipe  
(Main Pipe)

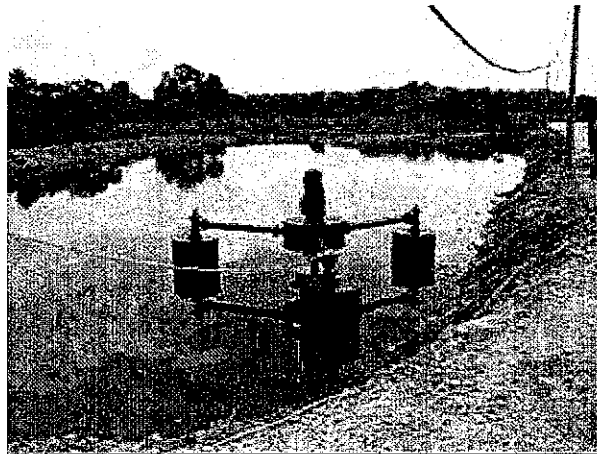
Aerator

The proper operation and maintenance of the leachate collection and treatment facilities is essential for the treatment of the leachate prior to discharging the effluent into the drains. The equipments such as the aerator and the recirculation pump must be maintained and serviced regularly and should be in good working conditions. The control panel should be inspected regularly and maintained.

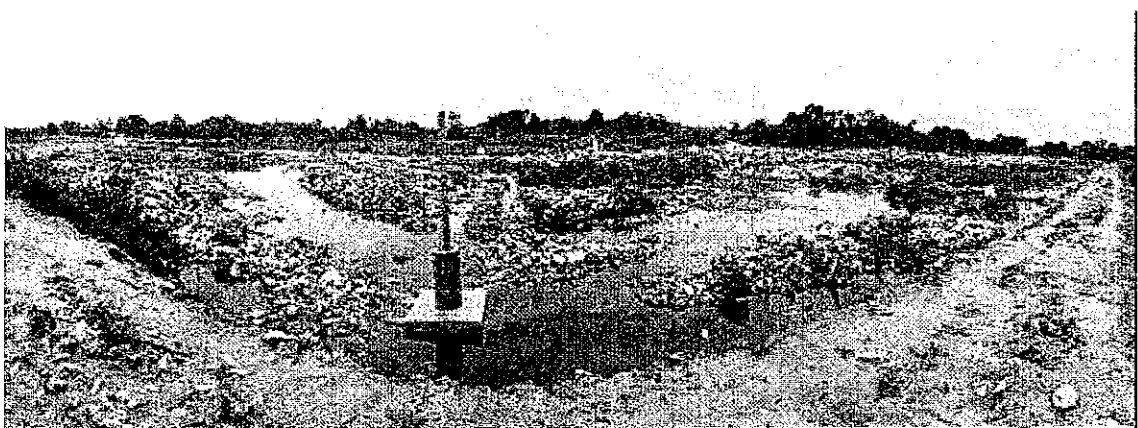
Leachate collection & gas venting System Installed by the LA  
(After pilot project works)

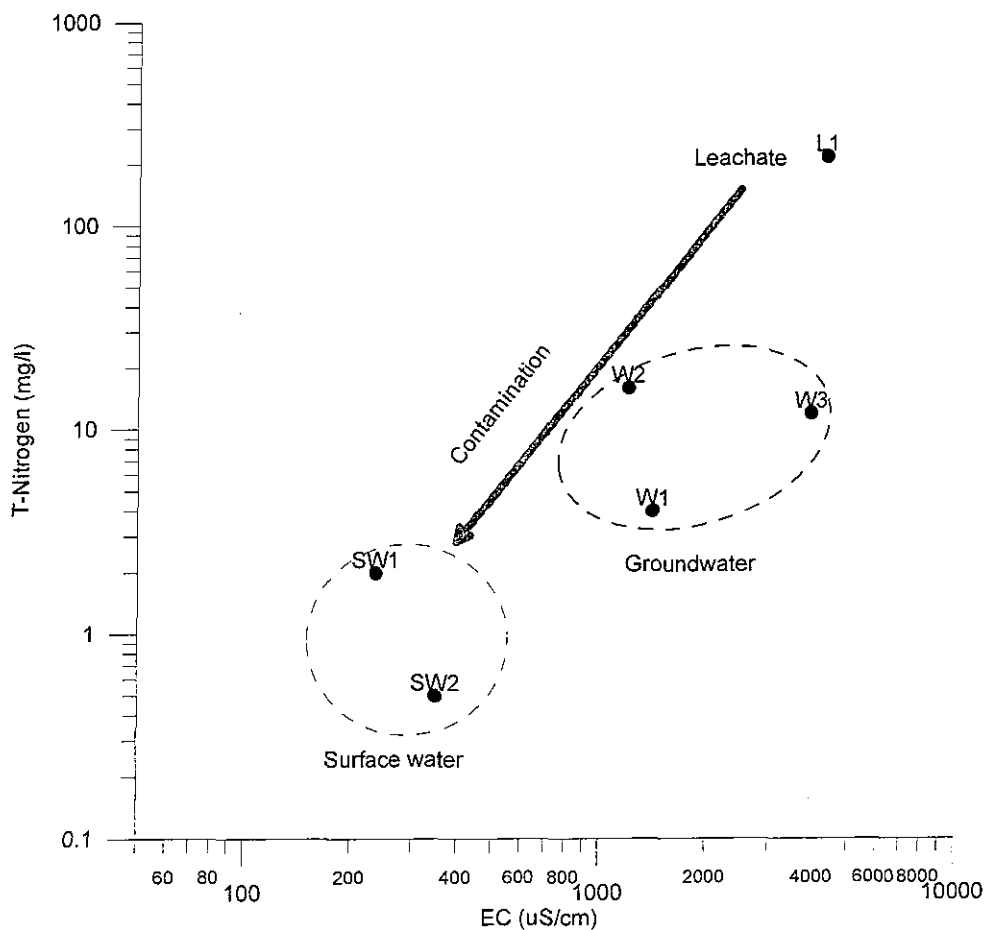
**Figure 7.5.6 Water Quality Relationship - Pekan Nenas PP**

The relationship between the quality of leachate, surface water and groundwater can be expressed in their total nitrogen and electric conductivity as shown in **Figure 7.5.6**, similar to the chart that was produced for Ampang Jajar PP.

From the chart, it can be observed that the 3 sample groups are apart, with leachate as the most contaminated, followed by groundwater and the surface water. Also it is noted that approximate ratio of Total nitrogen and Electric conductivity are the same for the three groups thus implying they may have the same source of contamination.

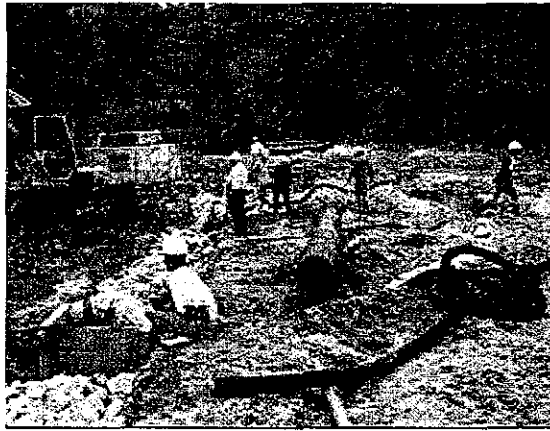
Installation of leachate collection pipe

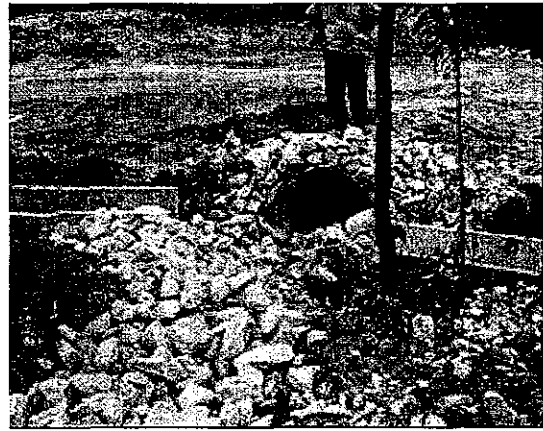
Storm water drainage below access road

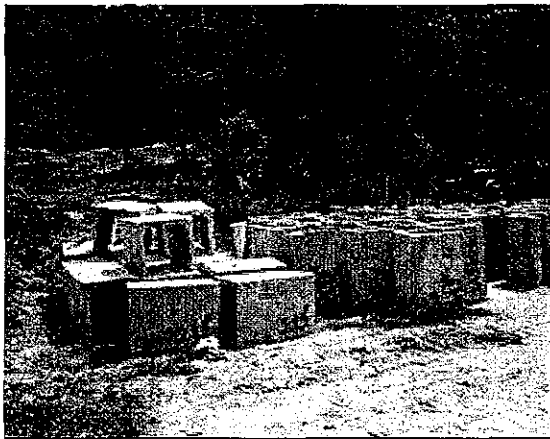
U-shaped drainage

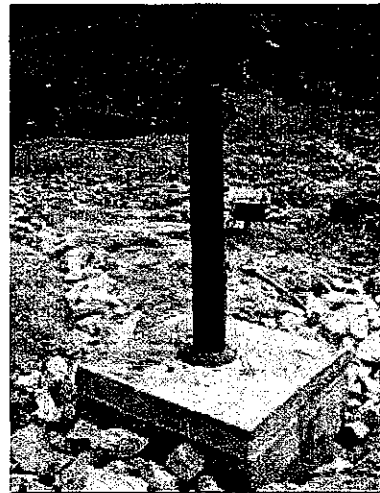
Gas ventilation pipe

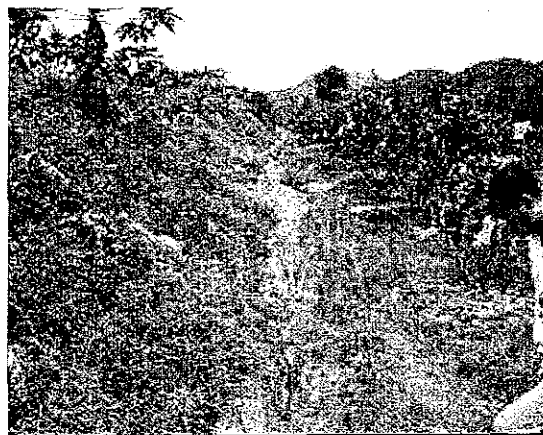
Storm water drainage at upper valley

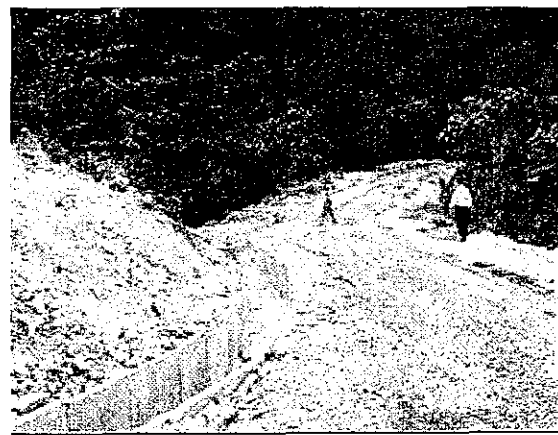
Improvement of access road and drain
