**Result of Scheme Formulation
in Mvomero District
Record of Site Inspection (Step-2)**

Record of Site Inspection Survey Sheet for Quick Site Inspection

1. General Information	Surveyed Date: May 24, 2004
(1) Name of the scheme : Bwage	
(2) Location (any point in the scheme) : Latitude: 5°57.628'S Longitude: 37°46.374'E

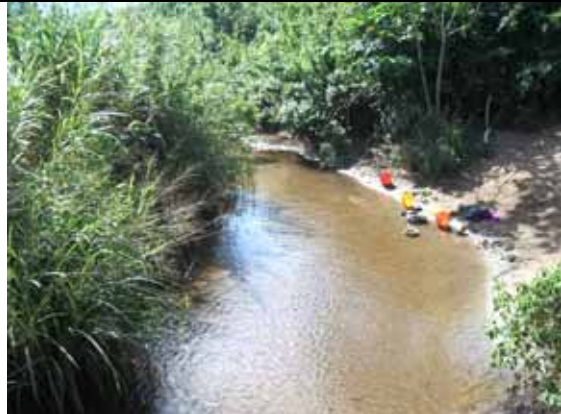
Water source.

Observation
Major part of the proposed potential area is presently not cultivated. To develop irrigation area, land clearing is required, so that the cost for land clearing should be considered in cost estimate.

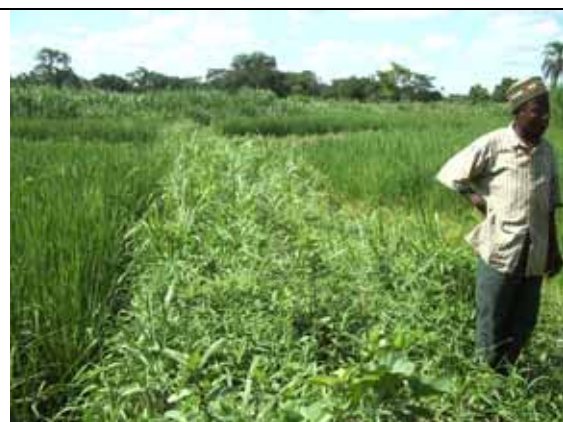
Irrigated paddy field.

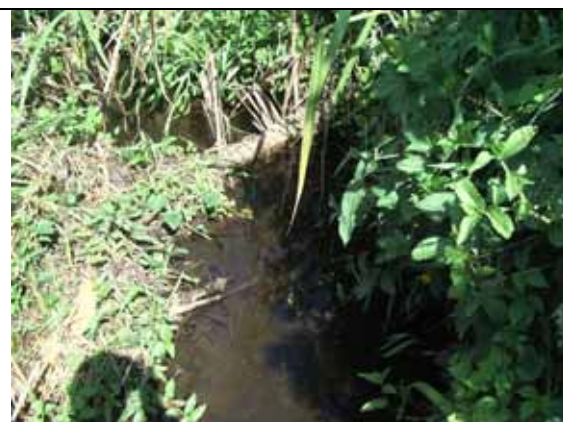
Traditional intake.

The scheme is presently irrigated by traditional irrigation system and no major facilities are observed. The irrigable area in wet season is 80 ha and 10 ha in dry season according to the beneficiaries. According to the villagers, the most sever problems for the scheme is drainage (or flood control). The problem seems to occur since the area is located very near from the river.

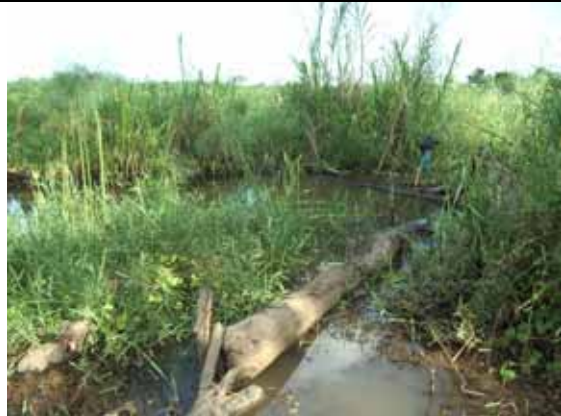
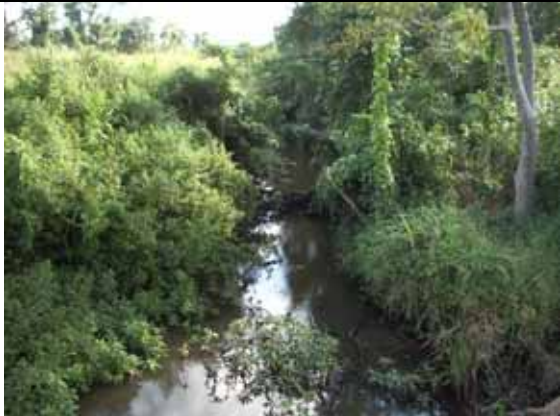
Sub-water source.	Main water source.

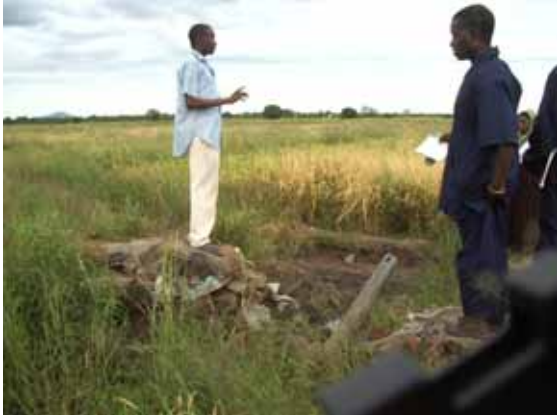
Information collection from beneficiaries.	Facility for water harvesting (not well functioning).

Damaged facility for water harvesting.	
Observation

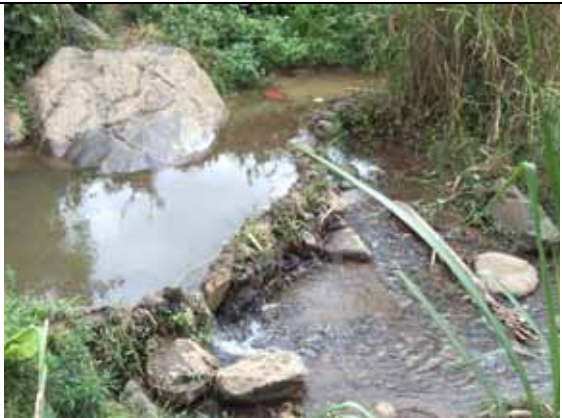
Information collection from extension staff.	Traditional intake.

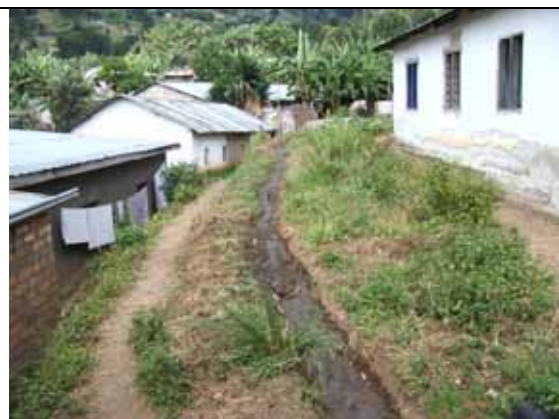
One of the canal systems near the village.

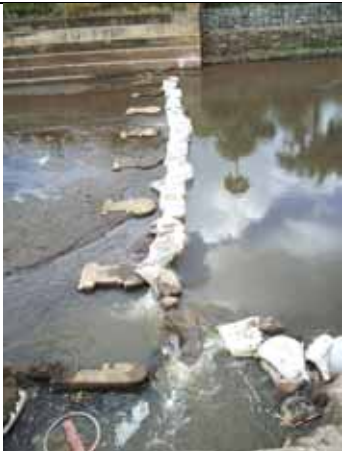
Information collection from village chief.	Damaged headworks by siltation.

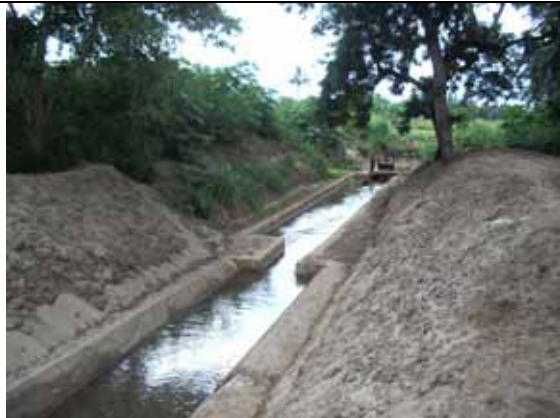
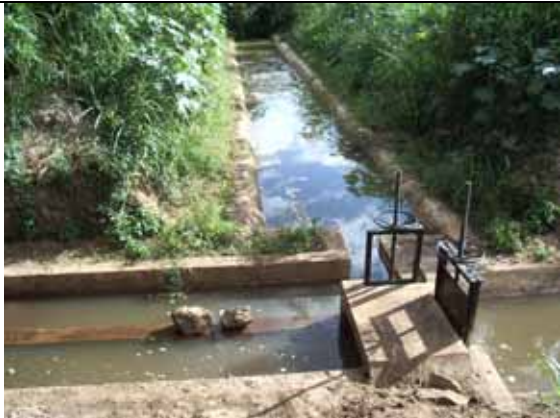
Intake with sand trap.	Sand flushing channel (not functioning well).

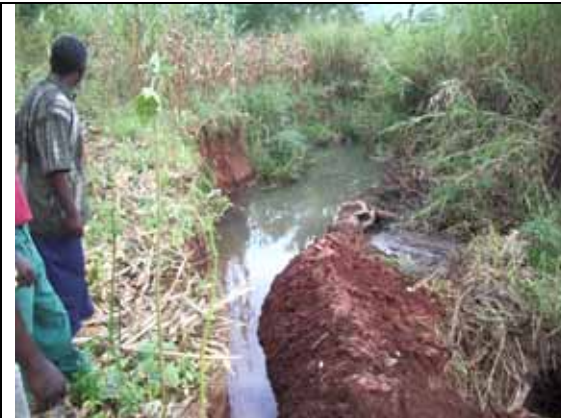
Information collection from village chief.	Traditional intake.

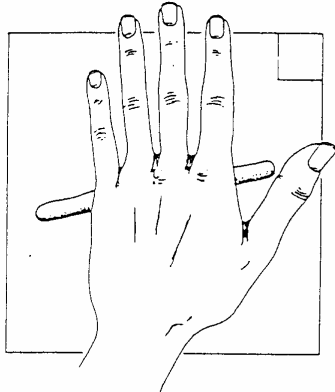
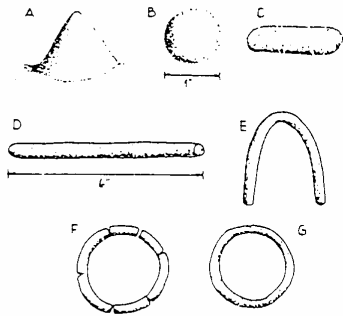
<p>A: Soil can only be shaped into a cone. No other shapes hold together.</p> <p>B: Soil can be formed into a circle, but not a rod shape.</p> <p>C: Soil can be formed into a stout rod shape.</p> <p>D: A thin rod (about 6 mm diameter) can be formed but not bent.</p> <p>E: Thin rod can be bent without breaking</p> <p>F: Circle can be formed with some breaks.</p> <p>G: Complete circle with no breaks can be formed.</p>
