Technical Specification for Khawr Kabir

1. SITE DESCRIPTION

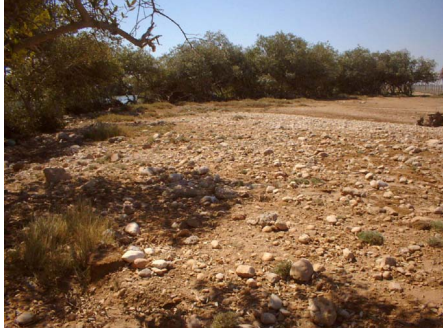
View of midstream of water channel

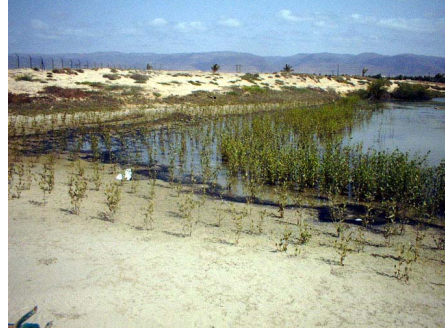
North shore near mouth of khawr

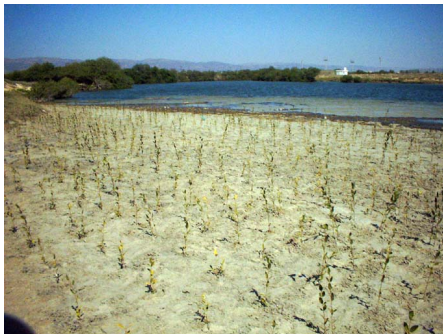
Transplanted seedlings near beach side

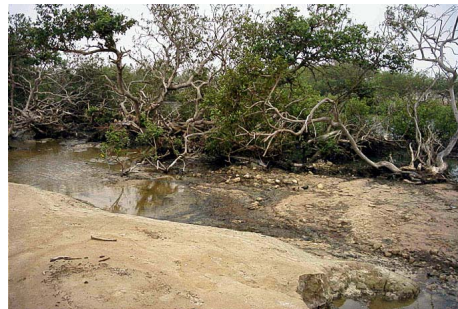
Standing dead trees at upstream of water channel

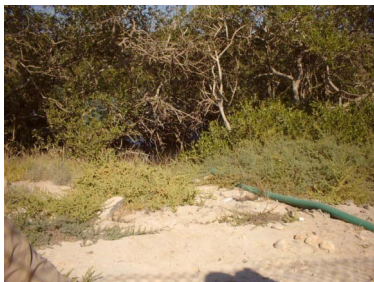
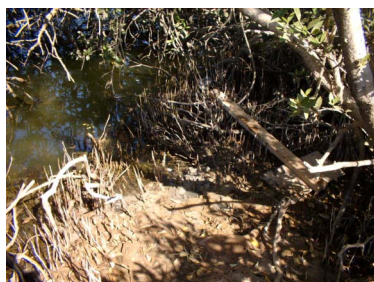
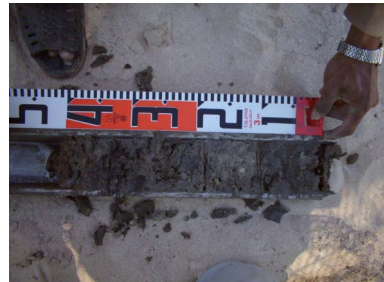
Front of nursery under vegetation (Profile No. Ka-1)

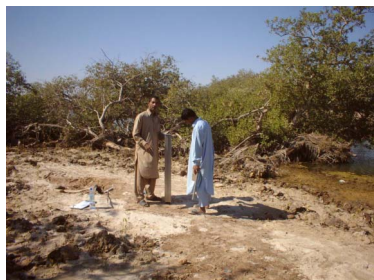
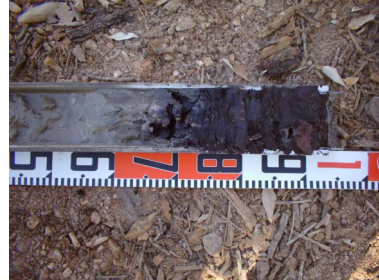
Upstream of khawr under vegetation (Profile No. Ka-2)

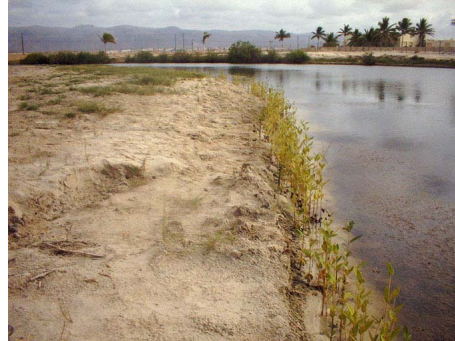
West shore with natural regeneration

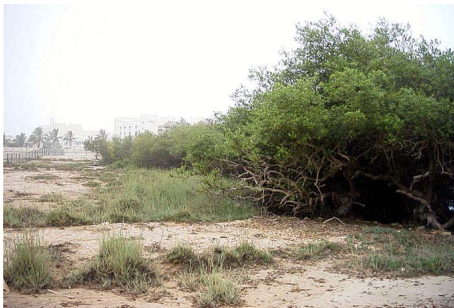
Mangroves at upstream of water channel

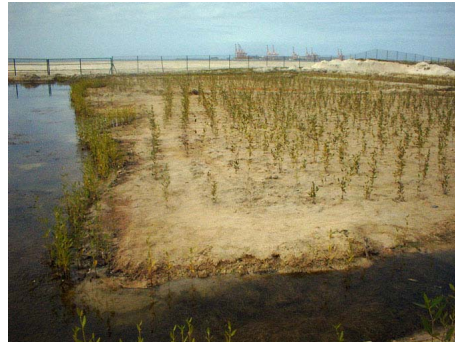
Transplanted trees on reclamation area

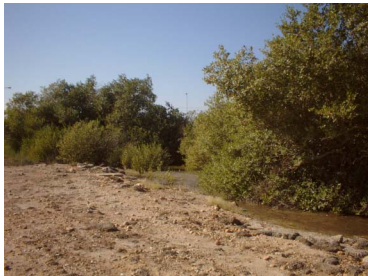
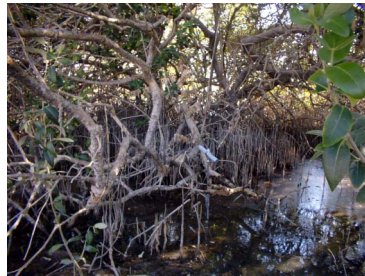
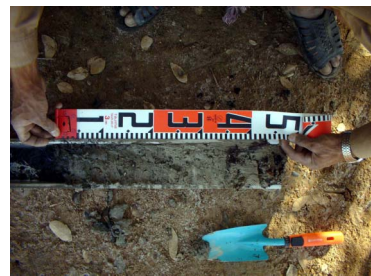
North shore, up-stream under vegetation (Profile No. Sa-1)

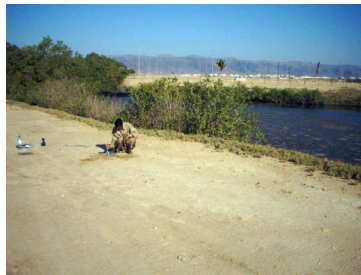
South shore, 1.5m away from water channel (Profile No. Sa-2)

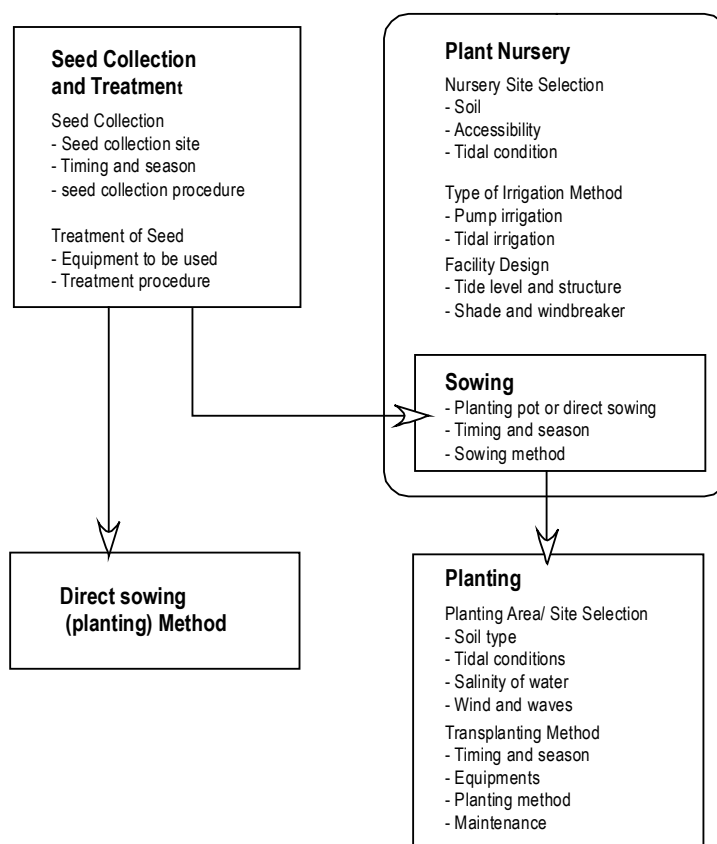
Figure 2.1.1 General Tasks for Mangrove Afforestation

Mangrove afforestation consists of certain tasks for successful planting. Figure 2.1.1 shows the general tasks to be taken. The guideline shows the procedure of each task in the following sections.

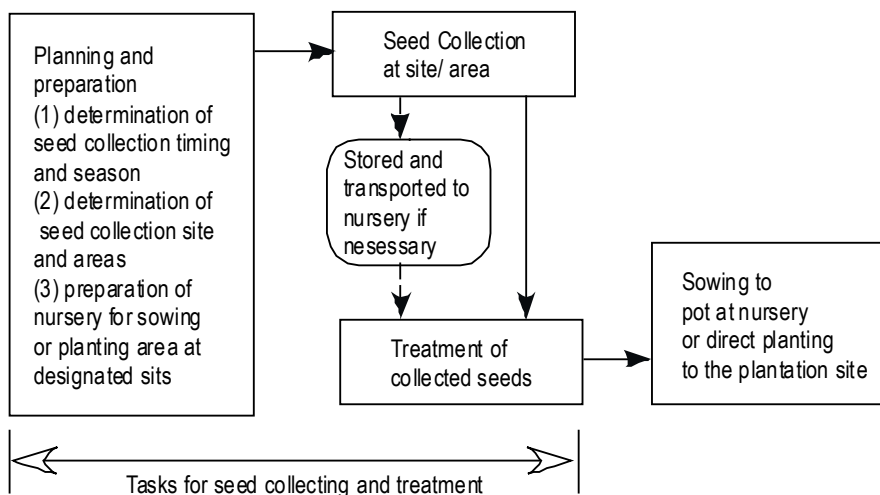
The following shows the general flow of seed collection and treatment.

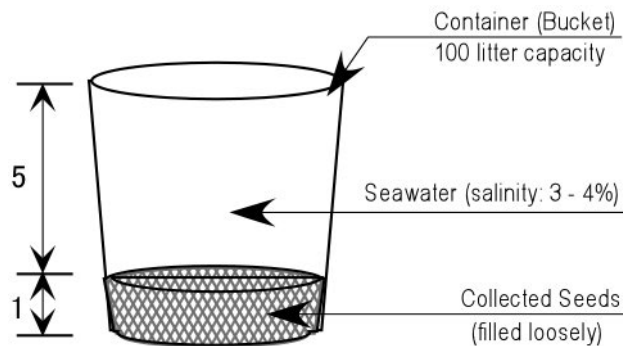
- At first, the collected seeds should be soaked and washed for 6 hours or more by seawater. Put the collected seeds into the large container and fill with fresh clean seawater. The amount of seeds put in to the container should be less than one sixth (1/6) of volume of the container to avoid damage to the seeds by their weight.

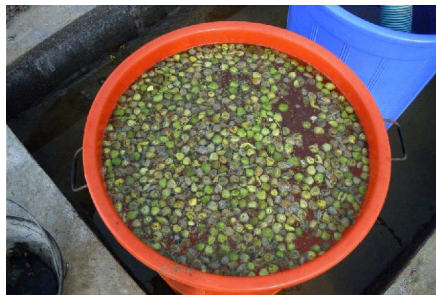
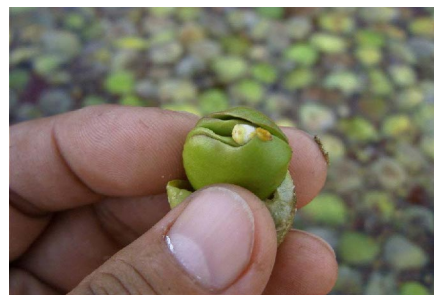
- After a little while, the wastewater in the container (bucket) will change color to brown. Change the water every 2 hours or more frequently.
- When changing the soaking water, cover the container by mesh net, and empty the wastewater out of the container. This water will damage the seeds and the nursery. Therefore, the wastewater used for soaking and washing the seeds should not be dumped inside the nursery but outside.

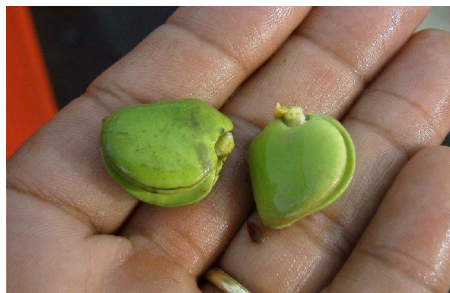
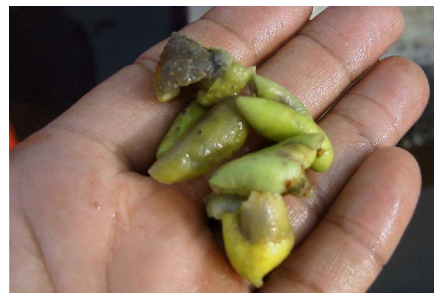
- Seed coats (pericarp) of the seeds will be peeled off by themselves, otherwise, they should be removed manually. Removed seed coats will also damage the seeds, so after the seed coats are removed, the seeds should be put into another plastic container (bucket) filled with new seawater for washing for 6 hours or more and the removed seed coats should be taken out of the bucket.

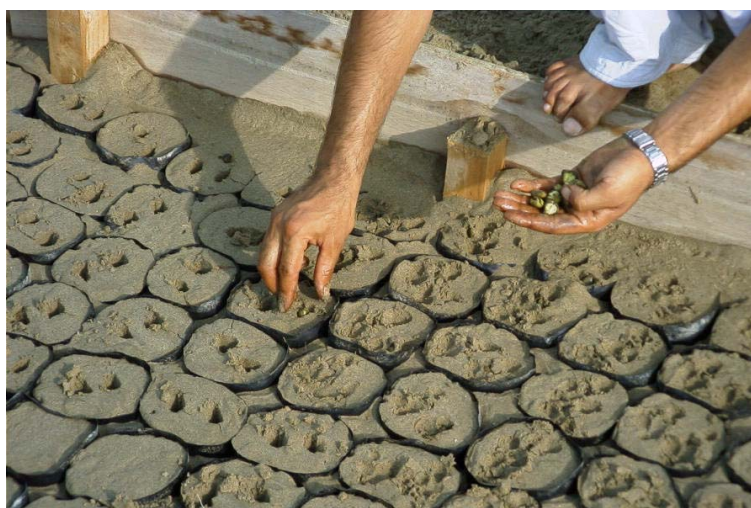
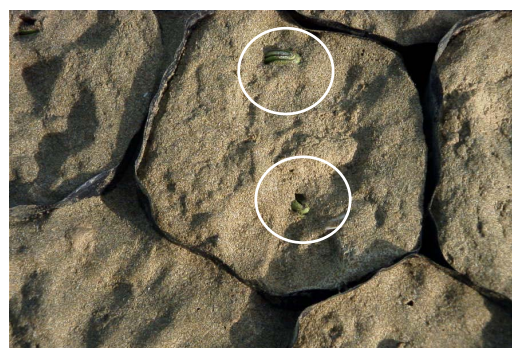
After the pre-treatment, seeds can be sown. The following pictures show an example of sowing into a seedling pot (agricultural vinyl pot) to be used in the nursery.

Depth for sowing

2~3 seeds/pot

- Seedling pot to be used is the agricultural vinyl pot. The size is 10cm diameter and 25cm height with punched holes for water to drain.

- Normal beach sand at the site or near the nursery should be used. No silt or muddy soil should be used.
- 2 to 3 seeds per pot.
- One third (1/3) to half (1/2) of the seed should be out of sand.
- Seedling pots should be under shade for 2 to 3 weeks after sowing seeds.

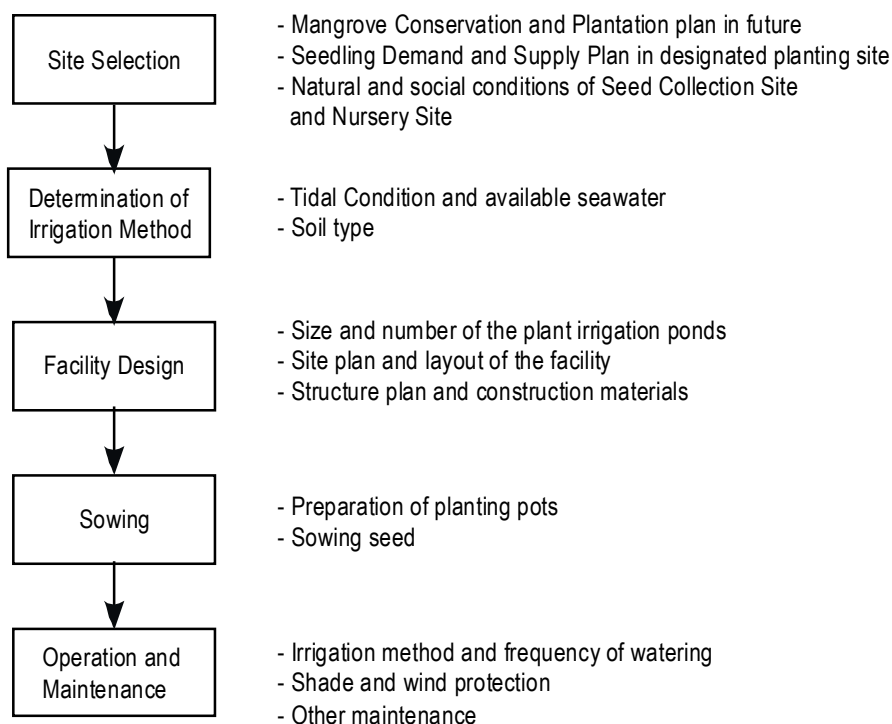
Figure 2.4.1 General Flows of Plant Nursery Development and Operation

Figure 2.4.1 shows a general flow of plant nursery development and operation.

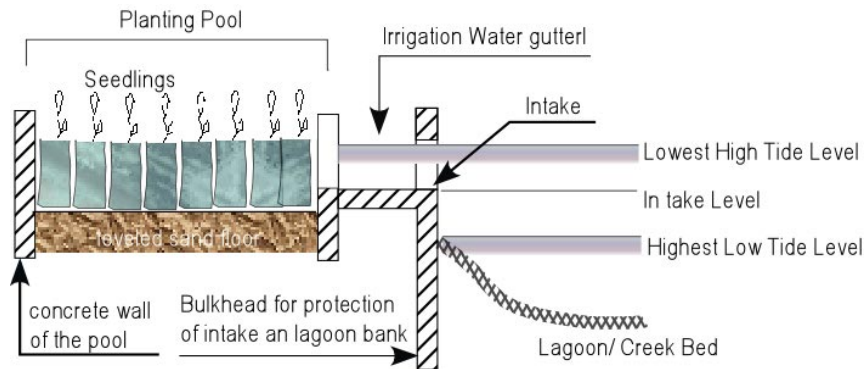
Figure 2.4.2 Concept of Tidal Irrigation

The following figures show the concept of tidal irrigation and an example of a nursery by tidal irrigation.

Select highest among H from the tide table (Highest H), and then set the outlet level at least 50 cm higher than Highest H.

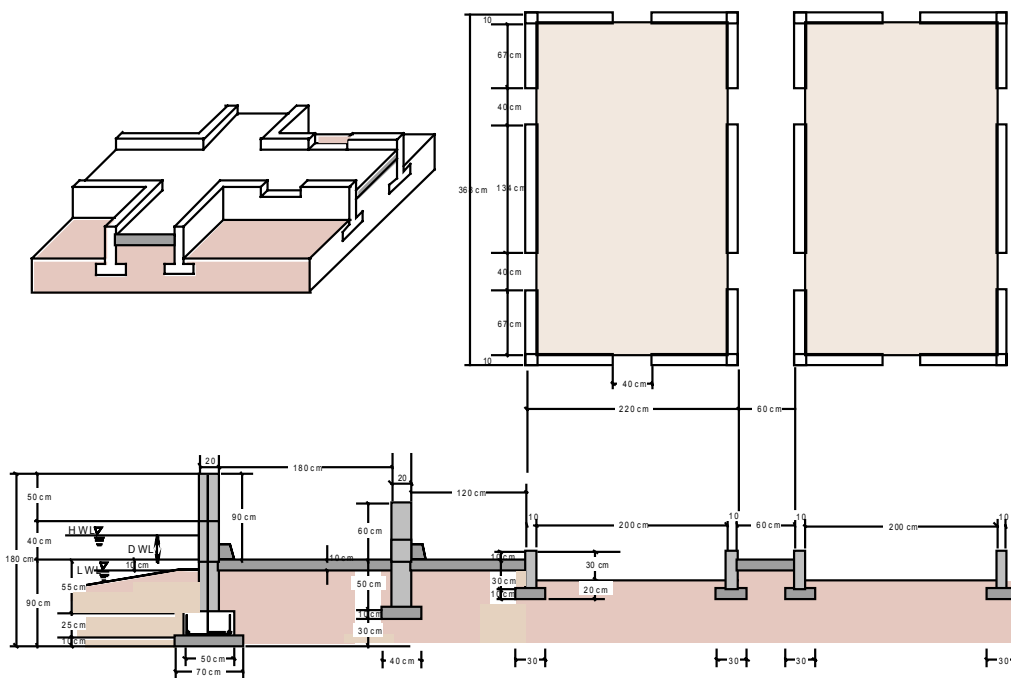
Figure 2.4.3 An Example of Nursery by Tidal Irrigation (at Qurm and Sur)

Irrigation water in the planting pool is drained from the bottom of the pool during the low tide period. High infiltration of the site (bottom of pool) is required.

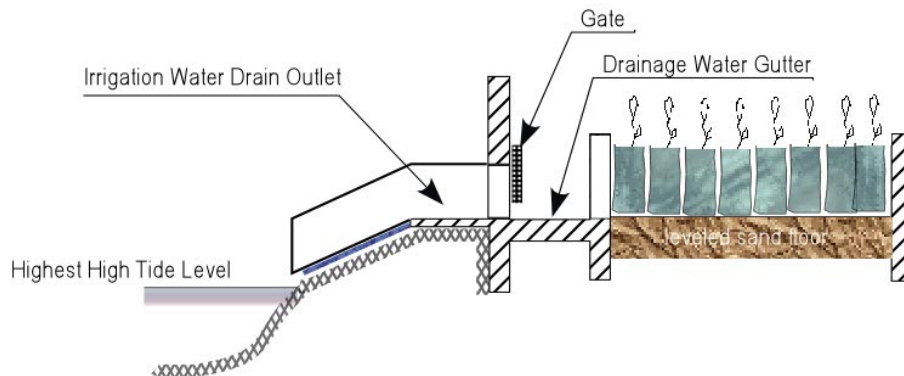
Figure 2.4.4 Drain Outlet for the Pump Irrigation Nursery

In case of the pump irrigation method, irrigation water from the planting pool is drained and discharged into the sea, lagoon or creek. Therefore, provision of the drainage

gutter and drain outlet is required, and they should be higher than the Highest High Tide level.

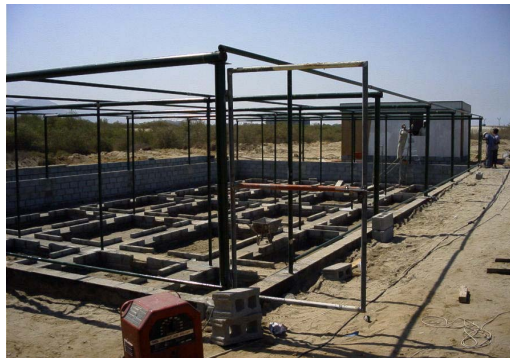
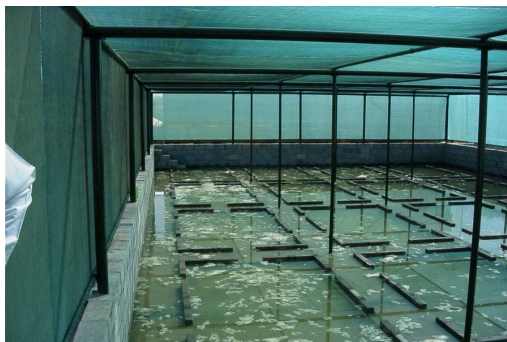
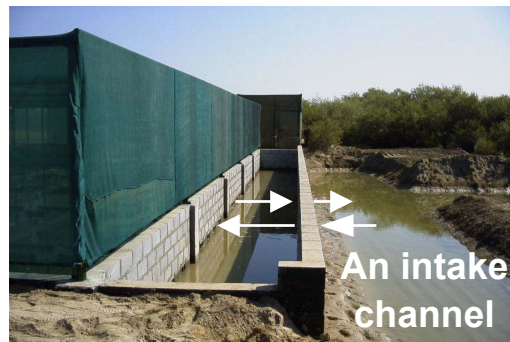
The following pictures show an example of shade and windbreaker covering the nursery.

Frame constructed by steel pipes.

Direct sunlight and hot dry wind damage sowed seeds and young seedlings. Provision of shade and windbreaker is required.

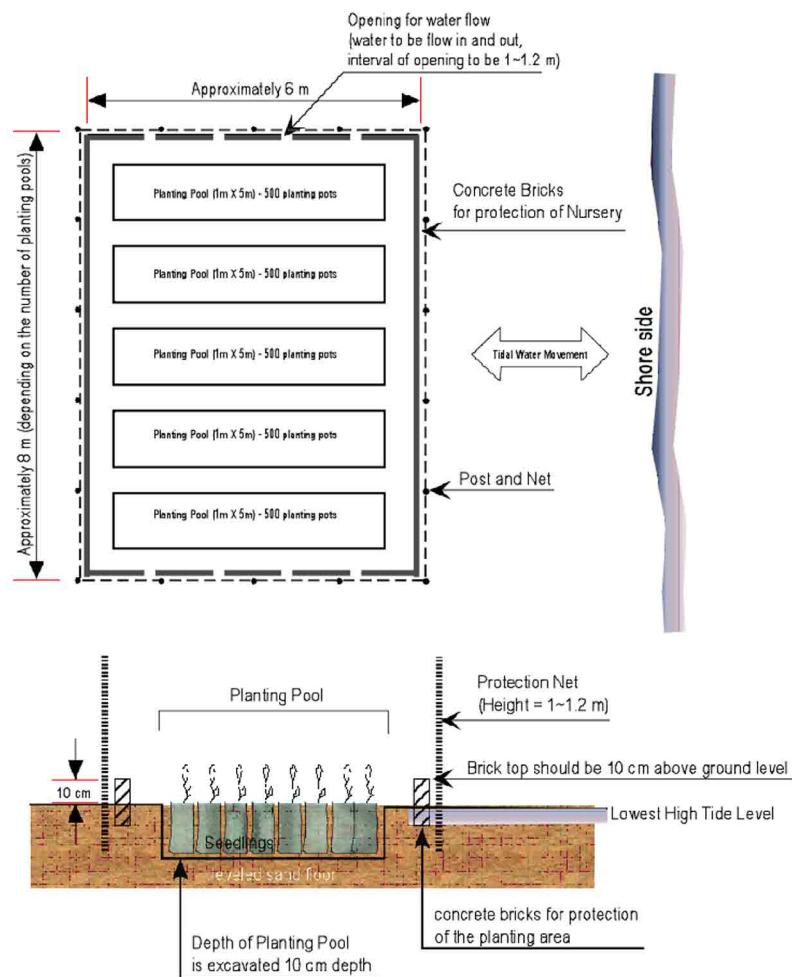
Schematic Design of Temporarily Nursery Construction

Facility design procedure and conditions to be fulfilled is also the same as the tidal irrigation type nursery. However the structure of the temporary nursery is much simpler than permanent type. The construction materials to be used are mainly available at site and minimal requirement of concrete structures.

Following figure shows the conceptual design of the temporary nursery layout and structure.

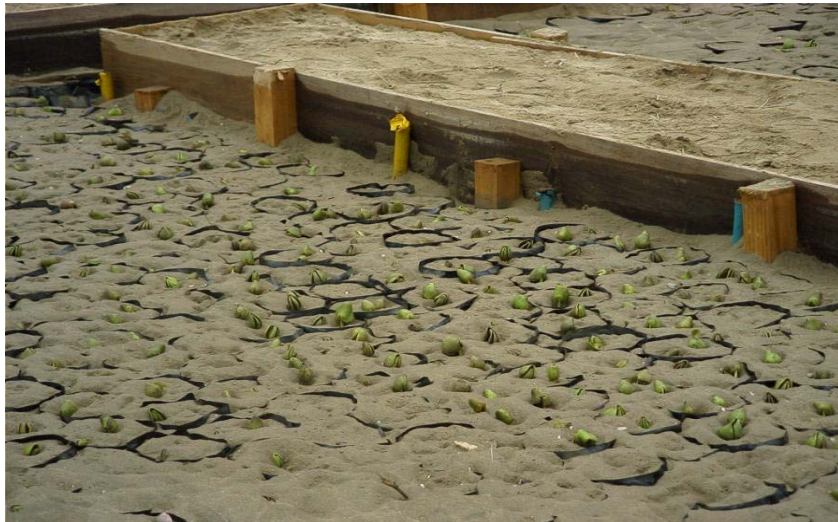
- Germination will be observed around 1 week ~ 10 days after the sowing as seen in this photograph.

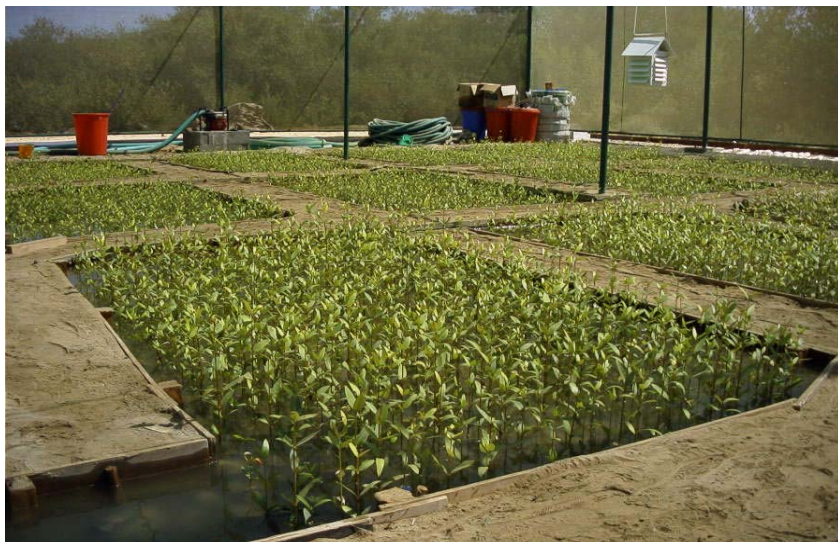
- This is a general view of the nursery almost 4 months after the sowing.

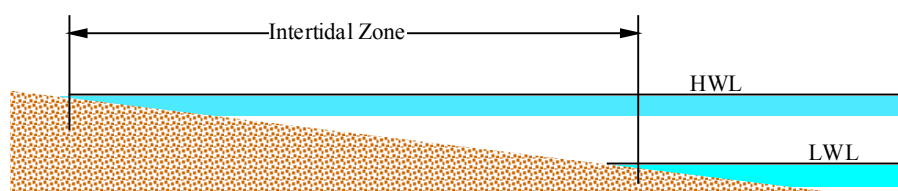
The following figure shows the inter tidal zone. At high tide, the ground will be covered with seawater, and at low tide, the ground will appear.

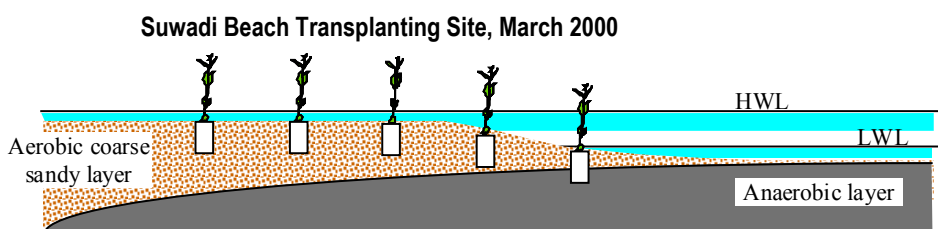
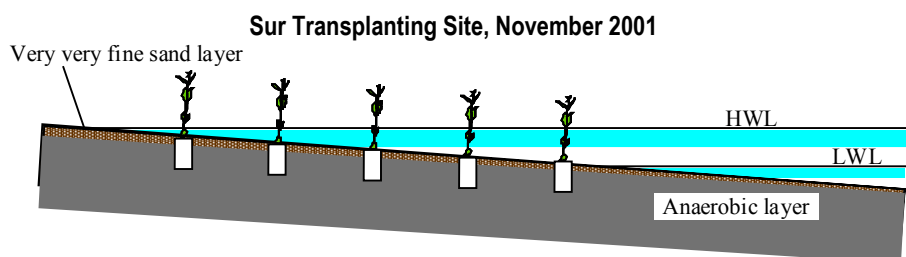
The following figures show examples of the designated planting area implemented in Oman.

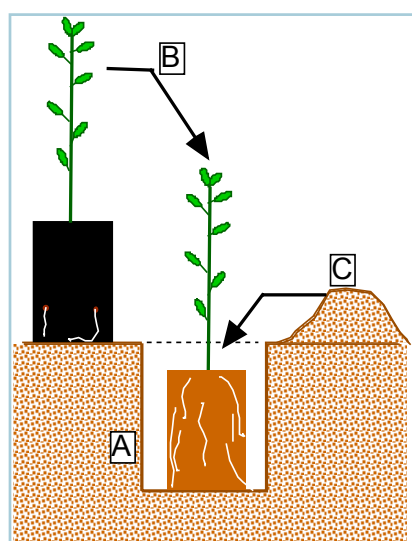
- Start transplanting work at the time of the lowest tide.
- Stretch a measuring rope at the designated planting area.
- Transplant seedlings at the mark on the rope, as shown in the figure below.

A: Dig a hole a little bit deeper than the pot

B: Remove the plastic pot and put the seedling with soil without damaging roots
