APPENDIX - 1 RESULTS OF LANDSAT IMAGE ANALYSIS

The Study on Integrated Management for
Ecosystem Conservation of the Anzali Wetland
in the Islamic Republic of Iran

APPENDIX - 2 MEASURES FOR LANDSLIDE AND SLOPE COLLAPSE

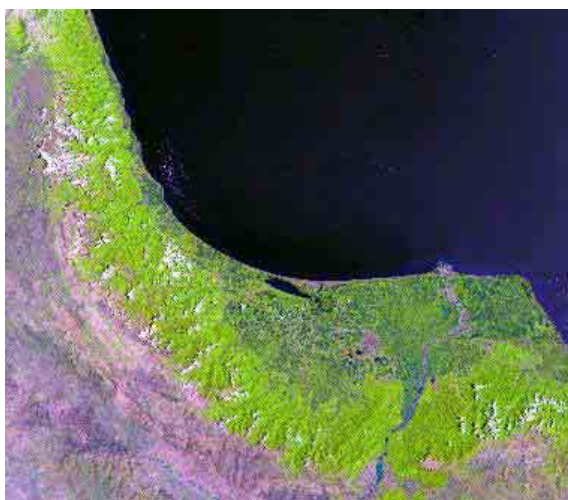
Figure A1.1.2 Image shoot on 14 June 1991

In these image, the image of 1991 is somehow less vegetation cover depend on early summer season picture.

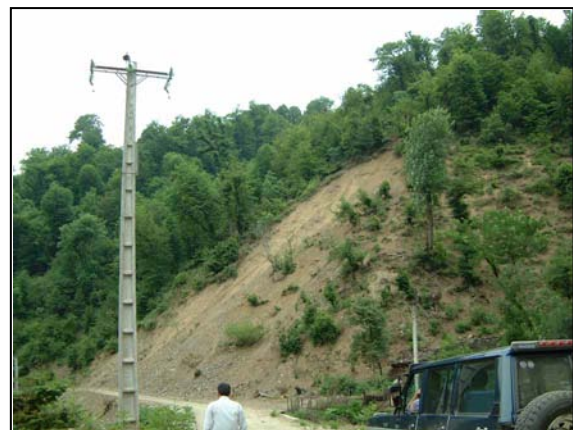
Photo A2.2.1.1 Slope Collapse at Upstream of the Chafroud River

A slope collapse (see Photo A2.2.1.1) is usually caused by a surface failure of slope. This type of collapse can be controlled by a combined method of shotcrete, soil nail, and a gabion beside the road.

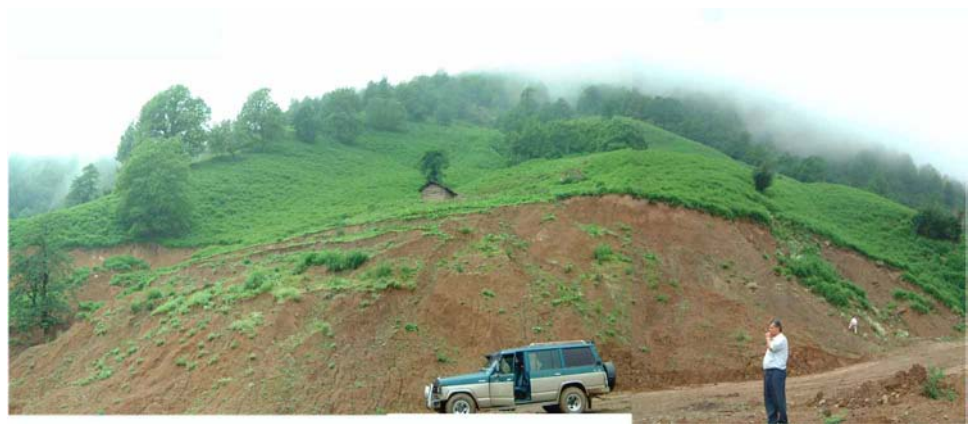
Photo A2.2.1.2 Landslide at upstream of the Shahamoallen River

Slip surface of weathered rock slide like as shown Photo A2.2.1.2 generally is shaped linear, and countermeasure works is needed to increase the resistance force. Counter weight embankment and ground anchor are typical methods of increasing resistance force. In the case shown in Photo A2.2.1.2, there is no place to install the counter weigh embankment; ground anchors are the recommended option.

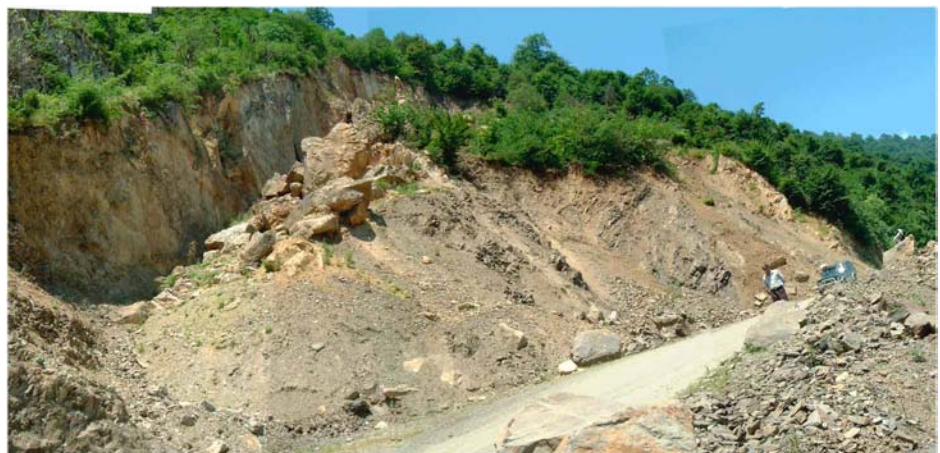
**Photo A2.2.1.3 Landslide at Upstream of the Masulero River
(Colluvial deposit type landslide)**

Most important matter of selection of countermeasure against landslide of colluvial deposit slide type (see Photo A2.2.1.3) is drainage works for surface water and groundwater like as channel works and

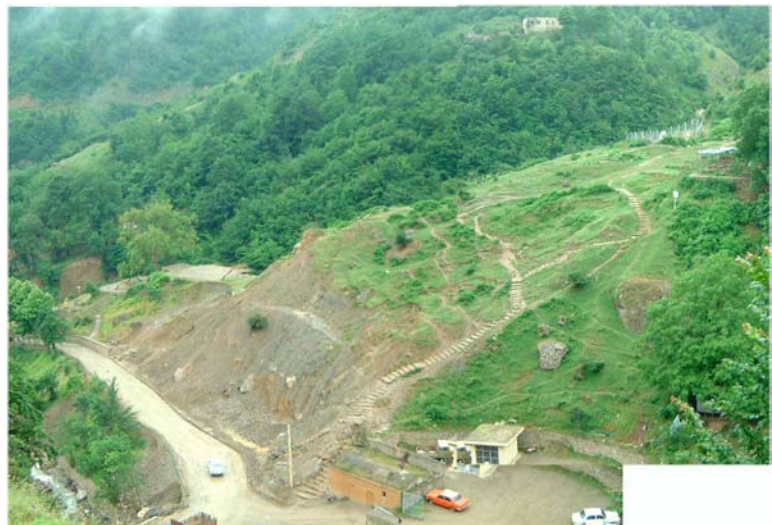
Photo A2.2.1.4 Landslide at Masuleh Town (Weathered rock type landslide)

Masuleh Town Landslide (Photo A2.2.1.4) is very large, sized length and width several handed meters, and it has the character of medium type of weathered rock slide and colluvial deposit slide. The movement of landslide is divided into several small blocks. It is assumed that present moving landslide block is toe part of whole landslide, and its length about 200 m.
