**DISASTER PREVENTION BASIC PLAN  
IN THE METROPOLITAN DISTRICT OF CARACAS  
IN THE BOLIVARIAN REPUBLIC OF VENEZUELA**

**FINAL REPORT  
SUMMARY**

March 2005

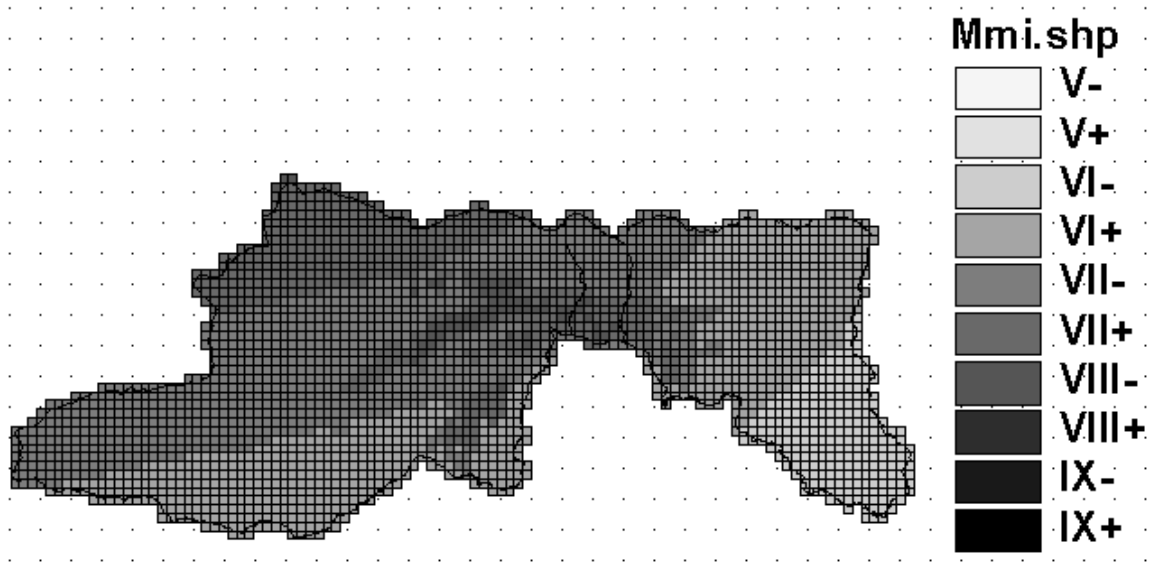
Figure 3.1.3 Estimated Seismic Intensity for the 1967 Earthquake

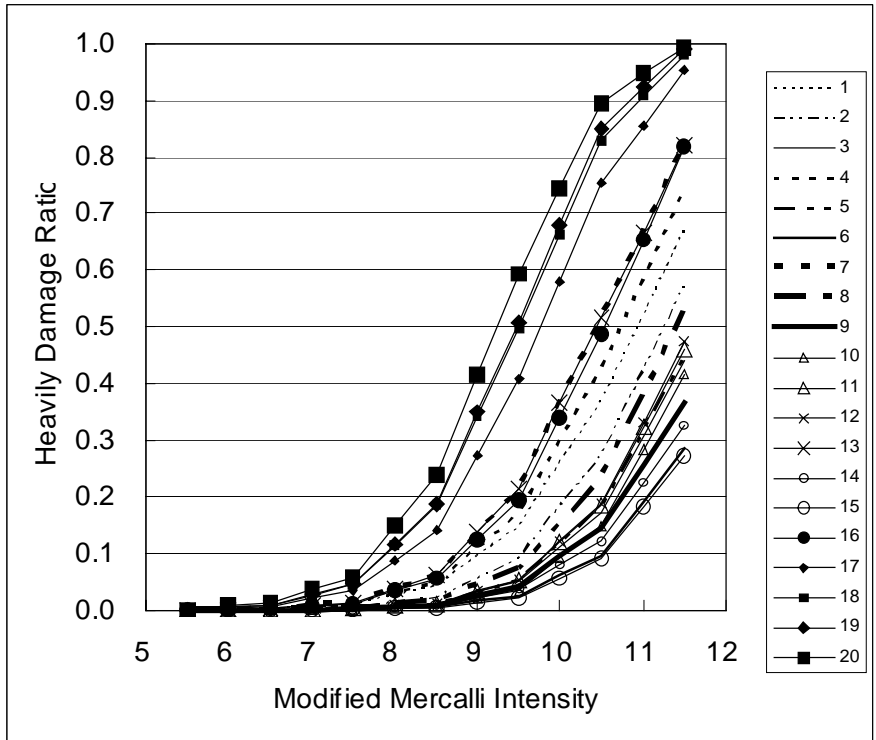
**Figure 3.2.3 Building Damage Function Used in this Study**

Figure 3.2.3 represents the damage functions determined by the described procedure, and will be used on the Study on the Disaster Prevention Basic Plan in the Metropolitan District of Caracas.

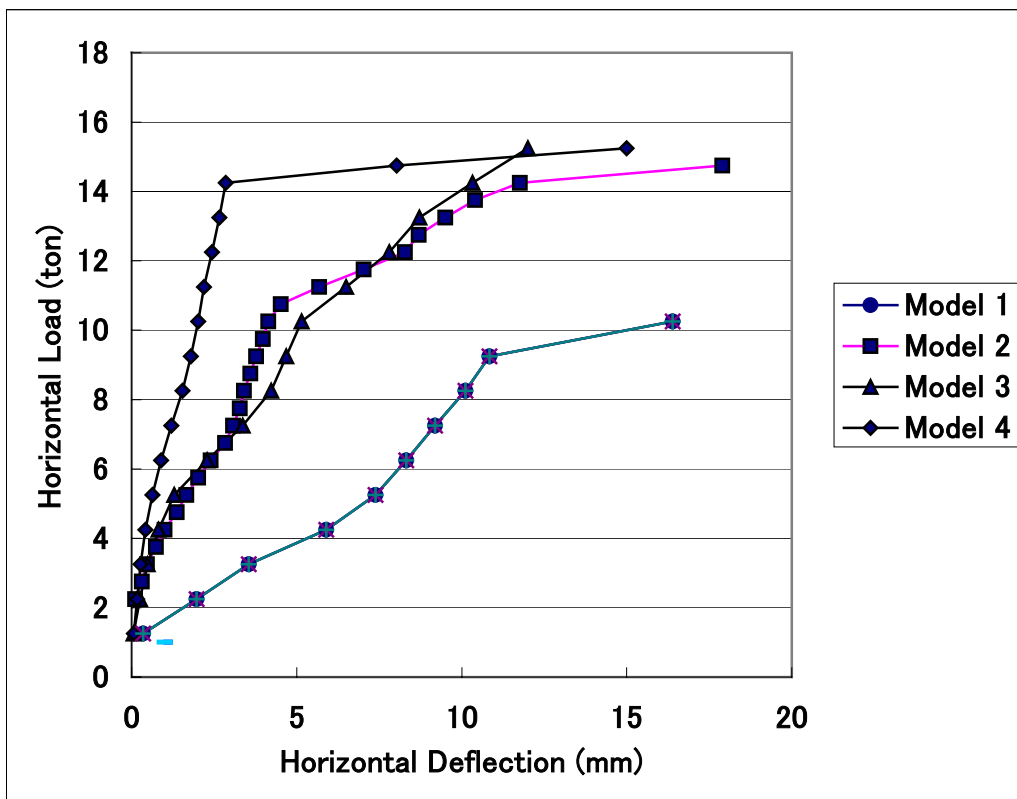
Figure 3.5.2 Horizontal Load and Deflection (Tested by IMME)

The building breaking test was executed to obtain a data on strength of houses in Barrio area, in addition to make an educational material to promote seismic reinforcement. By this nature, the test does not intended to propose a concrete method of reinforcement. As this kind of experiment was made for the first time in Venezuela, yet only four models are tested, it is recommended to continue this kind of experiment by Venezuelan side in the future.

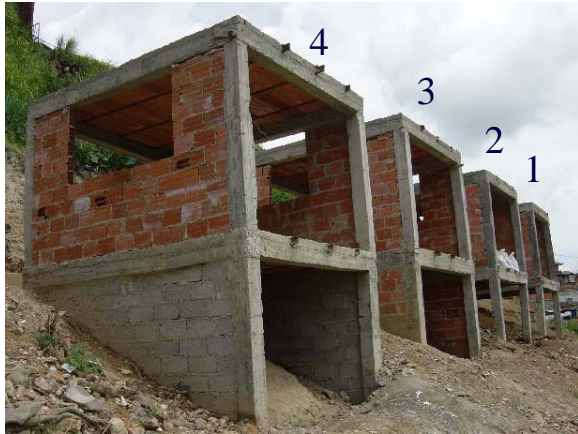
**Photo 3.5.1 Four Models for the Test**

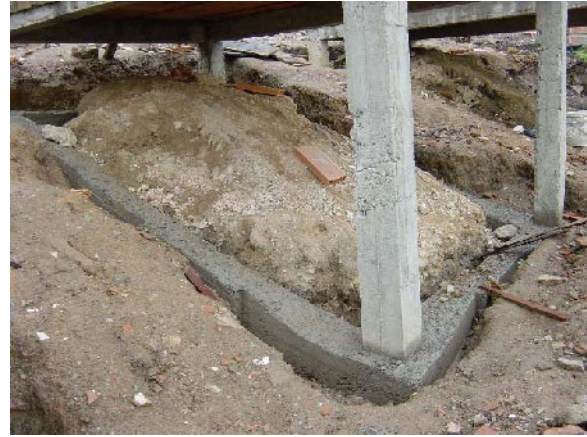
**Photo 3.5.2 Grade Beams**

No.	Reinforcement	Cost Impact	Method of reinforcement
1	No	0 %	None
2	Yes	5 to 7 %	Grade beams
3	Yes	10%	Grade beams & brick wall
4	Yes	15 %	Grade beams & concrete brick wall

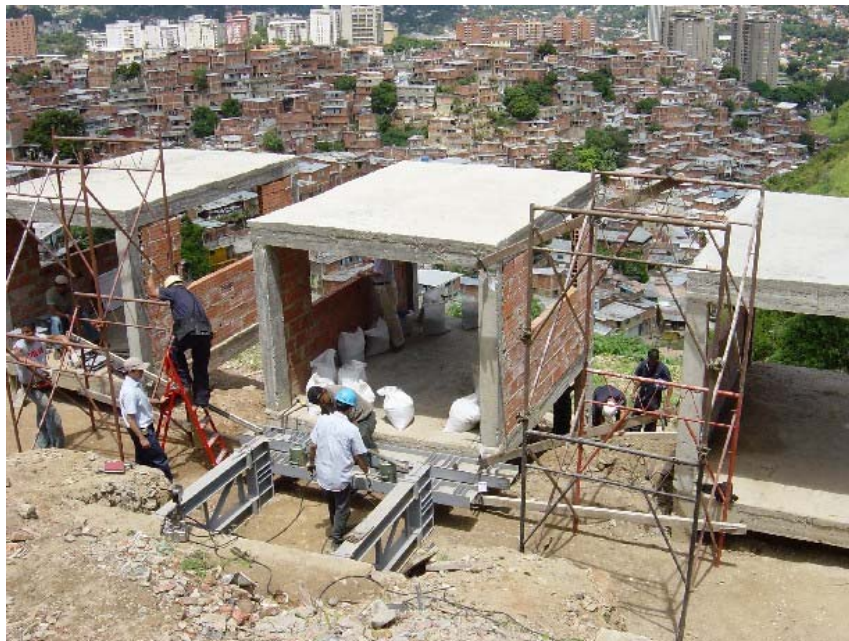
**Photo 3.5.3 Horizontal Loading by Hydraulic Jack**
