1. 案件名	ツバル国 フナフチ環礁電力供給施設整備計画
2. 要請の背景（協力の必要性・位置付け）	<p>(1) ツバル国（以下「ツ」国と称す）では、国家開発戦略である「VISION 2015（1998～2015年）」において、人材育成、公共セクター改革、民間セクター開発、離島の開発、基礎的インフラ整備、の5分野を重点活動計画として取り上げている。これらの重点活動計画の中で、電力は「基礎的インフラ整備」を実現するための重要なインフラと位置付けられている。</p> <p>(2) 「ツ」国電力セクターは、主に旧宗主国である英国およびEUの支援により首都フナフチの電力供給設備を整備してきたが、これらの設備は設置後20年近く経過して老朽化しているばかりか、電力需要の増加により過負荷状態となっている。このため発電設備、配電設備等の事故が頻発し、安定した電力供給に支障を来している。特に、1993年から2003年までの過去10年間で、最大需用電力は年平均7.46%の高い伸び率を記録し、最大電力は約2倍となっているが、供給力の増加が需要の伸びに追いつかず、近年は供給制限を実施せざるを得ない状況にある。</p> <p>(3) 上記(2)の様な脆弱な電力供給体制は、首都フナフチに在る「ツ」国の政治、経済等の中枢機能に支障を及ぼしているとともに、保健、衛生、教育といった行政サービスや市民生活にも重大な影響を与えている。このため、「ツ」国電力セクターは「発電設備の新設による供給力の確保」、「配電設備の更新による供給信頼性の確保」を喫緊の課題としているが、財政難のため課題の達成は困難な状況にある。</p> <p>(4) 本計画は上記の電力セクターの課題を達成するため、首都フナフチに信頼度が高く安定した電力を供給し、計画目標年次までの電力需要の増加に対応できる電力供給力を確保することを目的とし、フォガファレ発電所への発電設備の増設、並びに11kV配電設備・配電ケーブルの更新等を行うものである。</p>

**Proposed Funafuti Power Station
Re-development
Geotechnical Investigation**

Report prepared by:
TONKIN & TAYLOR INTERNATIONAL LTD

February 2005

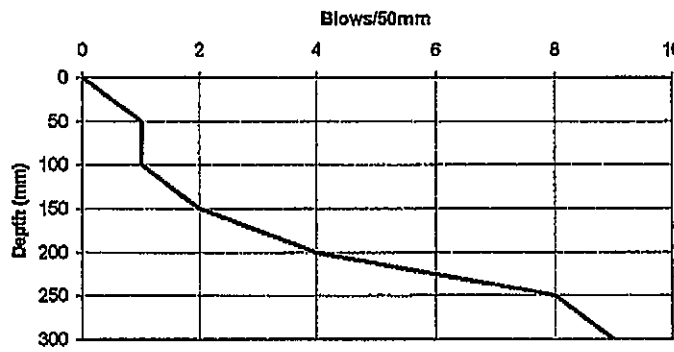
TEST 4A

Vertical Distance driven (mm)	Number of blows
50	1
100	1
150	2
200	4
250	8
300	9
350	>30
400	
450	
500

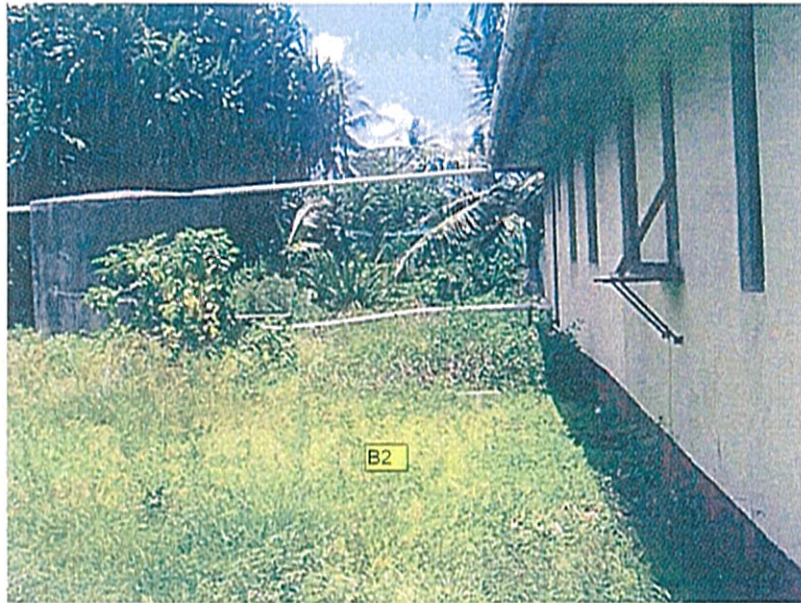
Photo(1): Area B2 (Dynamic Cone penetrometer test locations)

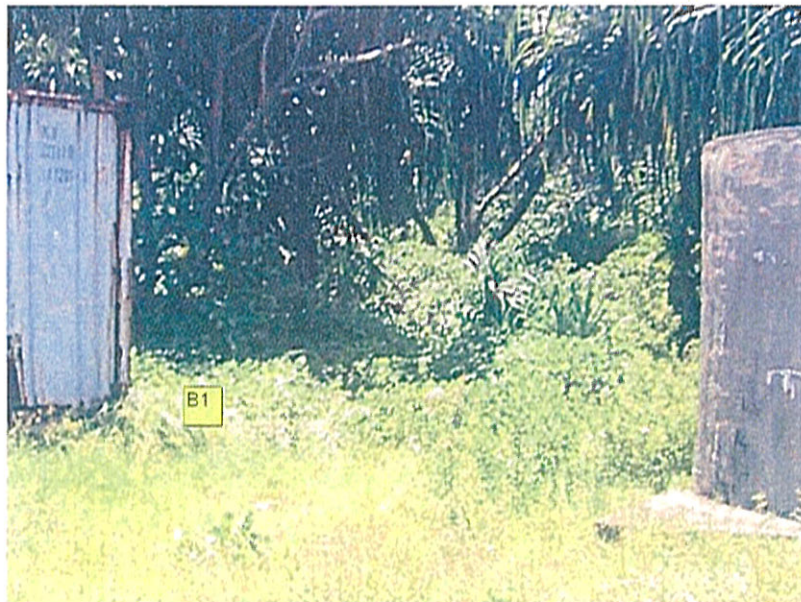
Photo(2): Area B1 (Dynamic Cone penetrometer test locations)

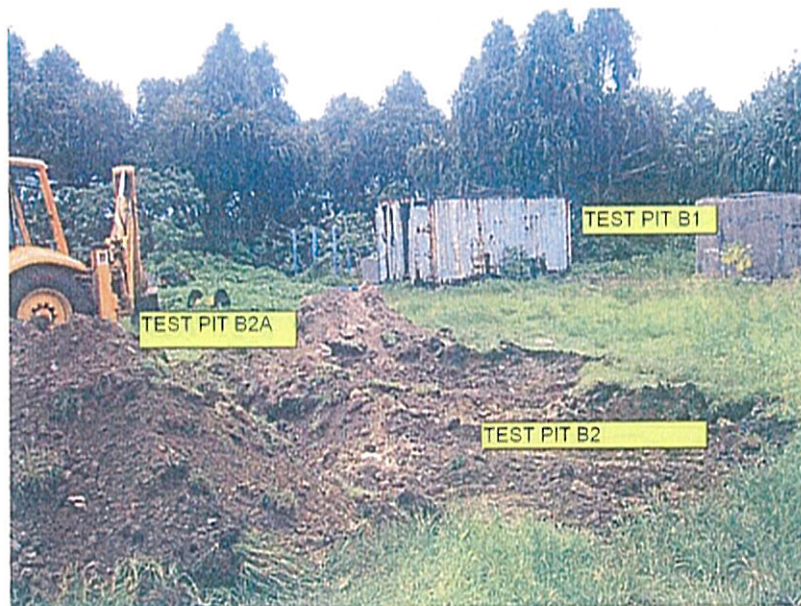
Photo(6): Test Pits B1, B2 and B2A

Following consultations with T&TI, E-D undertook a second stage of work which comprised putting down 3 trial pits excavated by a 12-tonne digger at the locations indicated on drawing no. 1, in Appendix A. All of the trial pits reached "refusal" at shallow depths, and the ground was too hard to reach the target depth of 5 m. Trial pits B1, B2 and B2A reached "refusal" at 0.20 m, 0.25 m, and 0.60 m depth respectively.
