6. Other Relevant Data

Result of Natural Condition Survey

(1) Topographic / Bathymetric Surveys

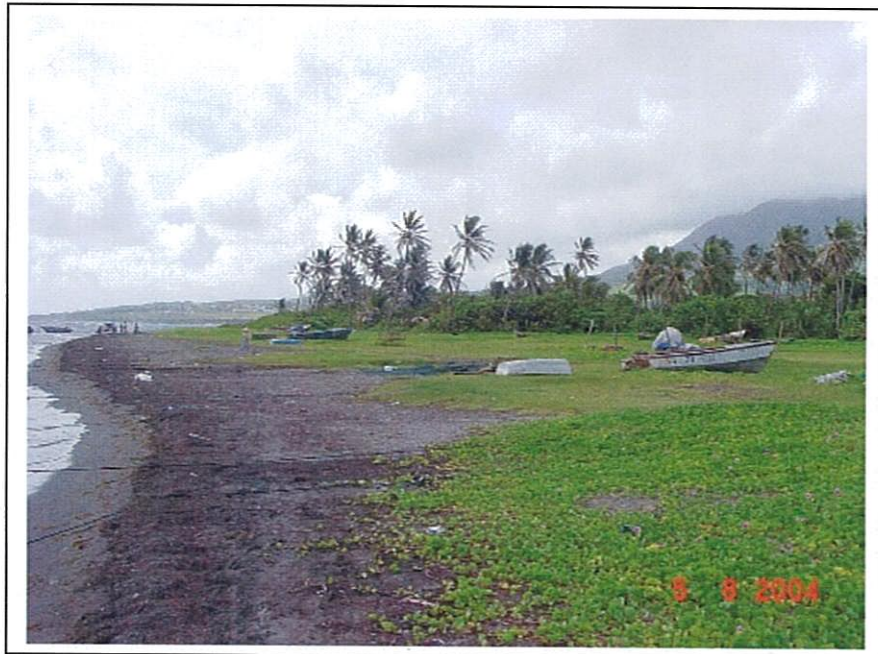
Figure 1 is a photograph of the land area of the site. It is presently used by fisherfolk for boat storage and net repair. Figure 2 shows a composite drawing showing the site topography and nearshore bathymetry. These results have been placed on geo-referenced image of the site taken from the IKONOS Satellite (1m resolution) in 2003.

Figure 1: Photograph of the Dieppe Bay Site

The site is predominantly flat sandy one, with well-developed wetland areas at its extreme south. The beach slope is gentle and protected from high-energy waves by an extensive barrier visible in the satellite image. The immediate nearshore bathymetry shows a well-defined channel feature across the entire survey site. At its deepest the channel is 5 metres. The general channel direction is from northeast to west.

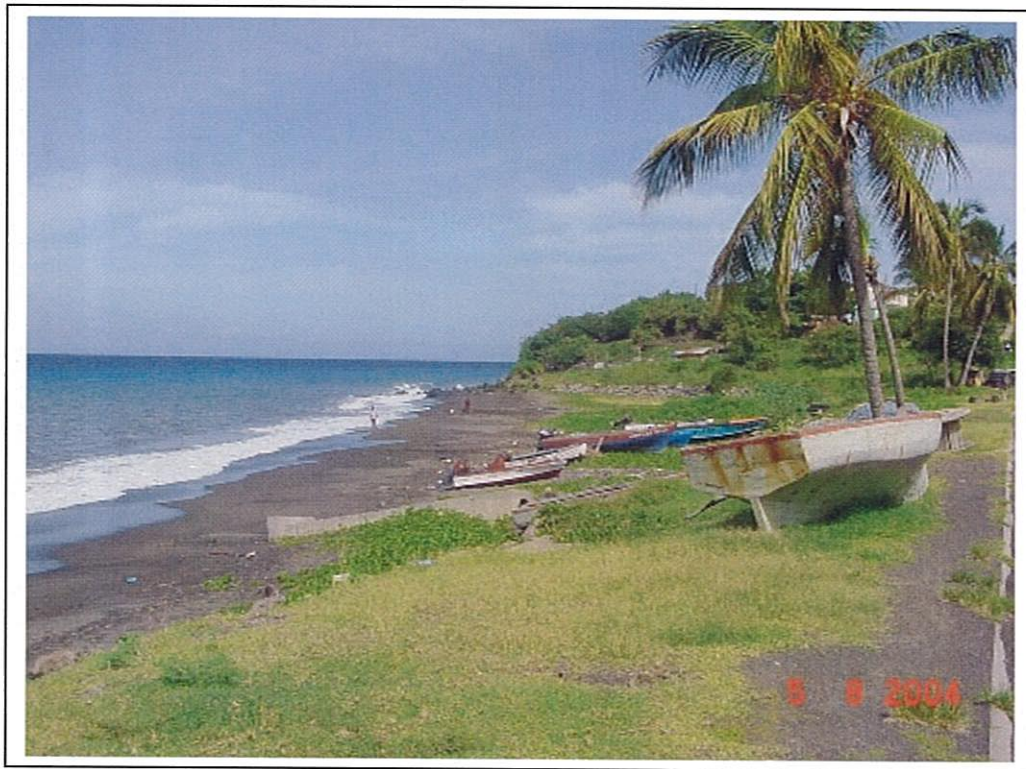
The photograph in Figure 3 shows the landside area at Sandy Point.

Figure 3 : Landing Site at Sandy Point

The topography at Sandy Point (Fig Tree Village in Pump Bay) shows is that of a sandy beach with a steep beach slope and a well-developed beach berm. The backshore appears subject to high-energy conditions, particularly swell waves during the passage if storms and hurricanes. The backshore is protected by coastal defense walls and rip rap features.

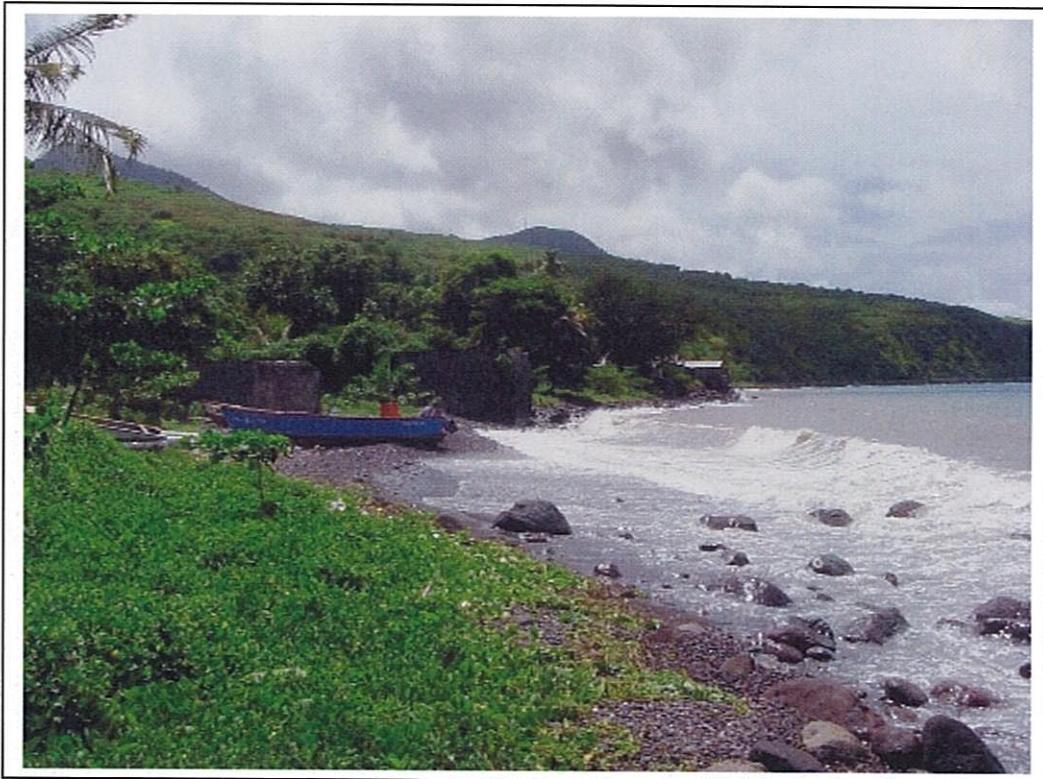
The photograph in Figure 5 shows the landside area at Old Road. Figure 6 shows the composite plot.

Figure 5 : Old Road Landing Site Area

The topography at Old Road shows is that of a pebble beach with a gentle beach slope and a well-developed beach berm. The backshore appears subject to high-energy conditions, particularly swell waves during the passage if storms and hurricanes. The backshore is unprotected.

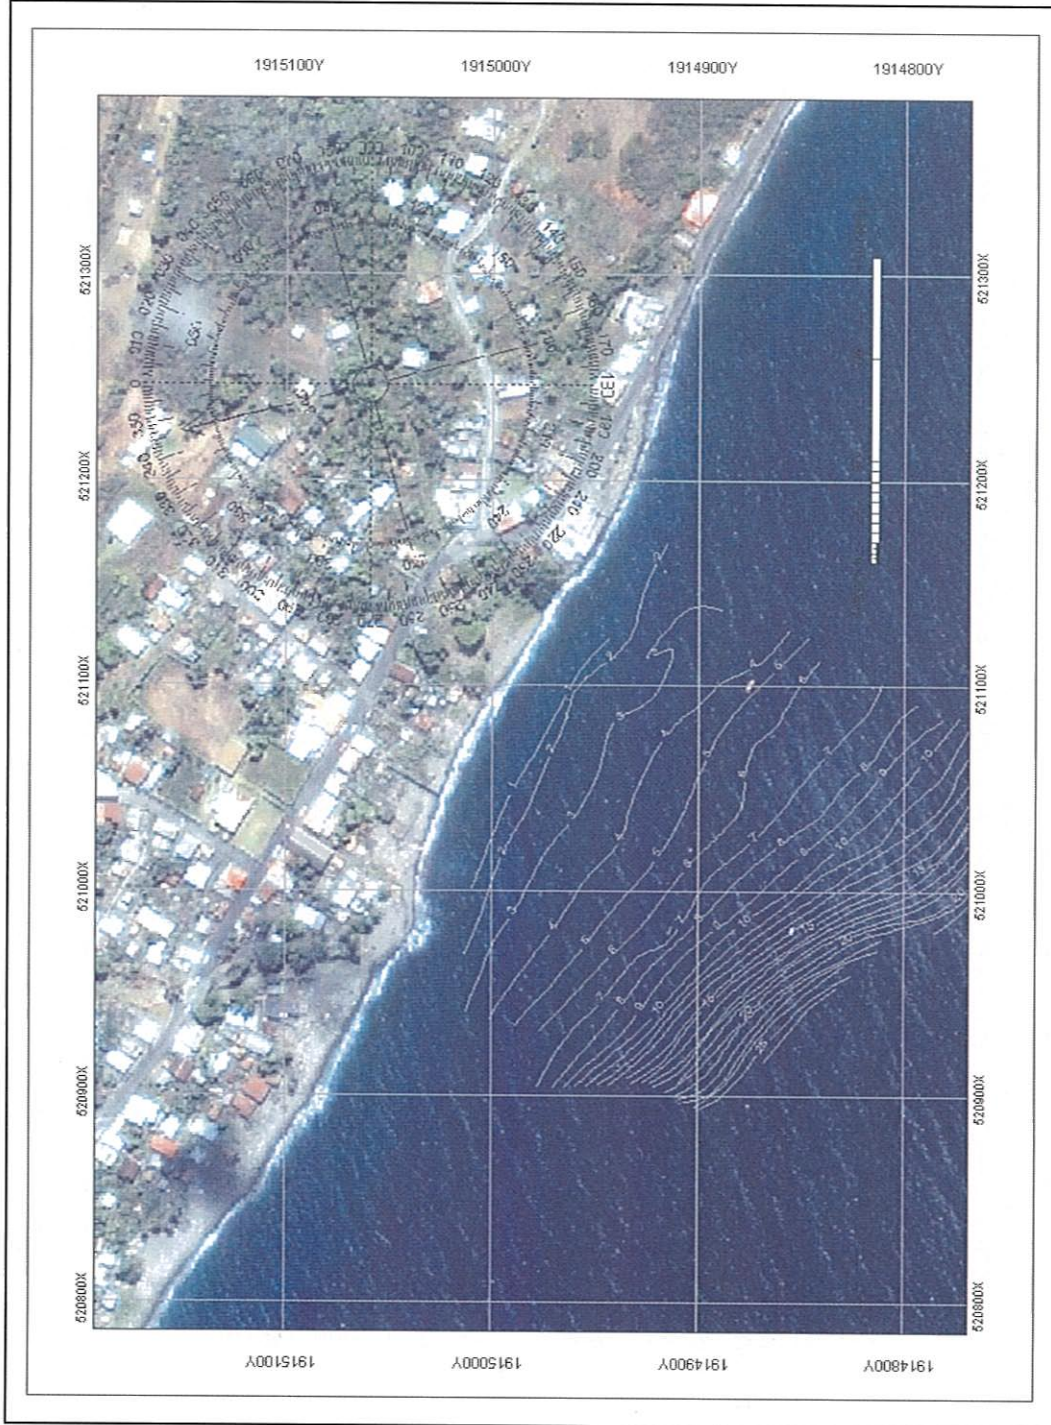
Figure 6 : Composite drawing showing bathymetry and topography at Old Road, St. Ki

The nearshore marine area bathymetry is typified by a regular but steep seabed that falls to 9-m water depth in less than 100m.
