THE URGENT REHABILITATION AND RECONSTRUCTION
SUPPORT PROGRAM

(REHABILITATION AND RECONSTRUCTION OF
WEST COAST ROAD IN NORTH SUMATRA)

FINAL REPORT

JUNE 2005

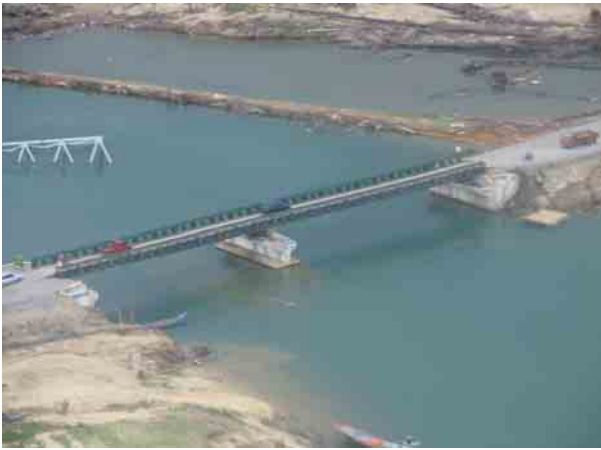
KM 14+160 Baba Bridge (bailey)

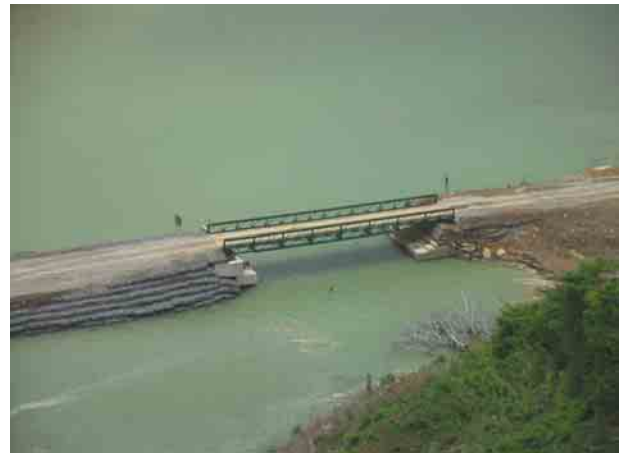
KM 27+840 Peulot Bridge (bailey+gabion protection)

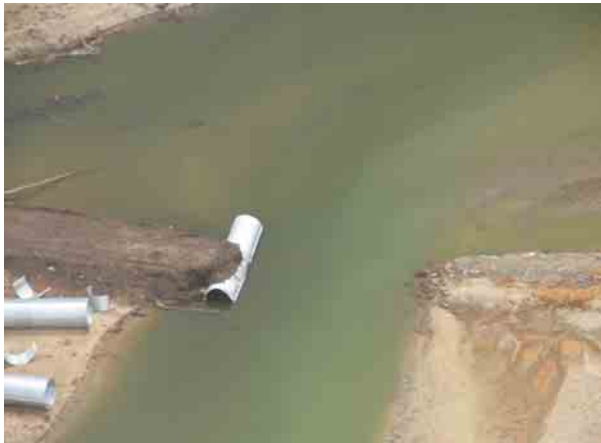
KM 58+880 (causeway underconstruction)

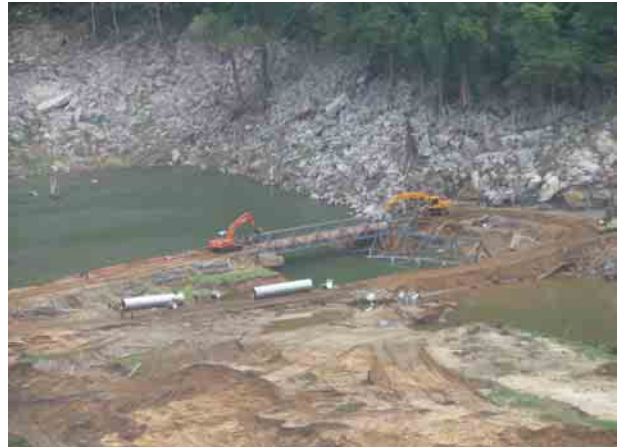
KM 63+340 Lhok Kareung Bridge (bailey underconstruction)

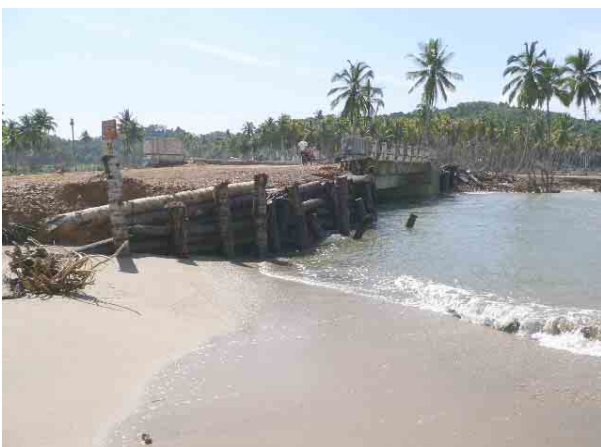
KM 152+850 Lhok Buaya Bridge (approach restored)

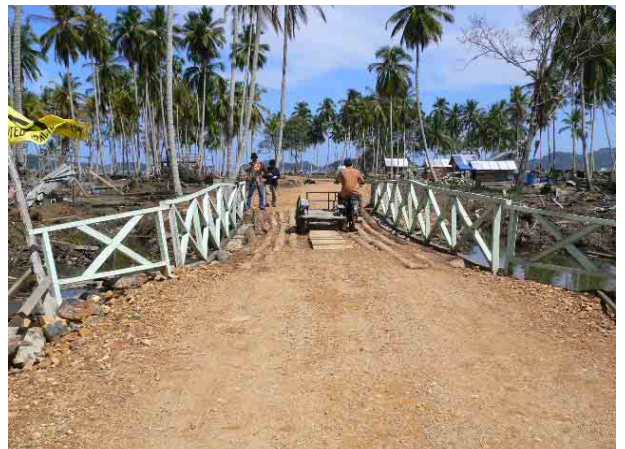
KM 153+850 Batee Tutong Bridge (timber)

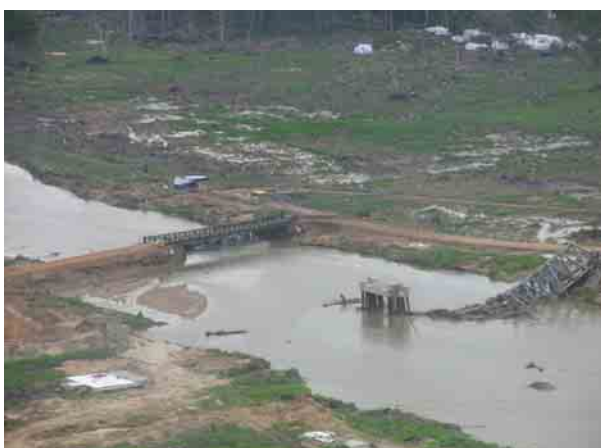
KM 163+450 Sabe Bridge (bailey)

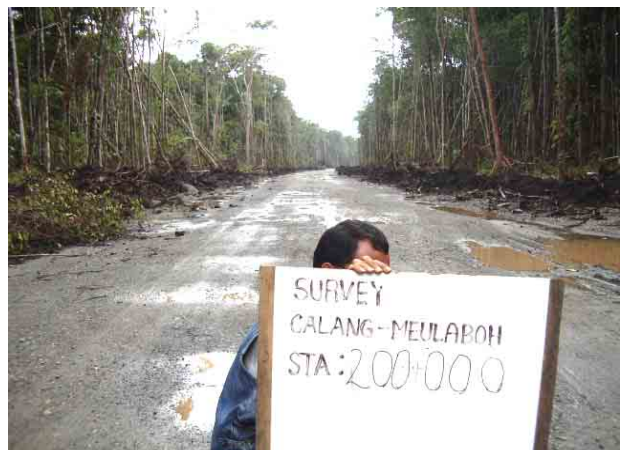
KM 200+000 (re-aligned in forest)

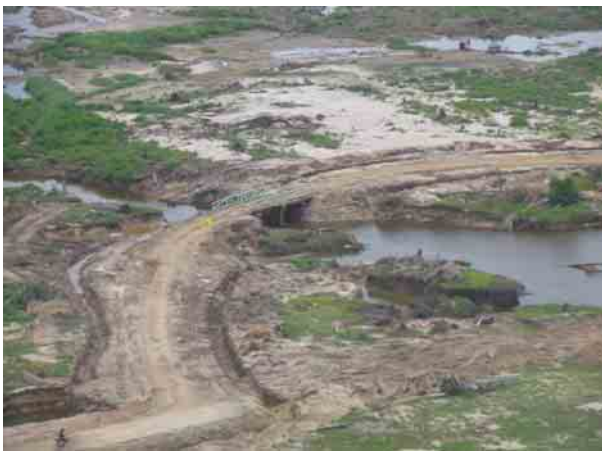
KM 164+540 Bakong 1 Bridge (west coast road)
(Reconstruct with concrete bridge along straight alignment)

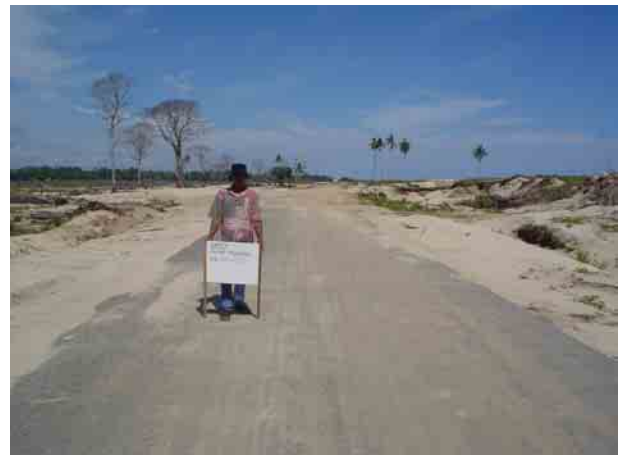
KM 167+000 (west coast road)
(AC overlay)

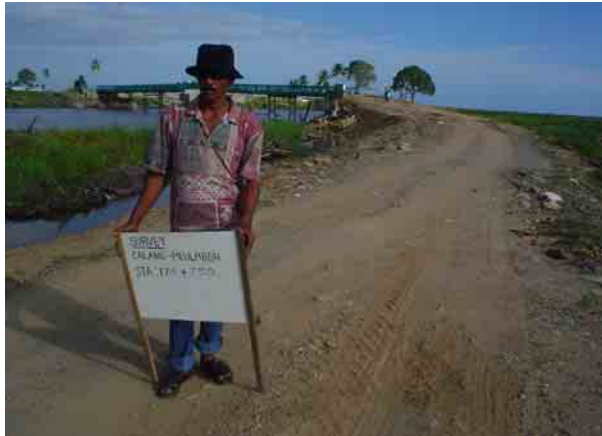
KM 174+250 (west coast road)
(Approach embankment and AC pavement)

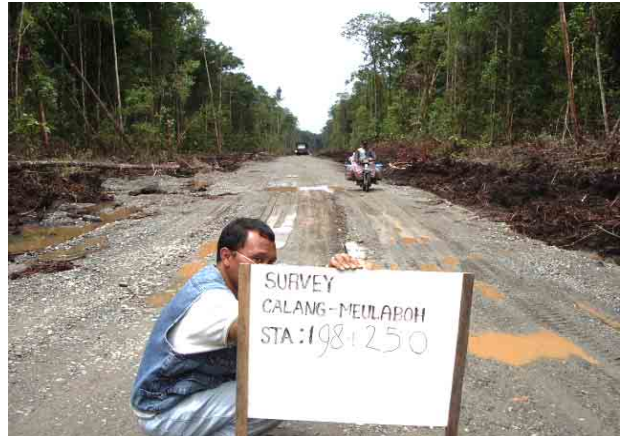
KM 198+250 (re-aligned forest section)
(AC pavement)

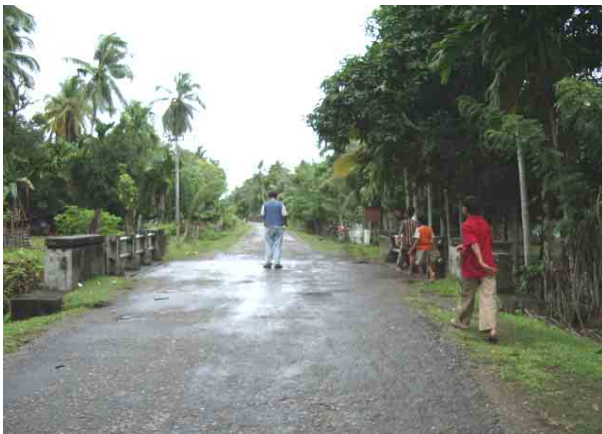
KM 213+000 (original village road)
(AC pavement)

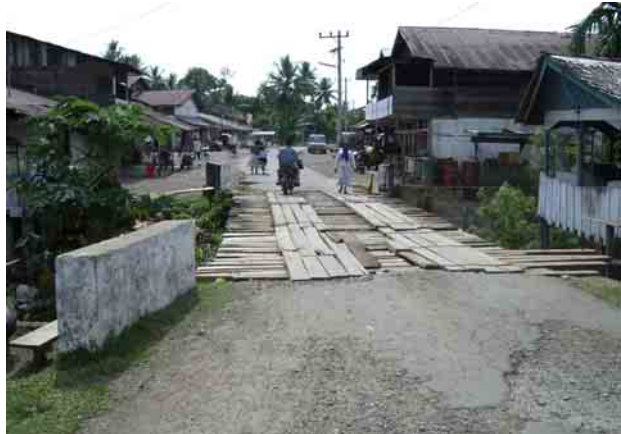
KM 236+183 Kureung Wayla Bridge (original village road)
(Reconstruct with concrete bridge)

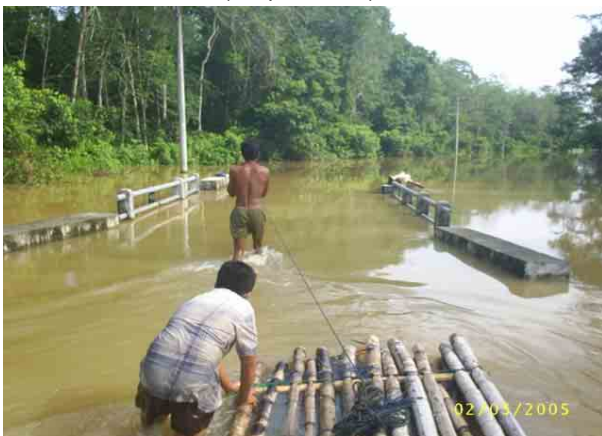
KM 246+800 (original village road, flood section)
(Raise road by embankment and AC pavement)

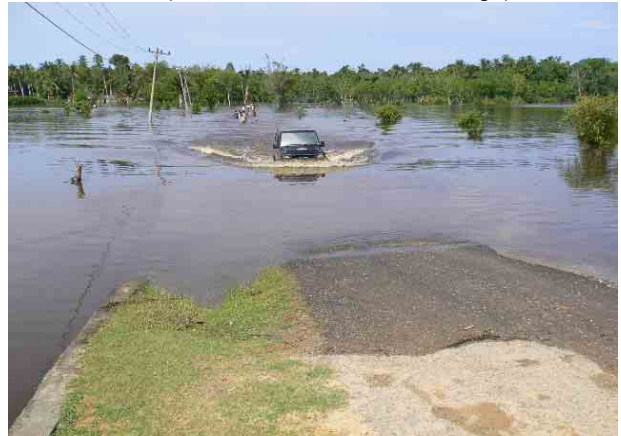
KM 251+000 (original village road, flood section)
(Raise road by embankment and AC pavement)
