## 8.4 現地再委託調査結果概要

**EXISTING STRUCTURES SURVEY (BRIDGES )**  
**ON**  
**THE BASIC DESIGN STUDY ON THE PROJECT**  
**FOR**  
**IMPROVEMENT OF KARARO – WAD SECTION**  
**OF NATIONAL HIGHWAY N-25**  
**IN THE ISLAMIC REPUBLIC OF PAKISTAN**

**IMPROVEMENT OF KARARO – WAD SECTION  
OF NATIONAL HIGHWAY N-25  
IN THE ISLAMIC REPUBLIC OF PAKISTAN**

**DRAFT REPORT  
ON  
SOIL & MATERIAL INVESTIGATION  
FOR  
IMPROVEMENT & UPGRADATION OF  
KARARO-WAD (SECTION 96.0 km)  
NATIONAL HIGHWAY (N-25)  
BALUCHISTAN**

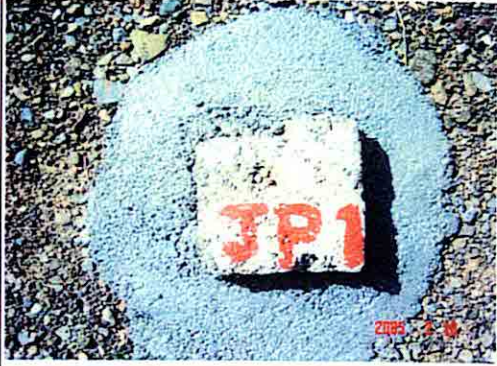
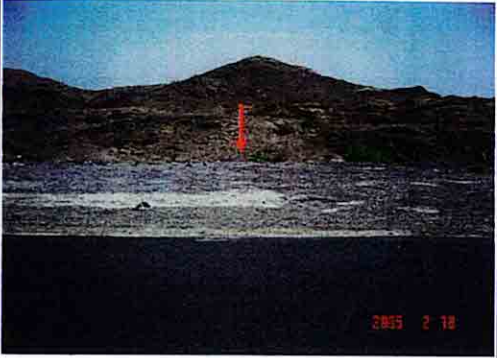
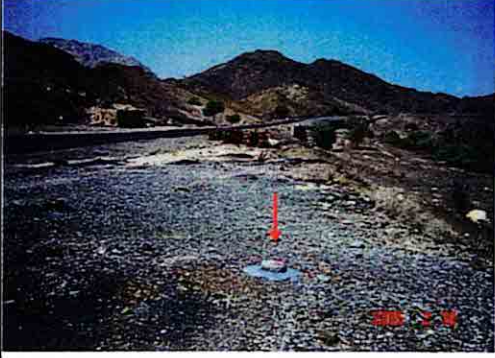
Permanent Control Point Description		The B/D Study on The Project for Improvement of Kararo-Wad Section of National Highway N-25 in the Pakistan	
Sketch	No. 1	Photo (short range view)

Northing =		
	Easting =		
	Elevation =		
	Local coordinates System (no projective method was adopted)		
	Grid North is approximate True North		
	Origin SBM Kararo		
	False Easting = 1,981,964.620 m		
	False Northing = 1,004,199.600 m		
	Scale factor = 1.000000		
	Datum Level is Pakistan National D.L.		
	Photo (middle range view)	Photo (distant view)

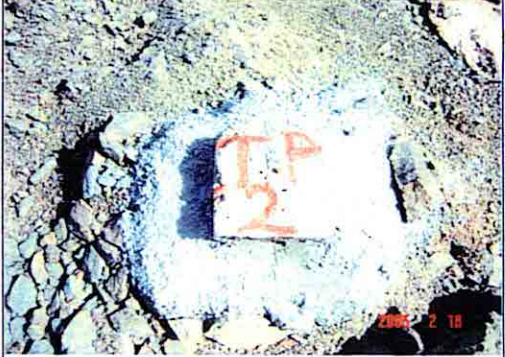
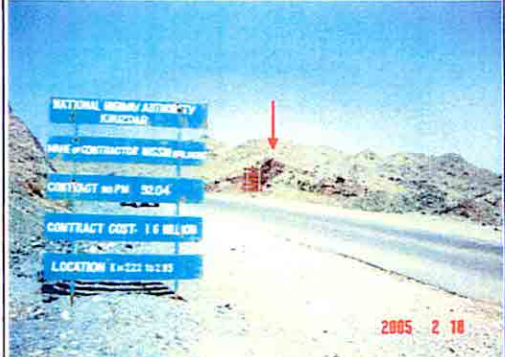
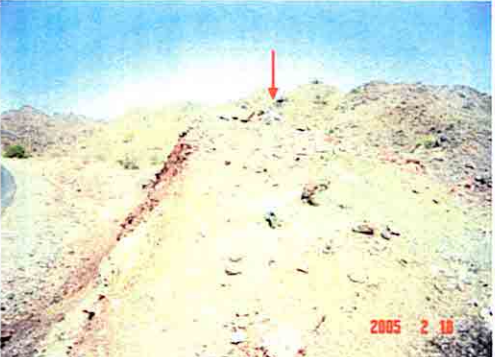
Permanent Control Point Description		The B/D Study on The Project for Improvement of Kararo-Wad Section of National Highway N-25 in the Pakistan	
Sketch	No. 2	Photo (short range view)

Northing =		
	Easting =		
	Elevation =		
	Local coordinates System (no projective method was adopted)		
	Grid North is approximate True North		
	Origin SBM Kararo		
	False Easting = 1,981,964.620 m		
	False Northing = 1,004,199.600 m		
	Scale factor = 1.000000		
	Datum Level is Pakistan National D.L.		
	Photo (middle range view)	Photo (distant view)

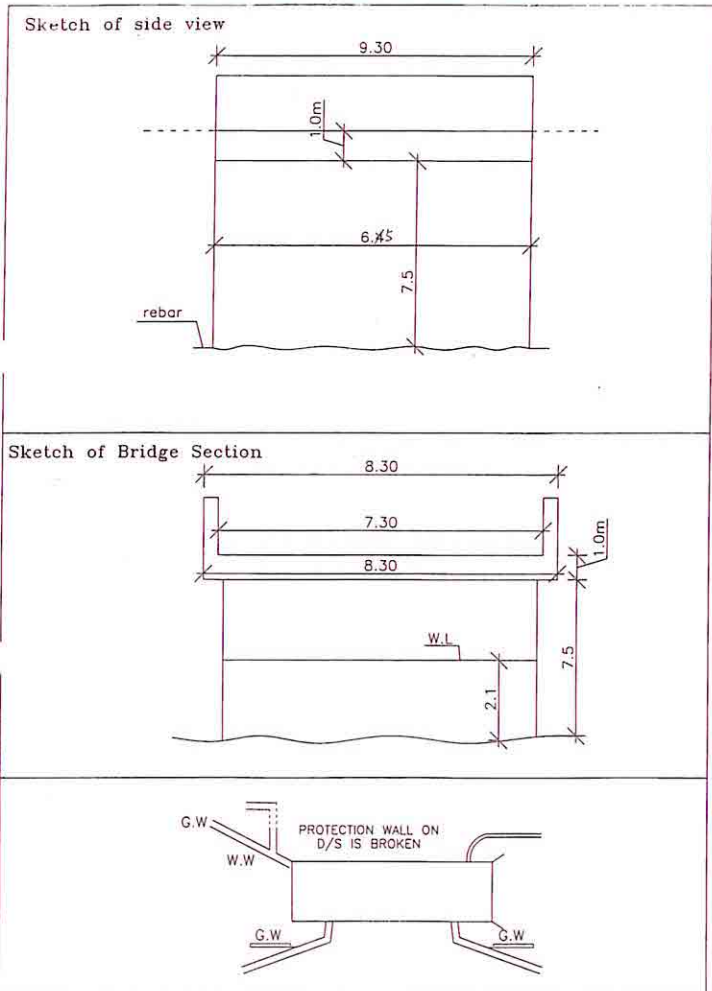
BRIDGE NO:1 (STATION NO: I+964)

Bridge Name: Bridge No. 1					
Distance: ..... Km from Karachi, River Name: .....					
Identified No.: -	Station No.: I+964				
Type of Bridge: Slab Bridge	Year of Built: 1960				
Number of Lane: 2	Availability of detour: No / Yes (0.2 Km from Bridge)				
Bridge Length: 01 Span @ 6.5 m = 6.5 m	Skew: 90 degree				
Bridge Width: 7.3 m (Carrageway), - m (Sidewalk), 7.3 m (Total)					
Maximum Flood Level: - m (above / under) the bridge surface					
Bridge Conditions (G: good, C: Cracked, P: Partly lack, R: Re-bar Exposed, B: Broken, S: Scored, E: Eroded, V: Vegetated)					
Extent and Degree (X: Serious Condition, M: Moderate Condition, O: Sound Condition)					
Surface:	Carrageway (Asphalt Pavement / Concrete Pavement), Damage ( G )				
	Sidewalk (Asphalt Pavement / Concrete Pavement), Damage (No Side Walk)				
Deck Slab:	RC Slab / Damage (C,M)				
Girder	Type: RC / Other (-)	Abutment:	Type: RC		
	Damage:	Left G1 (-)	Damage:	Karao A1 (G)

G2 (-)		Wad A2 (G)	
		G3 (-)	Pier:	Type: RC / Other (-)	
		G4 (-)		Damage:	Karao P1 (-)
		G5 (-)			P2 (-)
		Right G6 (-)			P3 (-)
	Cross Beam:	Type: RC / Other (-)		P4 (-)	
		Damage:	Karao Side B1 (-)		P5 (-)
			B2 (-)		P6 (-)
			B3 (-)		Wad P7 (-)
			B4 (-)	Wing Wall:	Type: RC
			B5 (-)		Damage:
			B6 (-)		Wad Side (G)
B7 (-)			Hand Rail:	Type: RC	
B8 (-)				Damage:	Left Side (C,O)
B9 (-)				Right Side (C,O)	
B10 (-)	Revetment:		Type: RC		
B11 (-)		Damage:	Karao Side (S,M) (Up / Downstream)		
B12 (-)			Wad Side (S,M) (Up / Downstream)		
B13 (-)		Rever Bank:	Damage:	Karao Side (G) (Up / Downstream)	
B14 (-)			Wad Side (G) (Up / Downstream)		
B15 (-)					
Utility Line: None / Electric/Water / Gas / Telecommunication / Optical fiber / Others (None)					
Attached Photos (General view, Side view (Left and Right), Defects, Damages, etc..)

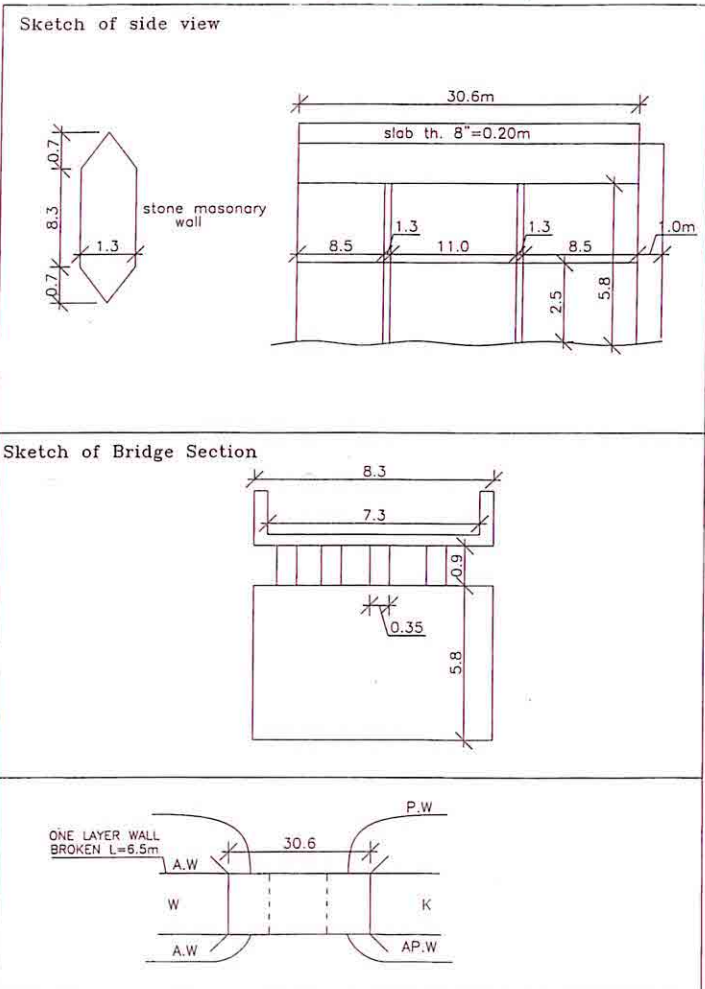
BRIDGE NO:2 (STATION NO: 3+625)

Bridge Name: Bridge No. 2		
Distance: ..... Km from Karachi, River Name: Jani Nadi		
Identified No.: -	Station No.: 3+625	
Type of Bridge: RC Grider	Year of Built: 1960	
Number of Lane: -	Availability of detour: No / Yes (No Km from Bridge)	
Bridge Length: 03 Span, 9.15m + 12.3m + 9.15m = 30.6 m	Skew: 90 degree	
Bridge Width: 7.3 m (Carriageway), - m (Sidewalk), 7.3 m (Total)		
Maximum Flood Level: - m (above / under) the bridge surface		
Bridge Conditions (G: good, C: Cracked, P: Partly lack, R: Re-bar Exposed, B: Broken, S: Scored, E: Eroded, V: Vegetated)		
Extent and Degree (X: Serious Condition, M: Moderate Condition, O: Sound Condition)		
Surface: Carriageway (Asphalt Pavement / Concrete Pavement), Damage (G)		
Sidewalk (Asphalt Pavement / Concrete Pavement), Damage (No Side Walk)		
Deck Slab: RC Slab, Damage (C,M)		
Girder	Type: RC	Abutment: Type: S.M
	Damage: Left G1 (C,M)	Damage: Karao A1 (P,M)

G2 (C,M)	Wad A2 (P,M)
	G3 (C,M)	Type: S.M
	G4 (C,M)	Damage: Karao P1 (B,M)
	G5 (-)	P2 (B,M)
	Right G6 (-)	P3 (-)
		P4 (-)
		P5 (-)
		P6 (-)
		Wad P7 (-)
Cross Beam:	Type: RC / Other (R.C)	
Damage: Kararo Side B1 (C,M)		
B2 (C,M)		
B3 (C,M)		
B4 (C,M)		
B5 (C,M)	Wing Wall: Type: RC	
B6 (C,M)	Damage: Karao Side (G)	
B7 (C,M)	Wad Side (G)	
B8 (C,M)	Type: RC / Other (S.M)	
B9 (C,M)	Damage: Left Side (B,M)	
B10 (-)	Right Side (G)	
B11 (-)	Type: RC	
B12 (-)	Damage: Karao Side (C,O) (Up / Downstream)	
B13 (-)	Wad Side (C,O) (Up / Downstream)	
B14 (-)	Karao Side (G) (Up / Downstream)	
B15 (-)	Wad Side (G) (Up / Downstream)	
	Rever Bank: Damage:	
Utility Line: None / Electric/Water / Gas / Telecommunication / Optical fiber / Others (None)		
Attached Photos (General view, Side view (Left and Right), Defects, Damages, etc..)

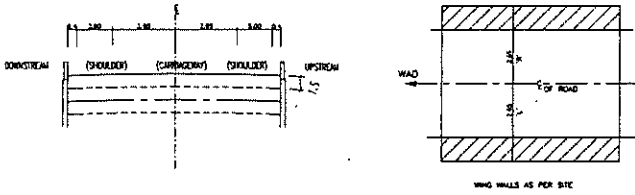
Distance : .....	km from Karachi, River Name : .....
Identified No. : .....	Station No. : 00+115
Type of Culvert : Box/Pipe/Other: (SAR)	Year of Built : OVER 20 YEARS
Road Width : 5.30 m(Carriageway), 2.80 m(Sidewalk), 13.1 m(Total)	
Number of Cell : 01	Skew : 90 degree
Size of Culvert : Inner: 2.10 m x 1.90 m, Thickness: top: 0.40 m, Vertical: ....., Bottom: ....., Total Width : 2.20 m	
Length : From inlet to outlet : 21.2 m	Earth covering : .....
Maximum Flood Level : .....	
Culvert Conditions: (G: Good, C: Cracked, P: Partly lack, R: Re-bar exposed, B: Broken, S: Scored, E: Eroded, V: Vegetated) Extent and Degree: (X: Serious Condition, M: Moderate Condition, S: Sound Condition)	
Headwall : Type : RC / Steel / Other (SM) Damage : Upstream (00%) , Downstream (00%)	
Inlet : Type : RC / Steel / Other (RC) Damage : (M) 90%	
Outlet : Type : RC / Stone / None / Other (SM) Damage : (00%)	
Erosion : Damage : None / Upstream (50) , Downstream (50)

Net Opening : 100% , Sedimentation : None / Yes (YES m from the top of inner)	
Hydraulic capacity: Inadequate / Adequate	
Flow capacity: Inadequate / Adequate	
Frequent of flood: No-flooding / Once a year / Frequent (once year)	
Attached Photos (General View, Inlet, Outlet, Defects, Damages, etc..)

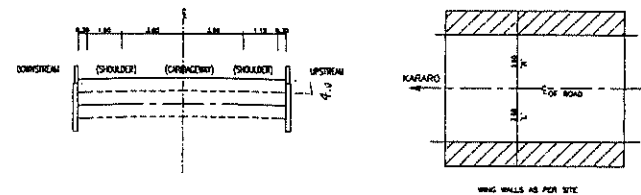
Distance : .....	km from Karachi, River Name : .....
Identified No. : .....	Station No. : 00+775
Type of Culvert : Box/Pipe/Other: (PG)	Year of Built : OVER 20 YEARS
Road Width : 6.20 m(Carriageway), 3.05 m(Sidewalk), 9.25 m(Total)	
Number of Cell : 01	Skew : 02 degree
Size of Culvert : Inner: 2.30 m x 1.90 m, Thickness: top: 0.30 m, Vertical: ....., Bottom: 0.30 m, Total Width : 2.55 m	
Length : From inlet to outlet : 22.7 m	Earth covering : 4 m
Maximum Flood Level : .....	
Culvert Conditions: (G: Good, C: Cracked, P: Partly lack, R: Re-bar exposed, B: Broken, S: Scored, E: Eroded, V: Vegetated) Extent and Degree: (X: Serious Condition, M: Moderate Condition, S: Sound Condition)	
Headwall : Type : RC / Steel / Other (RC) Damage : Upstream (00%) , Downstream (00%)	
Inlet : Type : RC / Steel / Other (RC) Damage : (G) 80%	
Outlet : Type : RC / Stone / None / Other (RC) Damage : (00%)	
Erosion : Damage : None / Upstream (50) , Downstream (50)

Net Opening : 90% , Sedimentation : None / Yes (YES m from the top of inner)	
Hydraulic capacity: Inadequate / Adequate	
Flow capacity: Inadequate / Adequate	
Frequent of flood: No-flooding / Once a year / Frequent (once year)	
Attached Photos (General View, Inlet, Outlet, Defects, Damages, etc..)

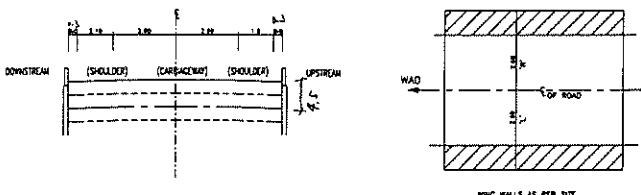
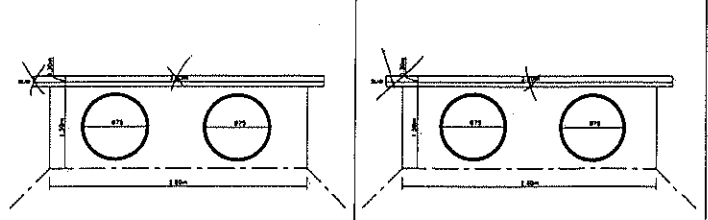
Distance : .....	km from Karachi, River Name : .....
Identified No. : .....	Station No. : 00+590
Type of Culvert : Box/Pipe/Other: (PIPE)	Year of Built : OVER 20 YEARS
Road Width : 3.20 m(Carriageway), 3.10 m(Sidewalk), 8.30 m(Total)	
Number of Cell : 01	Skew : 90 degree
Size of Culvert : Inner: 2.80 m x 1.5 m, Thickness: top: 0.30 m, Vertical: ....., Bottom: ....., Total Width : 8.90 m	
Length : From inlet to outlet : 8.90 m	Earth covering : .....
Maximum Flood Level : .....	
Culvert Conditions: (G: Good, C: Cracked, P: Partly lack, R: Re-bar exposed, B: Broken, S: Scored, E: Eroded, V: Vegetated) Extent and Degree: (X: Serious Condition, M: Moderate Condition, S: Sound Condition)	
Headwall : Type : RC / Steel / Other (RC) Damage : Upstream (00%) , Downstream (00%)	
Inlet : Type : RC / Stone / None / Other (RC) Damage : (B) 50%	
Outlet : Type : RC / Stone / None / Other (RC) Damage : (100%)	
Erosion : Damage : None / Upstream (50) , Downstream (50)

Net Opening : 50% , Sedimentation : None / Yes (YES m from the top of inner)	
Hydraulic capacity: Inadequate / Adequate	
Flow capacity: Inadequate / Adequate	
Frequent of flood: No-flooding / Once a year / Frequent (once year)	
Attached Photos (General View, Inlet, Outlet, Defects, Damages, etc..)

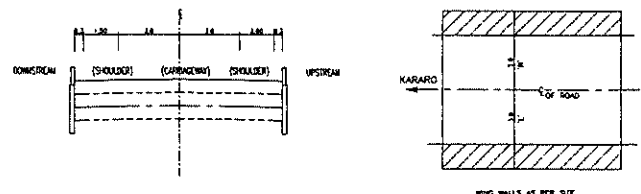
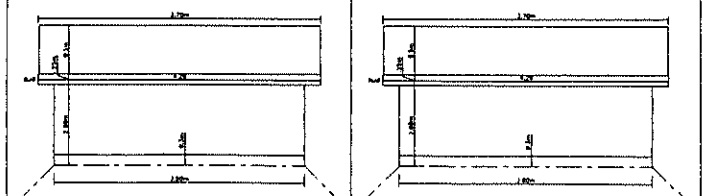
Distance : .....	km from Karachi, River Name : .....
Identified No. : .....	Station No. : 00+995
Type of Culvert : Box/Pipe/Other: (BR)	Year of Built : OVER 20 YEARS
Road Width : 8.0 m(Carriageway), 4.1 m(Sidewalk), 12.1 m(Total)	
Number of Cell : 01	Skew : 0 degree
Size of Culvert : Inner: 3.80 m x 2.80 m, Thickness: top: 0.45 m, Vertical: ....., Bottom: 0.4 m, Total Width : 10.1 m	
Length : From inlet to outlet : 10.1 m	Earth covering : 0.5 m
Maximum Flood Level : .....	
Culvert Conditions: (G: Good, C: Cracked, P: Partly lack, R: Re-bar exposed, B: Broken, S: Scored, E: Eroded, V: Vegetated) Extent and Degree: (X: Serious Condition, M: Moderate Condition, S: Sound Condition)	
Headwall : Type : RC / Steel / Other (BRICK) Damage : Upstream (00%) , Downstream (00%)	
Inlet : Type : RC / Steel / Other (RC) Damage : (B) 90%	
Outlet : Type : RC / Stone / None / Other (SM) Damage : (G) 90%	
Erosion : Damage : None / Upstream (70) , Downstream (50)

Net Opening : 90% , Sedimentation : None / Yes (YES m from the top of inner)	
Hydraulic capacity: Inadequate / Adequate	
Flow capacity: Inadequate / Adequate	
Frequent of flood: No-flooding / Once a year / Frequent (once year)	
Attached Photos (General View, Inlet, Outlet, Defects, Damages, etc..)
