資料 8-2-9. 危険物(磁気)探査結果

BACTEC SE Asia Pty. Ltd. (BACTEC) was engaged by ECOH Corporation, Japan, to conduct an Unexploded Ordnance (UXO) Survey of three sites required for the construction of a wharf and channel improvement. The project site was a battlefield during WWII and as such the possibility of UXO's being in the area was high. A magnetic survey and visual search was deemed to be the most effective way to locate any unexploded ordnance within the sites. It should be noted that marine growth over the last 60 years helped to mask the location of UXO's, without the use of a magnetometer.

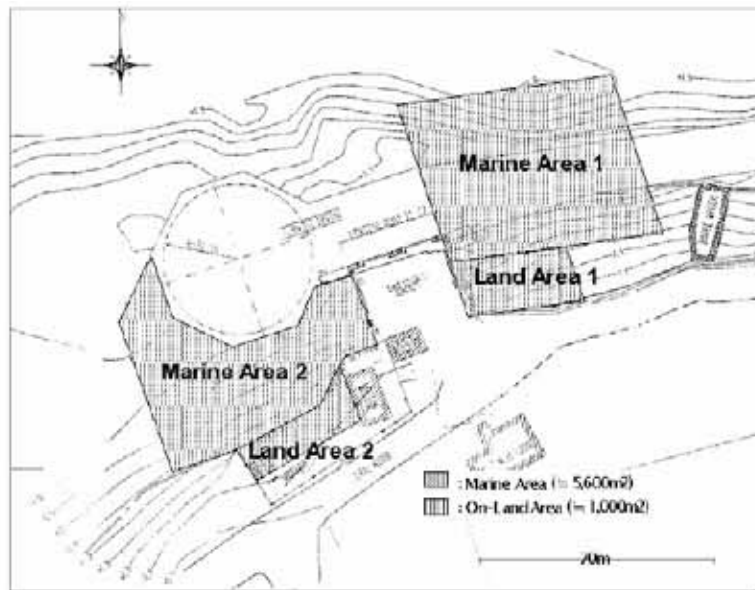
図 A.8.2.9-1 危険物調査範囲(北港周辺)

北港周辺の危険物調査範囲図を図 A.8.2.9-1 に示す。陸上部および水深 1.5m 以浅の海域は調査員が金属探知器を用いて金属の有無を探査した。水深 1.5m 以深の海域はダイバーが金属探知器を持って移動し、異常の確認は船上のモニターにより行った。一方、航路部における危険物探査の測線図を図 A.8.2.9-2 に示す。測線間隔は約 10m であり、ダイバーが船に曳航されながら目視にて地形の変化を確認し、異常が認められた場合は金属探知器で再探査した。次頁以下(資-67～資-87)に再委託先の BACTEC 社による調査結果を貼付する。

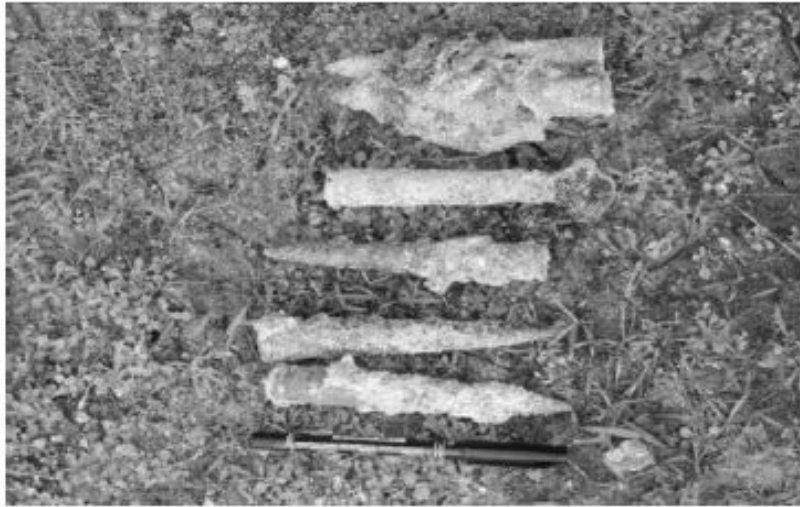
The first site was located east of the existing wharf and out from the high water mark. Total area covered was 15 x 35 metres (525 sq. metres). The site was soft-to-medium packed coral sand, with heavy kelp coverage in the sheltered area of the wharf. This site contained metal fragments in varying states of corrosion. The main items uncovered were reinforcement bar and scrap iron. 6 x 0.50 calibre machine gun rounds were located in this site. No other items of significance were located.

0.50 Cal ammunition found in Land Survey Site 1

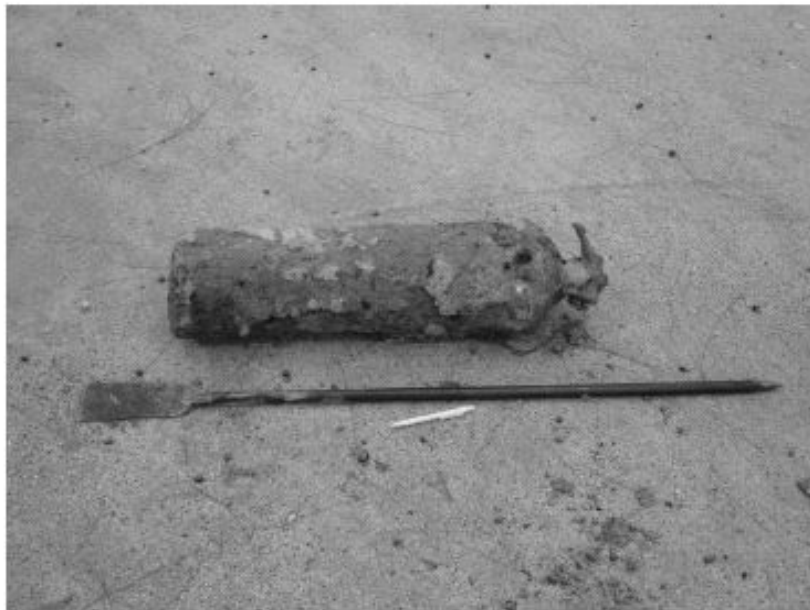
possibility of UXO existing in this area would be close to non-existent. Items uncovered included a fire extinguisher one metre below the surface, vehicle parts and scrap metal. No other items of significance were located. A UXO Survey Certificate for these two sites is attached at Appendix 3 to this report.

Fire extinguisher found 1metre down in Land Survey Site 2

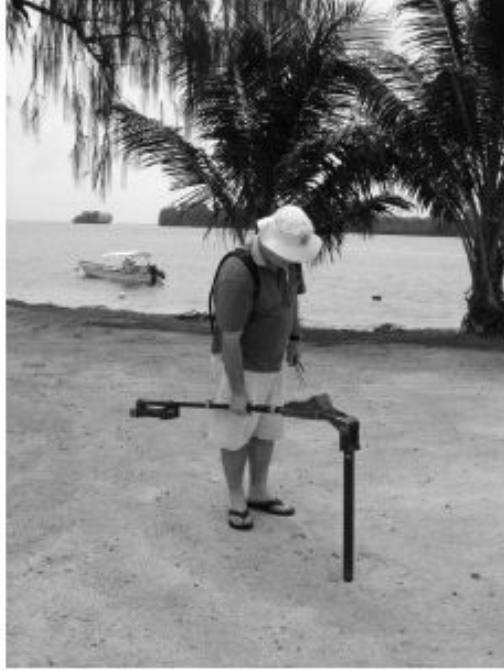
Magnetometer search Land Survey Site 2

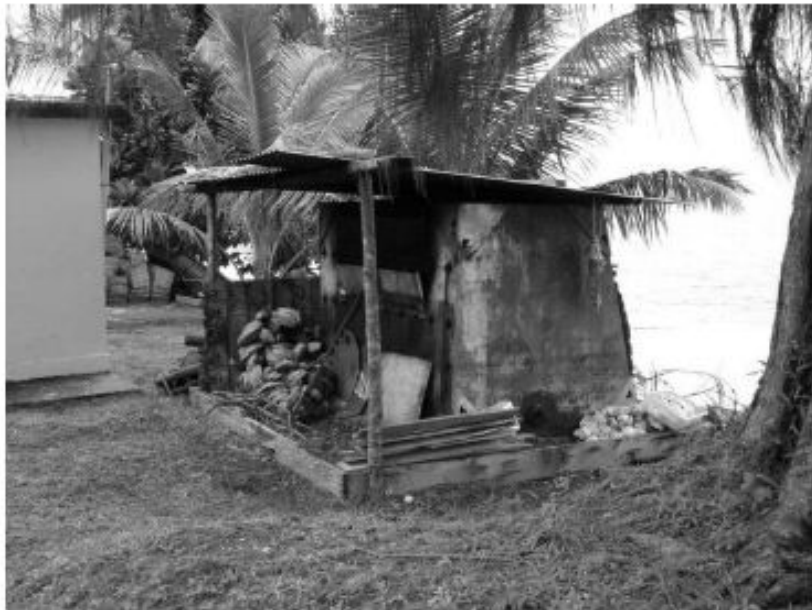
Furnace in Land Survey area Site 2

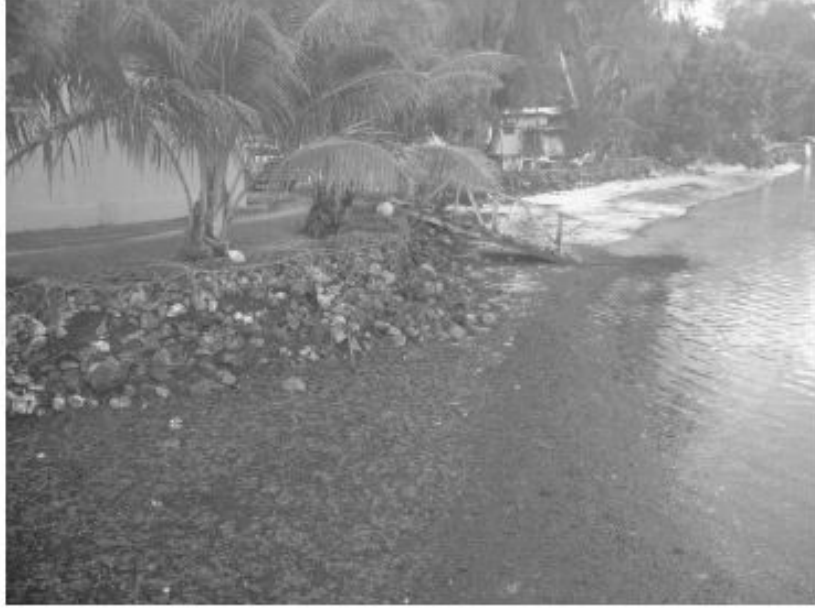
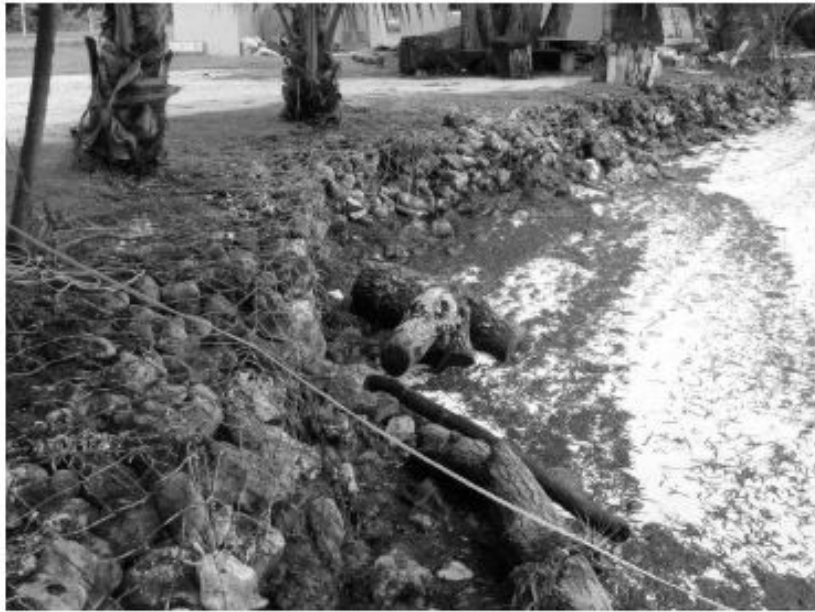
Gabion Sea wall in Land Survey Site 2

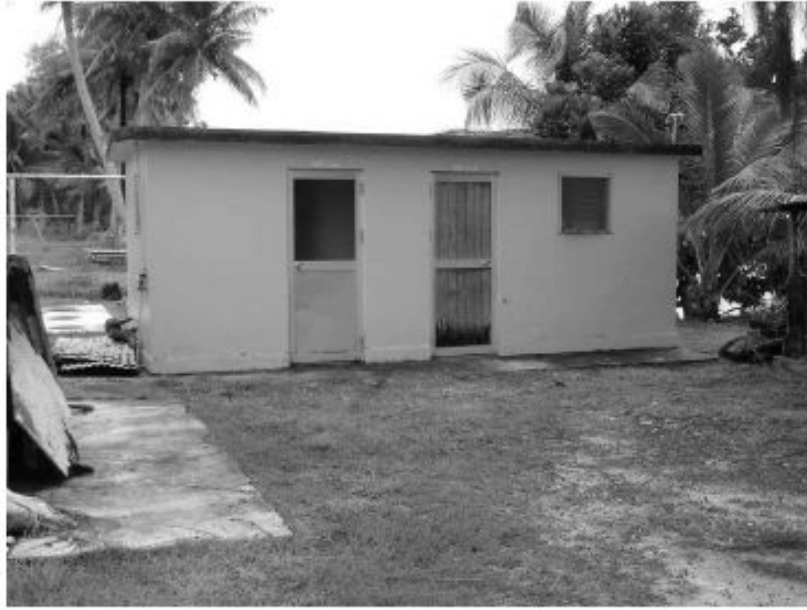
Shed in Land Survey Site 2

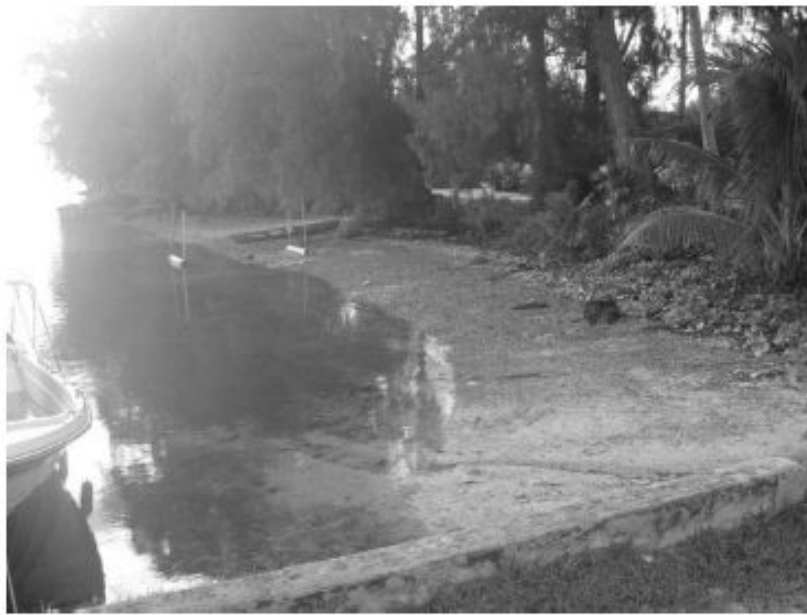
Land Survey Site 1

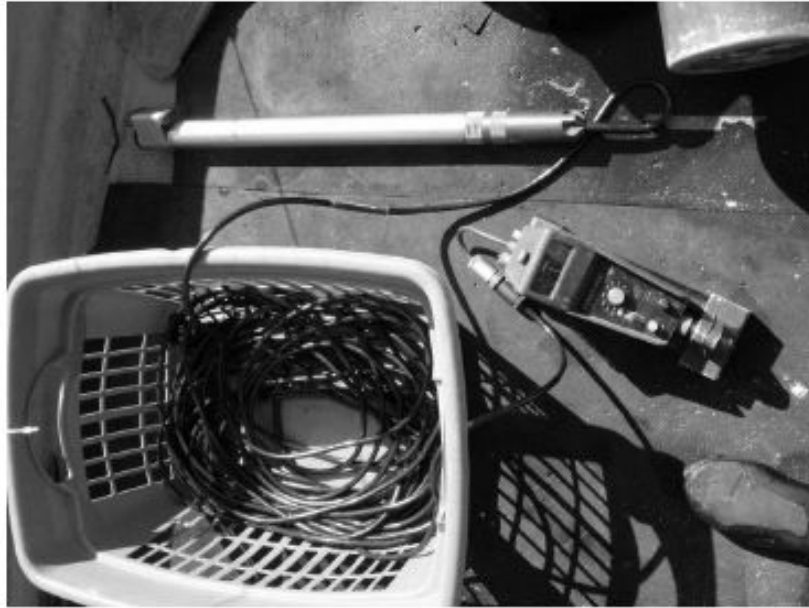
The Foerster Ferex 4.021 Analogue Gradiometer Magnetometer was used to conduct the magnetic survey at all sites. The Ferex is a search instrument designed to detect ferrous objects beneath the ground up to a depth of 6 metres. The depth capability is dependant on the size of the object, the magnetic signature and the aspect of the target. The 4.021 will detect a 25 lb. projectile at 2 metres. A 30 metre underwater cable was used during the survey of the basin area and the channel. Photographs of the equipment are attached at Appendix 6 of this report.

Underwater Magnetometer with 30 metres cable

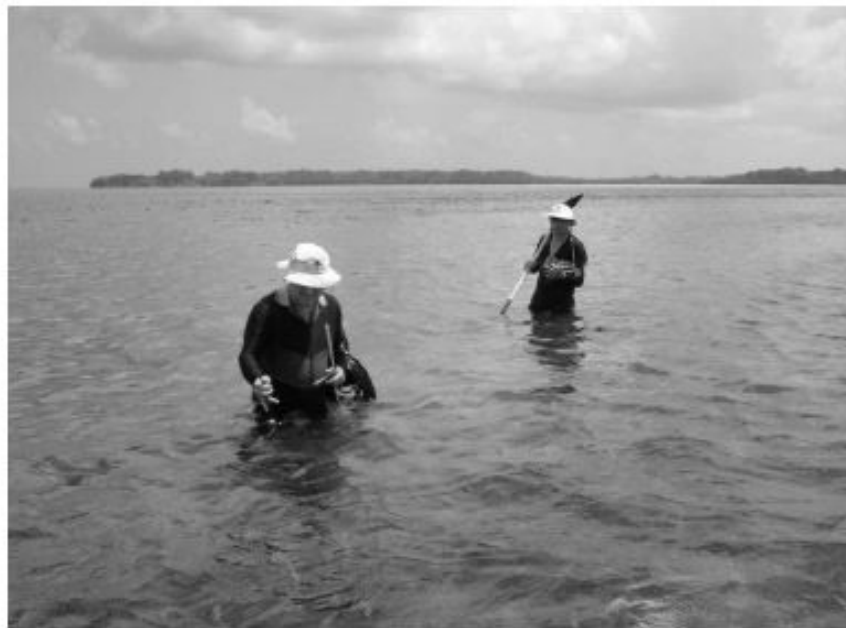
Magnetometer Survey of shallow in Main Channel

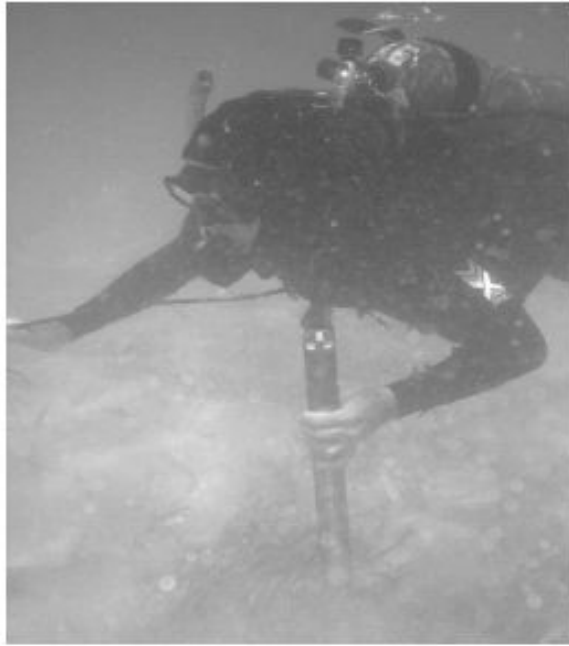
Both sites were initially visually inspected to establish the amount and type of ferrous obstacles in the area. This search was followed by a Magnetometer survey to investigate items under the sea bed. A diver manoeuvred the magnetometer probe around the sites with direction from the surface. Once a contact was pin pointed, the diver would excavate the area until the item giving the reading was found. All contacts were investigated and positively identified.

Diver using Underwater Magnetometer

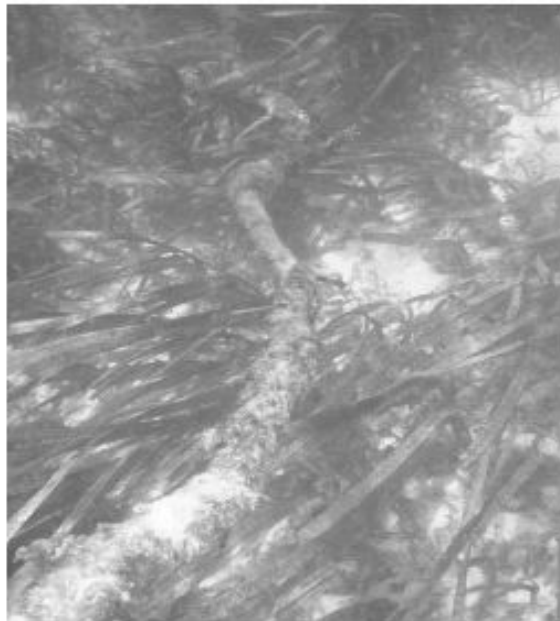
The three locations are listed to assist in future dredge plans, as the cable is 10 metres in the main channel and would pose a problem for dredges.

The cable was again relocated at 3 positions between Beacon 18 and 22 and once again was 10 metres in from the beacons. The cable had 4 rubberised cores and was protected by steel cable. A photograph of the cable is attached at Appendix 6 of this report.

Submarine Cable pulled out of seabed, Main Channel.

The submarine cable located during the main channel survey should be noted if dredging operations are to take place. Local sources have said that there is a telecom cable somewhere in the main channel, but as this cable would have a copper core in rubberised wrapping, it was impossible to locate with the magnetometer. After discussions at the local government offices, it was confirmed that a telecom cable was laid in the left hand side of the channel coming from Koror in 1994.
