Appendix 6-2. Results of Natural and Environmental Survey

Basic Design Study on the Project for the Southern Outlying Peleliu State Water Quality
Survey
ECOH CORPORATION LIMITED

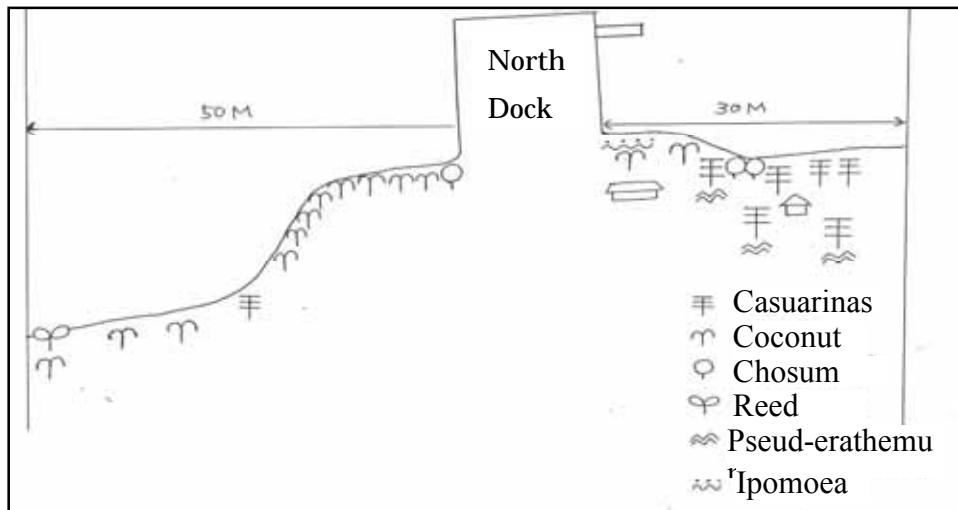
Figure A.6.2.2-1 Layout Map of Trees around North Dock

Figure A.6.2.2-1 shows the growing conditions of trees near North Dock. Large Casuarinas trees and coconuts trees and Chosms (Palauan name) trees are growing. One casuarinas tree is growing at the west shore area of North Dock. And about ten casuarinas trees are growing east grand area of North Dock. Casuarinas trees have much leaves and make shades. These areas are useful place for resting of citizen of Peleliu. Coconuts and chosms trees are rather small and have few leaves.

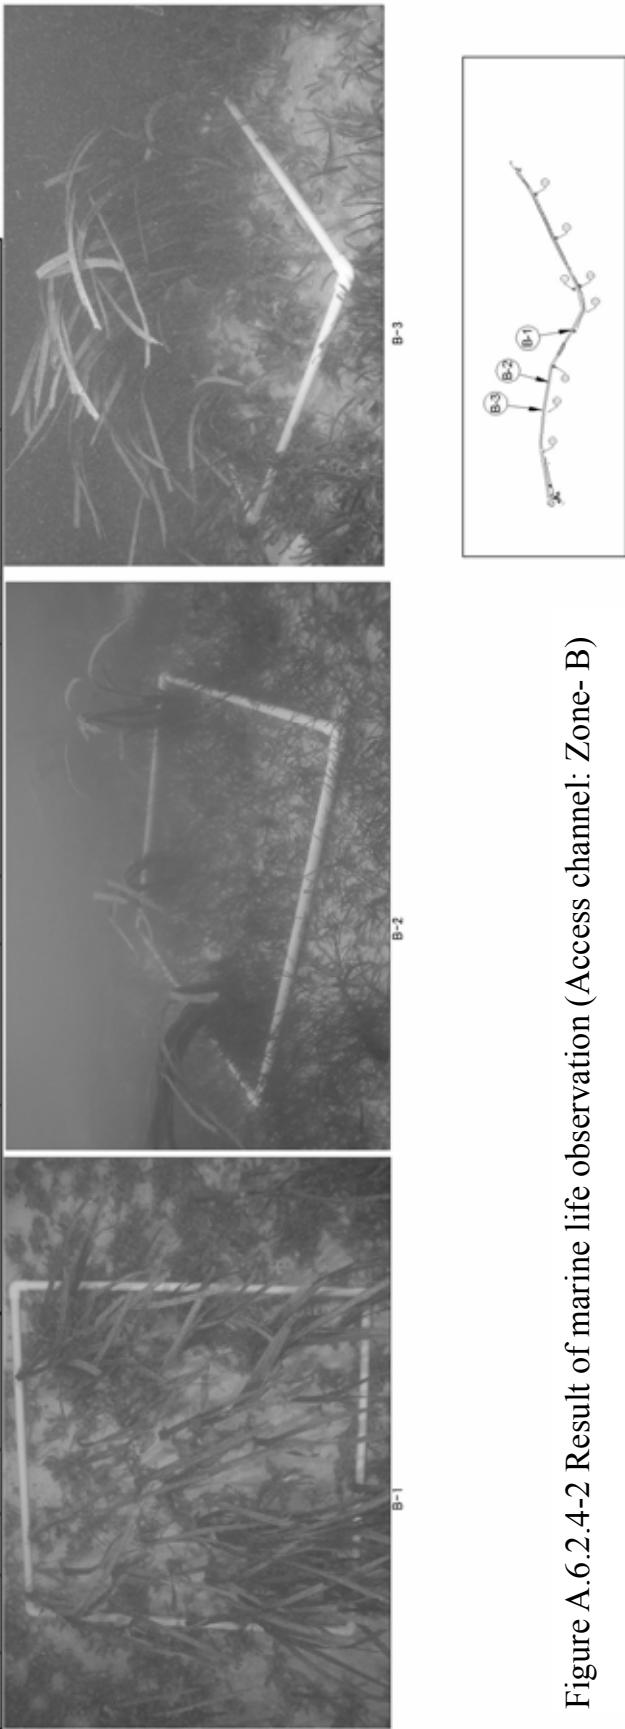
Figure A.6.2.4-2 Result of marine life observation (Access channel: Zone- B)

Mnne Lite Observation by Quadrat method
2005/Aug/11

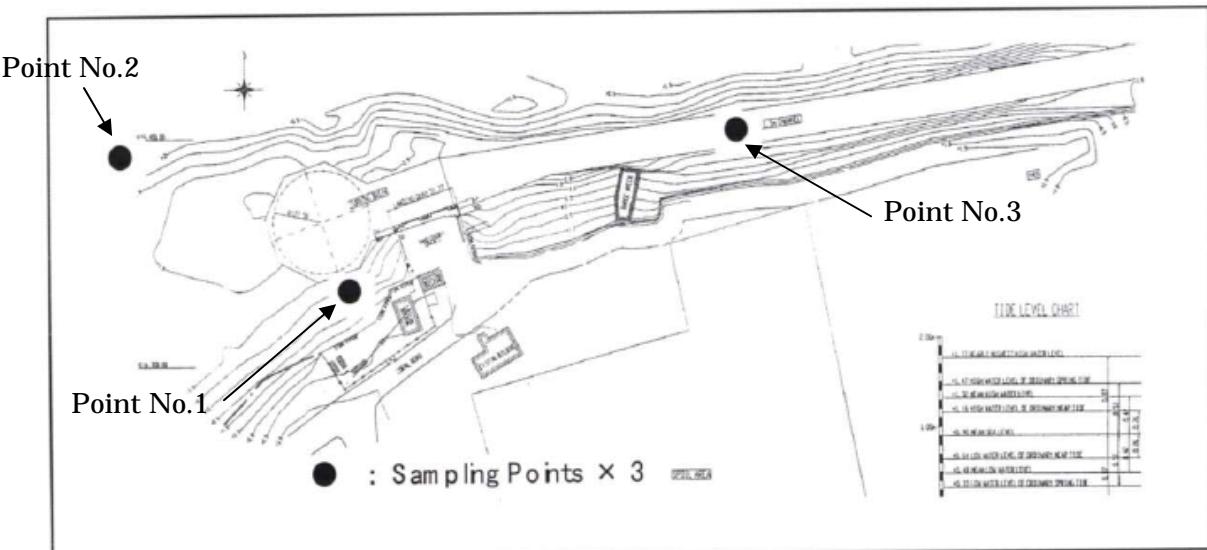
Figure A.6.2.6-1 Location of sampling points

Seabed sediment quality analysis has been carried out at the site shown in Figure A.6.2.6-1. Samples were collected from seabed by diver. Results of grain size analysis are shown in Figure A.6.2.6-2 to A.6.2.6-4.

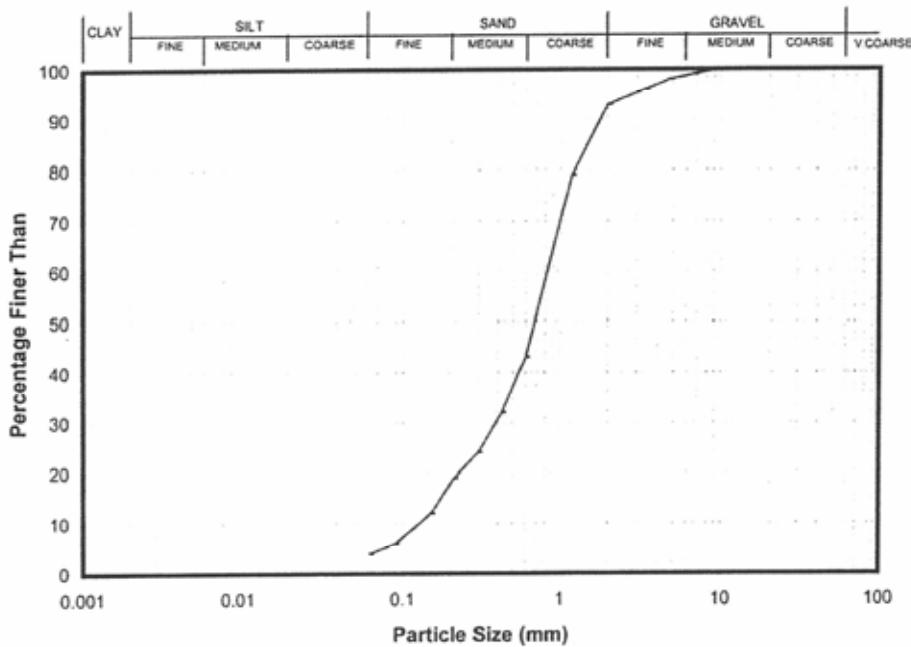
Figure A.6.2.6-2 Result of sediment quality investigation (Point No.1)

Plate No.:
Site : North Dock, Pelelieu Island, Palau
BH No.: --- Sample No.: S1
Test Method Used : NZS 4402 : 1986 Test 2.8.2 Dry Sieve

Sieve (mm)	Total % Passing	Sieve (mm)	Total % Passing
63.0	---	2.00	93
53.0	---	1.18	79
37.5	---	0.600	43
26.5	---	0.425	32
19.0	---	0.300	24
13.2	---	0.212	19
9.50	100	0.150	12
6.70	99	0.090	6
4.75	98	0.063	4
3.35	96

Description : Coral mixed with shell fragments and sand, loose/free water, light grey with white.

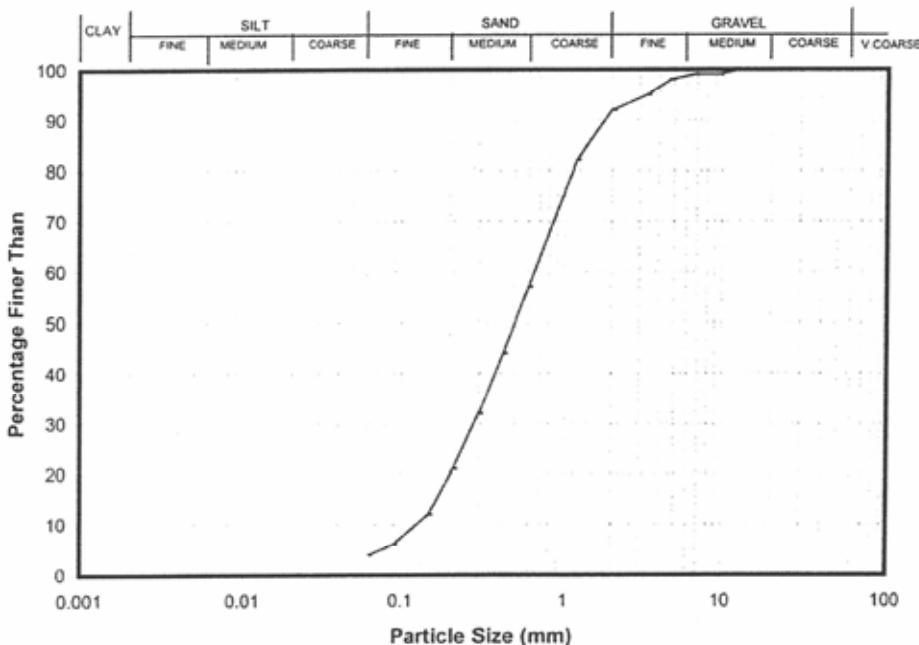
Figure A.6.2.6-3 Result of sediment quality investigation (Point No.2)

Plate No.:
Site : North Dock, Peleliu Island, Palau
BH No.: --- Sample No.: S2
Test Method Used : NZS 4402 : 1986 Test 2.8.2 Dry Sieve

Sieve (mm)	Total % Passing
63.0	---
53.0	---
37.5	---
26.5	---
19.0	---
13.2	100
9.50	99
6.70	99
4.75	98
3.35	95

Sieve (mm)	Total % Passing
2.00	92
1.18	82
0.600	57
0.425	44
0.300	32
0.212	21
0.150	12
0.090	6
0.063	4

Description : Coral mixed with shell fragments and sand, loose/free water, light yellow with grey/ white.

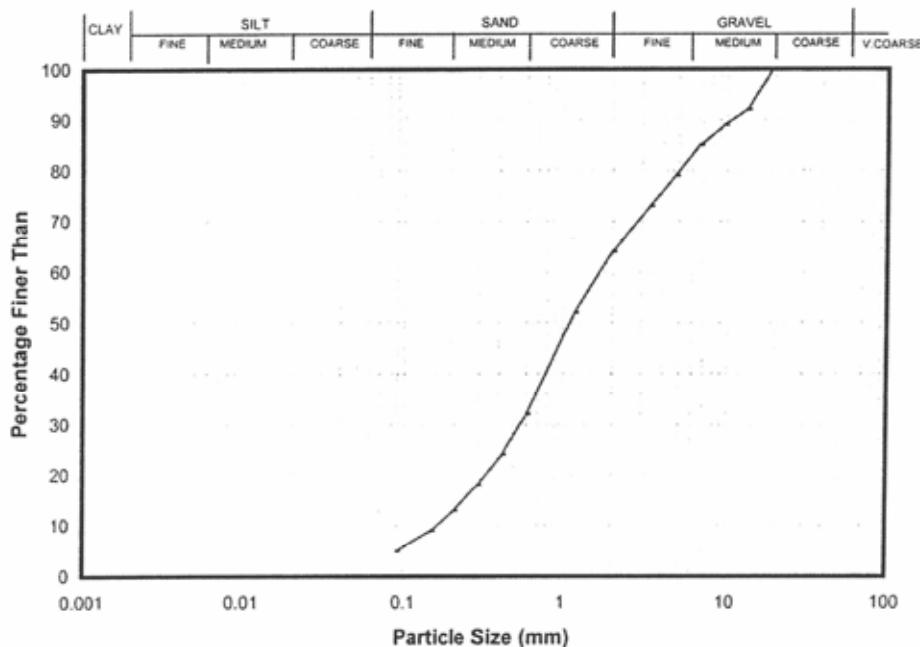
Figure A.6.2.6-4 Result of sediment quality investigation (Point No.3)

Plate No.:
Site : North Dock, Peleliu Island, Palau
BH No.: --- Sample No.: S3
Test Method Used : NZS 4402 : 1986 Test 2.8.2 Dry Sieve

Sieve (mm)	Total % Passing
63.0	---
53.0	---
37.5	---
26.5	---
19.0	100
13.2	92
9.50	89
6.70	85
4.75	79
3.35	73

Sieve (mm)	Total % Passing
2.00	64
1.18	52
0.600	32
0.425	24
0.300	18
0.212	13
0.150	9
0.090	5
0.063	4

Description : Coral mixed with shell fragments and sand, loose/free water, dark grey with white.

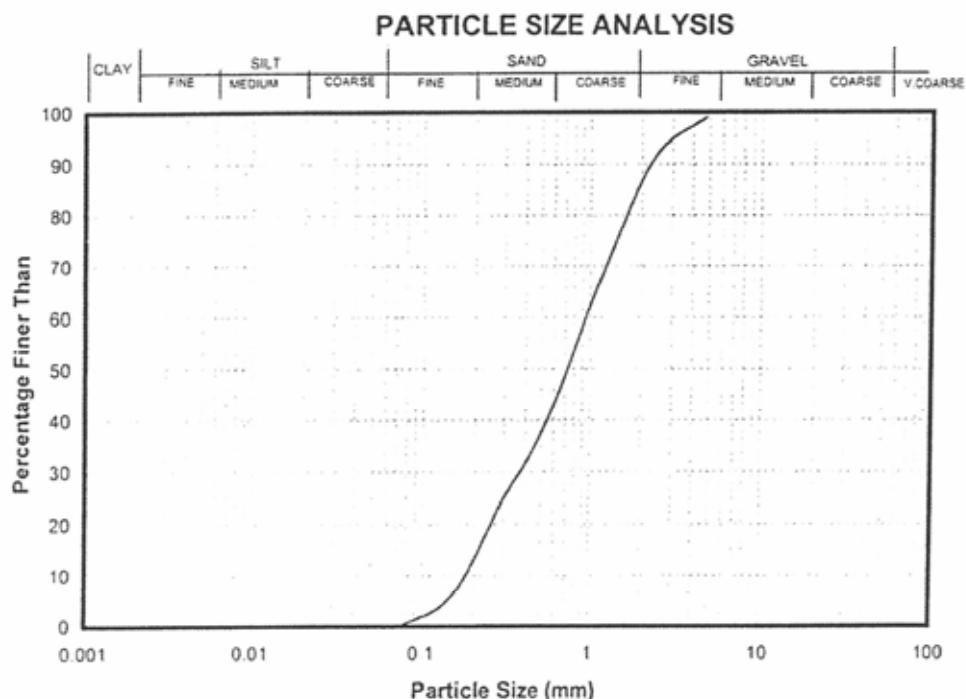
Figure A.6.2.7-1 Particle size analysis (PTC, sand)

Plate No.: 1
Site : Peleliu Island, Palau
Sample No. : PTC Quarry - Sand
Test Method Used : NZS 3111: 1986: Test 6 Sieve Analysis and Calculation of Fineness modulus

Total % Passing	Sieve (mm)
---	13.2
---	9.5
100	6.7
99	4.75
91	2.36
68	1.18
43	0.600
33	0.425
25	0.300
6	0.150
0	0.075

Sample history : As received condition
Description : SAND (coarse to fine), loose, some gravel

Remarks: Fineness Modulus = 2.70

Material analysis was carried out. Two samples of sand and gravels from two quarry sites were sampled. The samplings were carried out at two quarry site of PTC (Palau Transportation Company) and Hawaiian Belau Rock (HBR). Laboratory result test are shown in Table A.6.2.7-1 to A.6.2.7-2. Results of particle size analysis are shown in Figure A.6.2.7-1 to A.6.2.-4.

Item	Relative Gravity	Moisture Content	Particle size analysis
Sand	2.69	13%	Figure A.6.2.7-1
Cobble	2.77		Figure A.6.2.7-2
Gravel	2.80

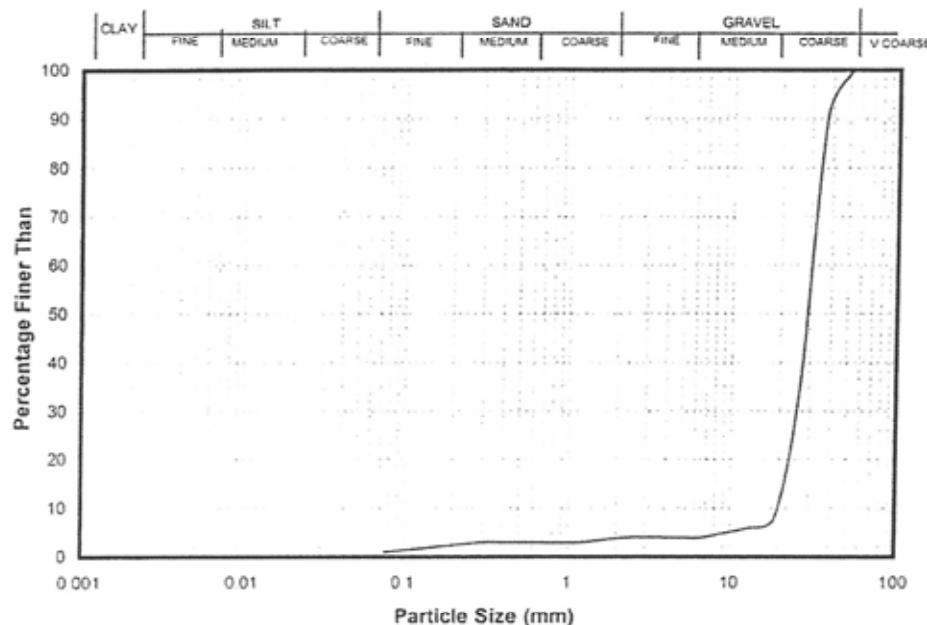
Figure A.6.2.7-2 Particle size analysis (PTC, gravel)

Plate No.: 2 Page of
Site : Peleliu Island, Palau Job No.: 750485
Sample No. : PTC Quarry - Cobble Depth : --- (m)
Test Method Used : NZS 3111: 1986: Test 6 Sieve Analysis and Calculation of Fineness modulus

Total % Passing	Sieve (mm)
100	53
91	37.5
35	26.5
8	19
6	13.2
5	9.5
4	6.7
4	4.75
4	2.36
3	1.18
3	0.600

Total % Passing	Sieve (mm)
3	0.425
3	0.300
2	0.150
1	0.075

Description : GRAVEL (Coarse), Loose, some sand and small gravels

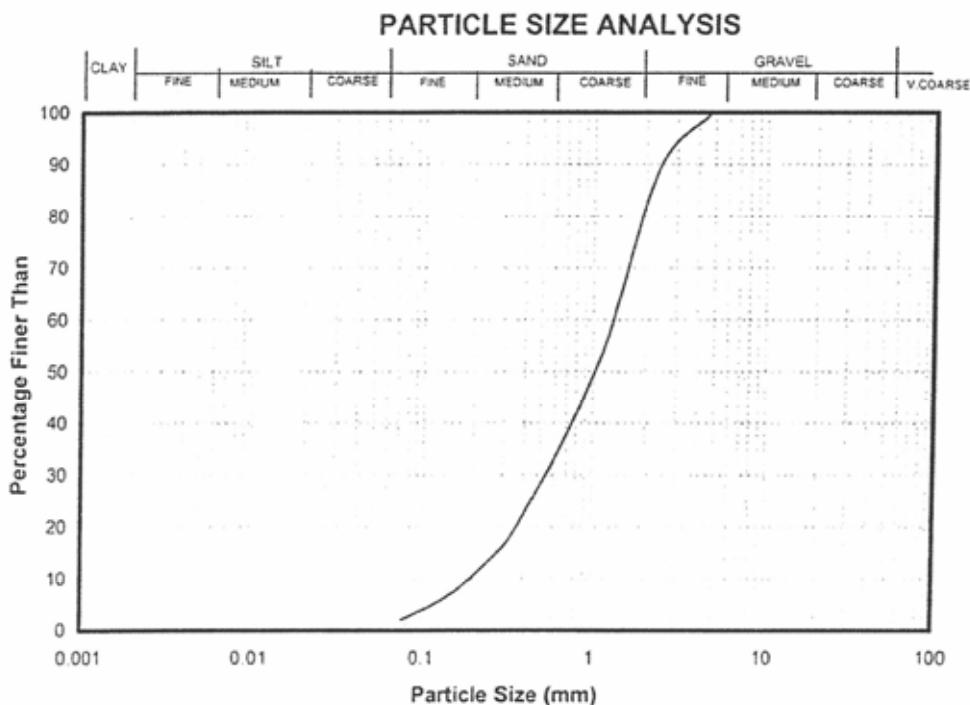
Figure A.6.2.7-3 Particle size analysis (HBR, sand)

Plate No.: 3
Site : Peleliu Island, Palau
Sample No. : Hawaiian Rock Corp - Sand
Test Method Used : NZS 3111: 1986: Test 6 Sieve Analysis and Calculation of Fineness modulus

Total % Passing	Sieve (mm)
---	13.2
---	9.5
---	6.7
100	4.75
89	2.36
55	1.18
33	0.600
24	0.425
16	0.300
7	0.150
2	0.075

Description : SAND (coarse to fine), loose, some gravel

Remarks: Fineness Modulus = 3.00

Item	Relative Gravity	Moisture Content	Particle size analysis
Sand	2.64	6.6%	Figure A.6.2.7-3
Cobble	2.55		Figure A.6.2.7-4
Gravel	2.61

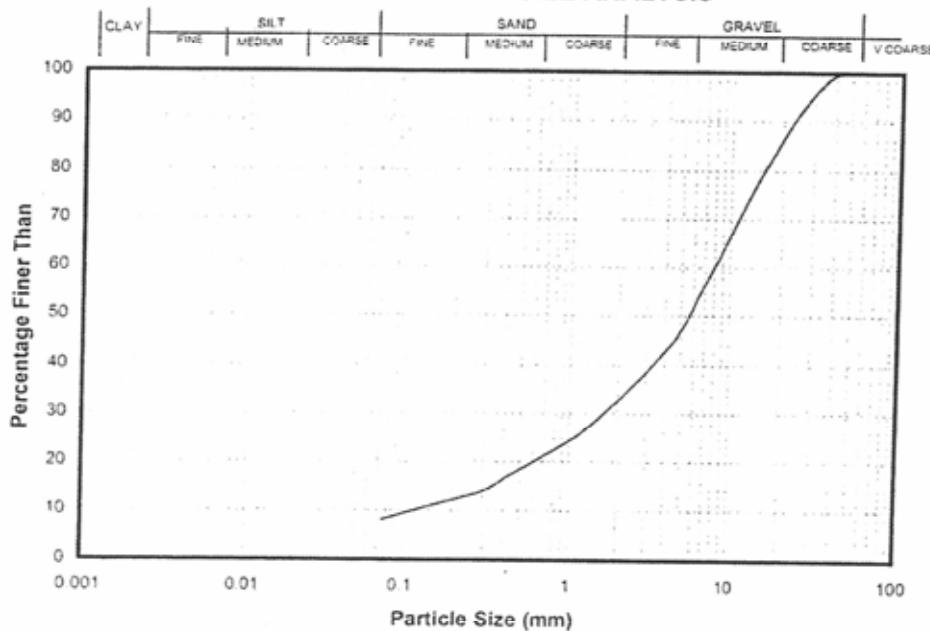
Figure A.6.2.7-4 Particle size analysis (HBR, gravel)

Plate No.: 4 Page of
 Site : Peleliu Island, Palau Job No. : 750485
 Sample No. : Hawaiian Rock Corp Quarry - Cobble Depth : --- (m)
 Test Method Used : NZS 3111: 1986: Test 6 Sieve Analysis and Calculation of Fineness modulus

Total % Passing	Sieve (mm)
100	53
99	37.5
93	26.5
85	19
75	13.2
65	9.5
55	6.7
46	4.75
35	2.36
26	1.18
20	0.600

Total % Passing	Sieve (mm)
17	0.425
14	0.300
11	0.150
8	0.075

Sample history : As received condition
 Description : GRAVEL (Coarse to fine), sandy, loose,

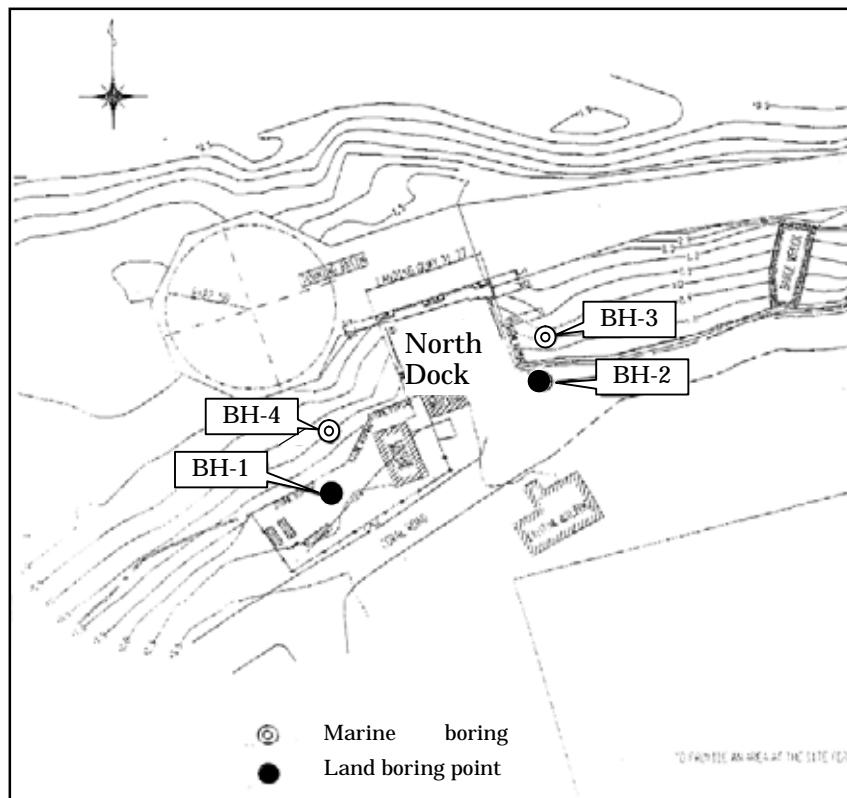
Figure A.6.2.8-1 Location of Bore Holes

Soil investigation has been conducted at 4 locations of the project site. Figure A.6.2.8-1 shows the bore hole points. Bore hole has been drilled to -7m depth at BH-1 and BH-2, -4.5m at BH-3, -9.5m at BH-4. At all bore hole bearing layer had appeared (refer to Figure A.6.2.8-2 to A.6.2.8-5).
