CHAPTER 29

TRAFFIC FLOW IMPROVEMENT PLAN IN CITY CENTRE

29.1 PRESENT CONDITIONS AND ISSUES

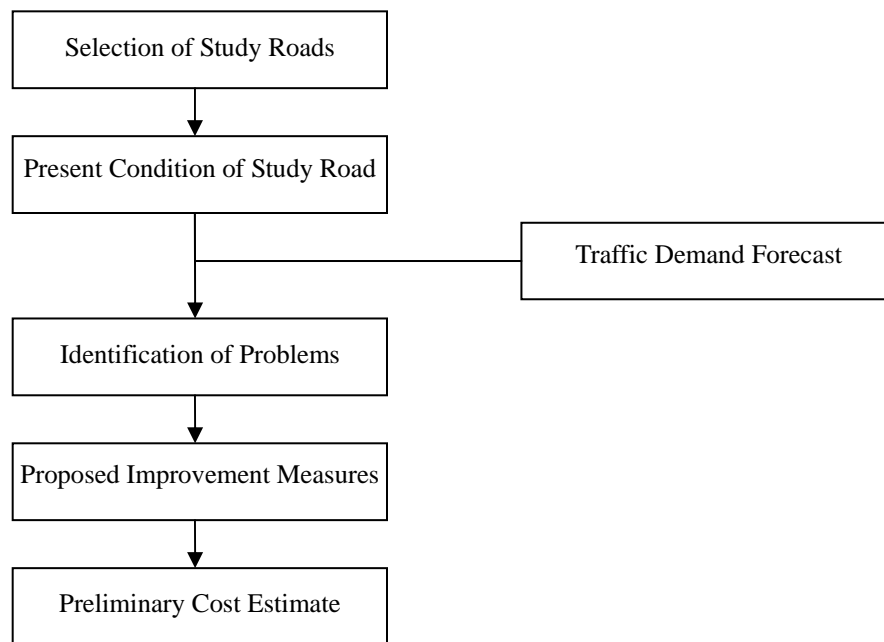
FIGURE 29.2-1 STUDY APPROACH

The objective of this Study is to prepare a functional road system connecting the CBD and to provide effective facilities for the smooth inflow of traffic into and outflow from the CBD. The study approach for roads connecting the CBD is shown in Figure 29.2-1.

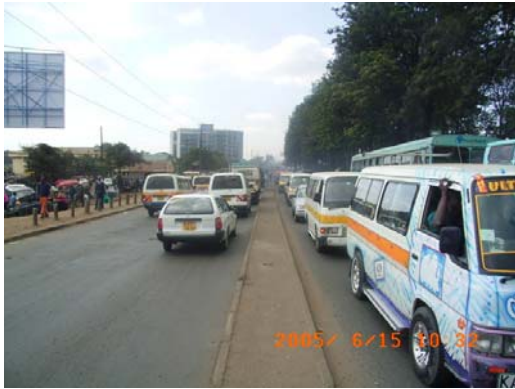
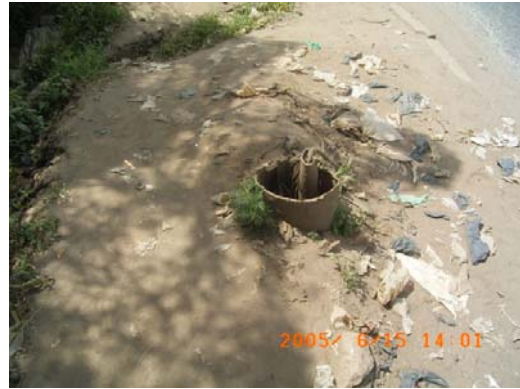
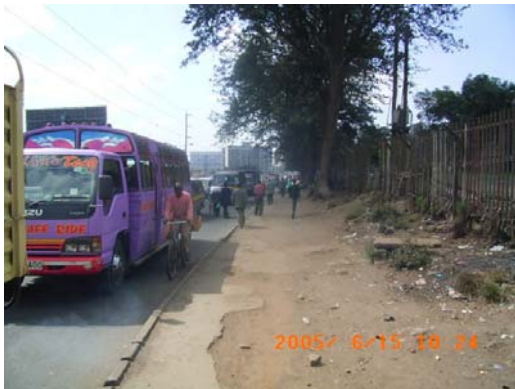
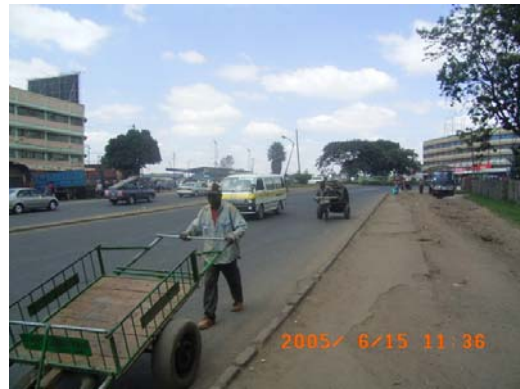
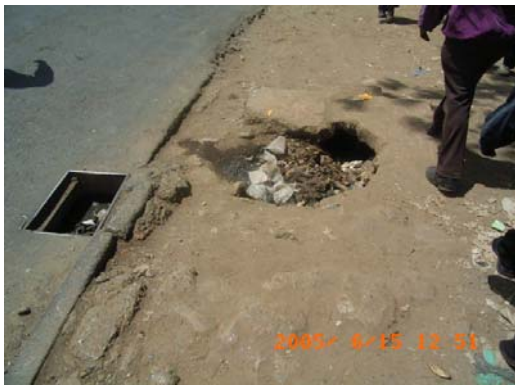
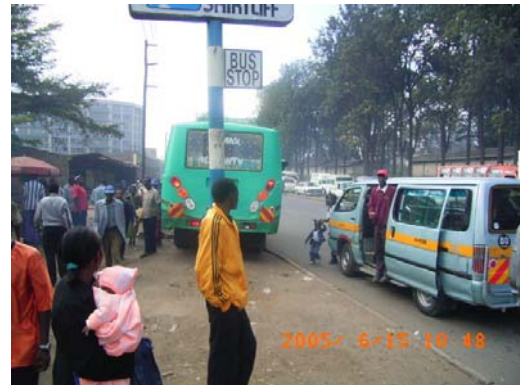
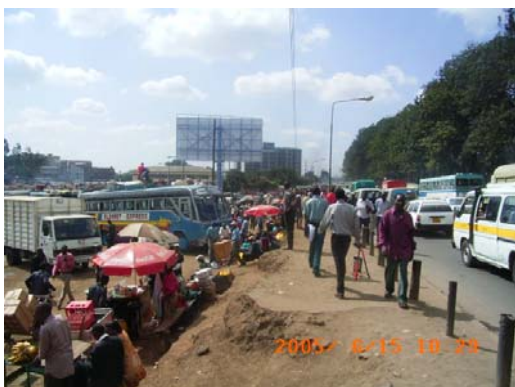
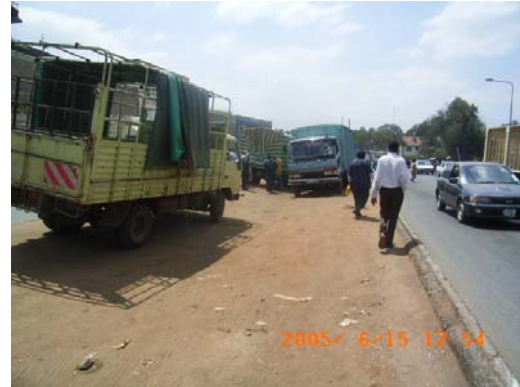
FIGURE 29.2-5 TRAFFIC PROBLEMS AND ISSUES

Direction of Traffic: Unbalanced Traffic by Lane

Street Light: Non-functional

NMT: No pavement. State of Negligence

NMT on Carriageway

Drainage: Mal-function and poor maintenance

Public Transport

NMT: No improvement. State of Negligence

Traffic Regulation: Parking on NMT

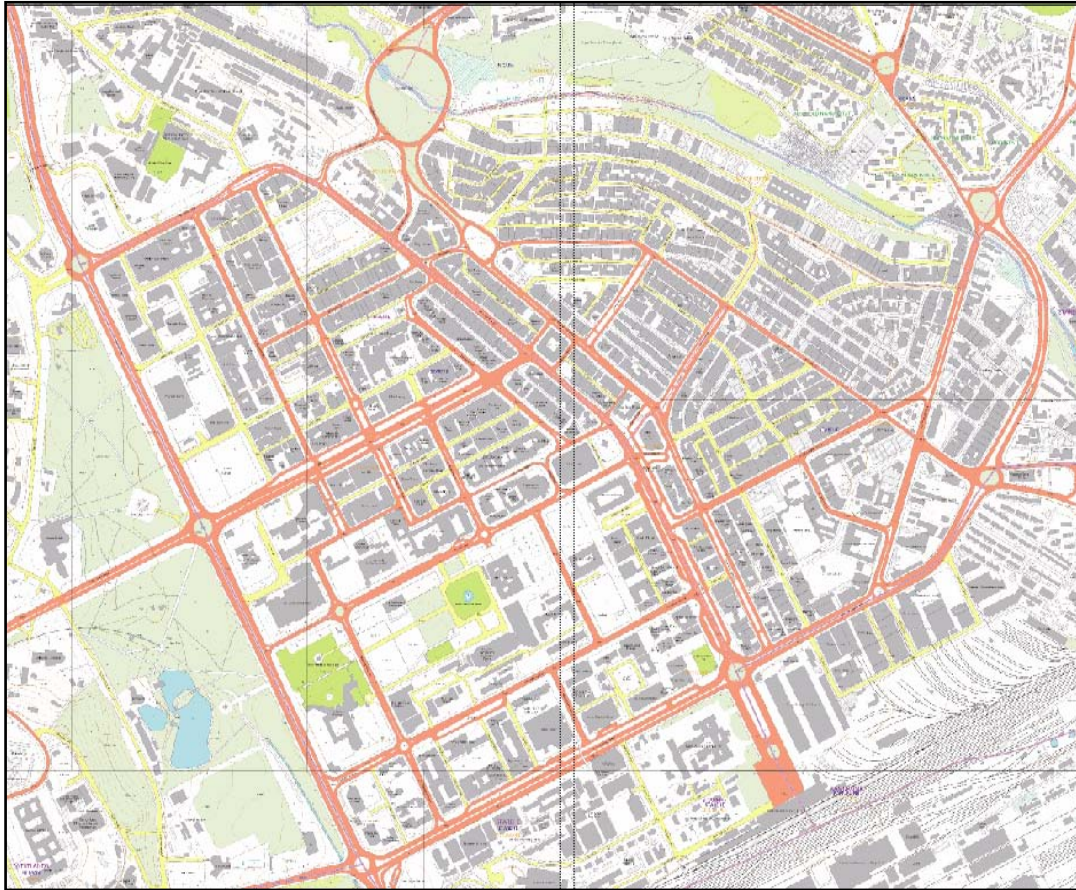
**FIGURE 29.3-2 STUDY AREA FOR TRAFFIC FLOW IMPROVEMENT
INSIDE THE CBD**

Figure 29.3-2 shows the existing road network in the CBD of Nairobi. The road network in the CBD is comparatively developed as a grid type. The total length of the road network in the CBD is about 25.4 km, of which arterials cover about 6.0 km, collectors about 12.1 km and the remaining 7.3 km are local roads (see Table 29.3-1).

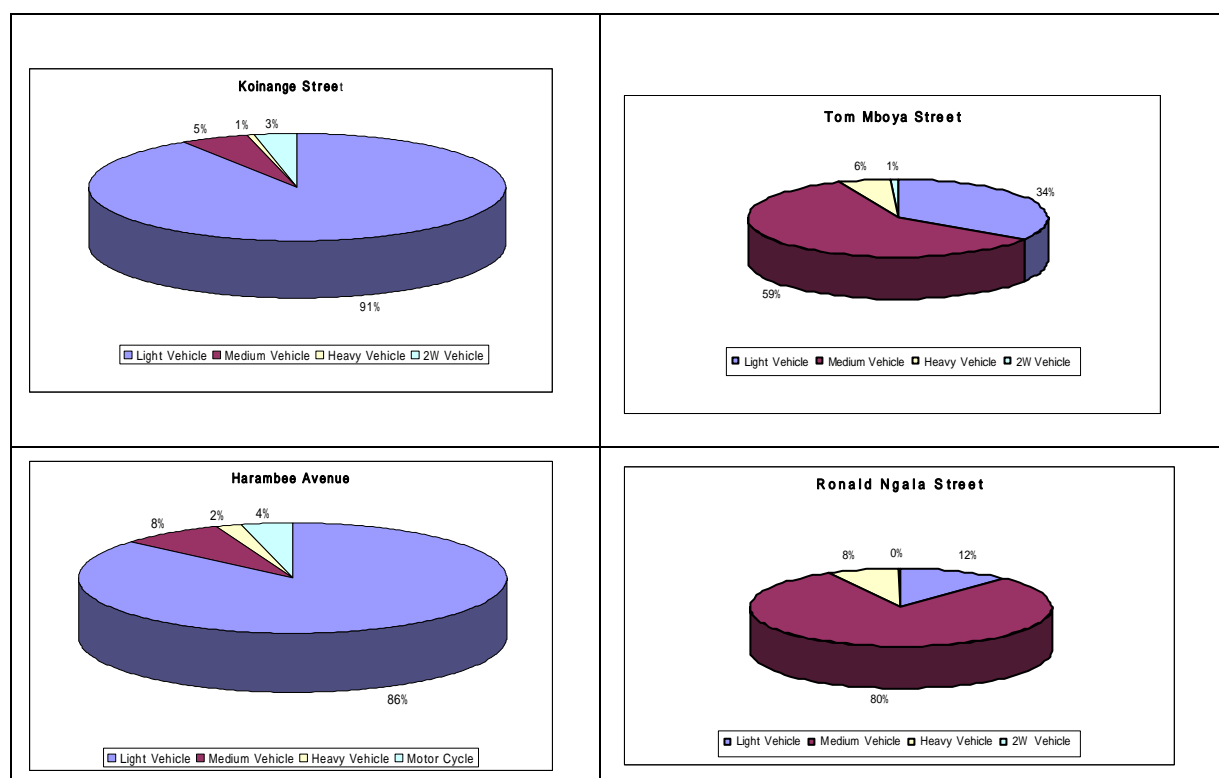
FIGURE 29.3-3 VEHICLE COMPOSITION ON MAJOR ROADS IN THE CBD

Figure 29.3-3 shows the vehicle composition on Koinange Street, Harambee Avenue, Tom Mboya Street and Ronald Ngala Street. Figure 29.3-4 shows NMT traffic volume inside the CBD, while Figure 29.3-5 shows the variation of traffic volume of Koinange Street and Tom Mboya Street.
