Road Damage Inventory for Jhelum Valley Road (Muzaffarabad - Chakotti)

Road Damage Photo for Jhelum Valley Road (1)

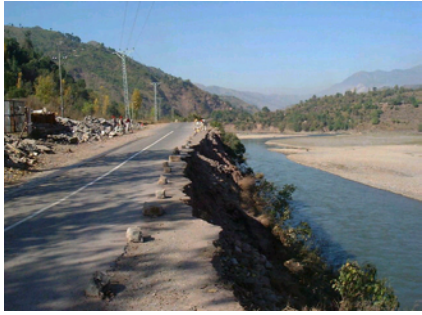
Photo No. 4 (6+400 to 6+560)	Photo No. 5 (8+100 to 8+800)	Photo No. 6 (9+900 to 10+100)

Km		Length (m)	Damage Description	Photo No.
from	to			
0 + 300	0 + 380	80	- Collapse of mountain side slope (slope height : about 40 m) - Road height form river-bed : about 7 m	1
5 + 250	5 + 380	130	- Mountain side slope collapse - Road shoulder falling dawn to valley side	2
6 + 150	6 + 300	150	- Road body of river side falling dawn - Road height form riverbed : about 14 m	3
6 + 400	6 + 560	160	- Road shoulder falling dawn to river side	4
7 + 700	7 + 720	20	- Road shoulder falling dawn to river side	
8 + 100	8 + 800	700	- Collapse of mountain side slope (slope height : about 20 to 30 m) - Road shoulder falling dawn to river side	5
9 + 900	10 + 100	200	- Collapse of mountain side slope (slope height : about 15 to 20 m)	6
10 + 300	10 + 400	100	- Collapse of mountain side slope (slope height : about 40 m) (Road height form river-bed : about 7 m)	7
11 + 100	11 + 650	550	- Falling rock boulder - Road shoulder falling dawn to river side - Masonry revetment collapse	8
