Table A1.4.1 Water Policy and Irrigation Management of Asian Countries (1/4)

**Figure 1 Irrigation Diagram of the Pilot and Control Area**

**Figure 2 H-Q Curve of D-1 (Rajangana LB Tract 2 Pilot Area)**

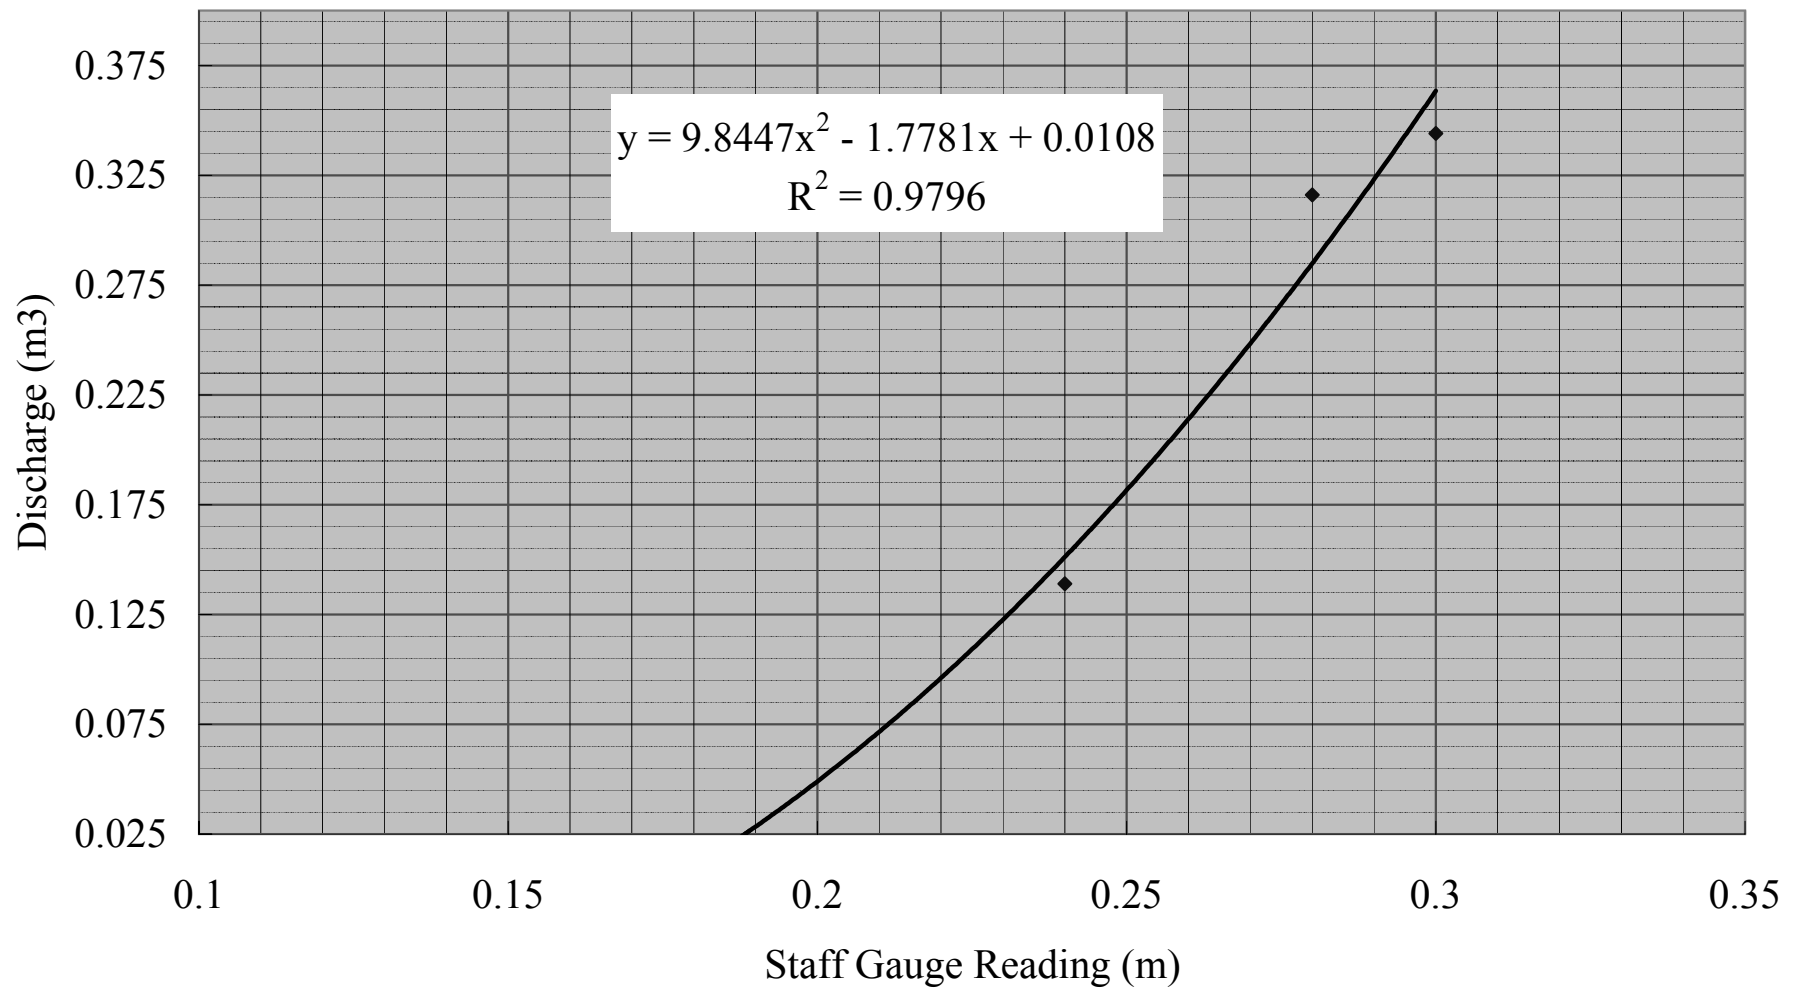
- (a) D-canal: H-Q curve was prepared and water level was measured at beginning point (BP) of D-2 canal (Form A\_Control Area).
- (b) F-canal: Among the existing measuring devices at each turnout, the ones with little damage on the weirs were selected and the measuring gauges were repainted (FC21A, FC23, FC29, FC31, FC32, FC34). In addition to them, temporal measuring weir were installed at FC38 and FC40. Water level at those turnouts was monitored using Form B\_Control Area.

Pilot Area	Control Area
D-canal	<p style="text-align: center;"><u>Preparation of H-Q curve</u></p> <ul style="list-style-type: none"> <li>- Measure the discharge with current meter in several flow conditions</li> <li>- Plot the water level and measured discharge</li> <li>- Draw the H-Q curve</li> </ul>

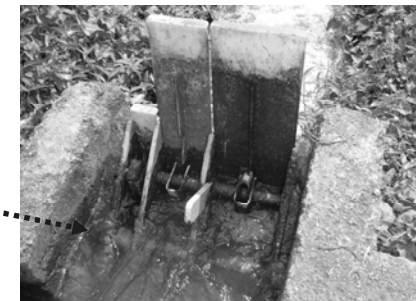
2. Water level measurement bar  
- How to check water level

- 1 Readings are to be taken once a day in the morning between 9:30 and 10:30.
- 2 Water level is judged by checking the level at the horizontal bar attached on the baffle gate (see right). If the water level is almost same as that of bar, mark "yes". If the level is lower, mark "no".
- 3 If the water is spilling over appurtenant duckbill or diagonal weir, select "yes."
- 4 In the remarks column, any occurrences such as gate closure, deviation from issue schedule, misappropriation attempts are recorded.

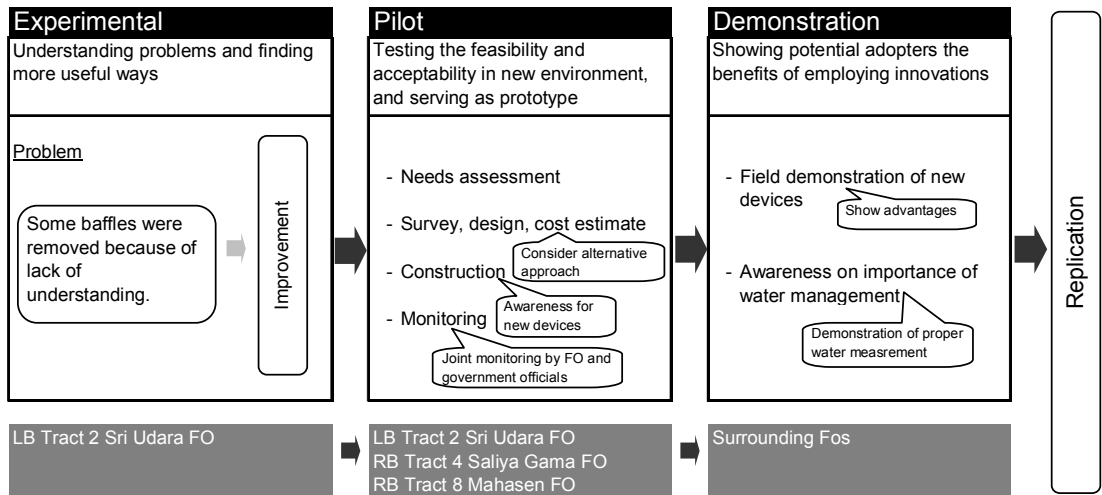
**Figure 6 Application Process of New Devices**

A pilot phase will come in the next step. One of the important points is to overcome the problems observed in the experimental site. Some approach should be taken to enhance the understanding of farmers on new devices. In addition, devices damaged due to daily operation shall be rehabilitated in that experimental site. At the same time, that approach should be adapted to some areas, for example, one block in RB tract 4 and another block in RB tract 8. After those installations, joint monitoring will be done by FOs and government officers.

When the monitoring period is over, a demonstration phase will start. Surrounding blocks will be the target area. It will not only show the advantage of new devices but also encourage the farmers the awareness of water management. Those processes in D- and F-canal level will contribute to the improvement of water management in surround area.
