**BASIC DESIGN STUDY REPORT  
ON THE PROJECT  
FOR  
THE RECONSTRUCTION OF BRIDGES  
IN EAST GUADALCANAL  
IN  
THE SOLOMON ISLANDS**

**JULY 2006**

**JAPAN INTERNATIONAL COOPERATION AGENCY**

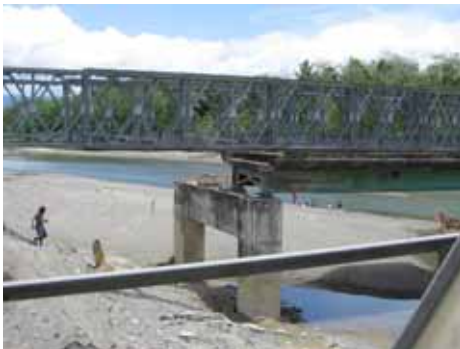
Photo 2.2 Two spans missing of the old bridge

- The old bridge is of 5-span simply supported composite girder bridge, each span length 21m, constructed by Australia in 1984. During the Cyclone Namu in 1986, water flow with enormous mud and debris shut the gap between piers and finally one pier and two spans of superstructure on the east bank were washed away (Photo 2.2, Figure 2.4). Furthermore as the westernmost pier inclined toward downstream by 50cm, the remaining superstructure bended, and impassable (Photo 2.3).

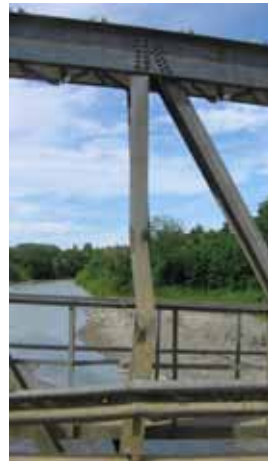
Photo 2.5 Vertical member damaged by hit

- In addition to such natural disasters, it is confirmed that principle truss members above the deck surface such as diagonal and vertical elements have been damaged as shown in Photo 2.5.

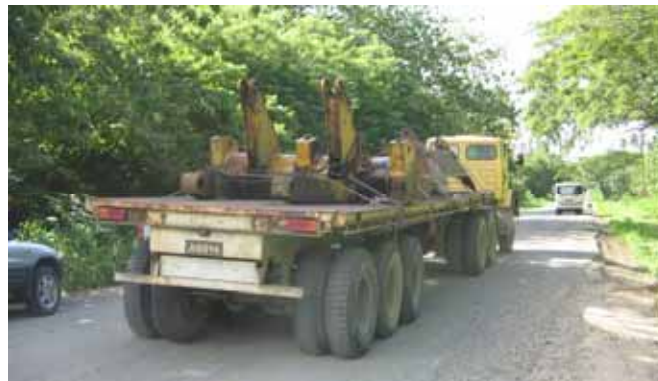
Photo 2.6 Heavy trailer truck running on the objective area

Major companies plan to use heavier trailer truck such that GPOL will utilize 49t trailer, Earth Mover 60t and Gold Ridge 66t, although heavy-duty trailers have run already as shown in the Photo 2.6.

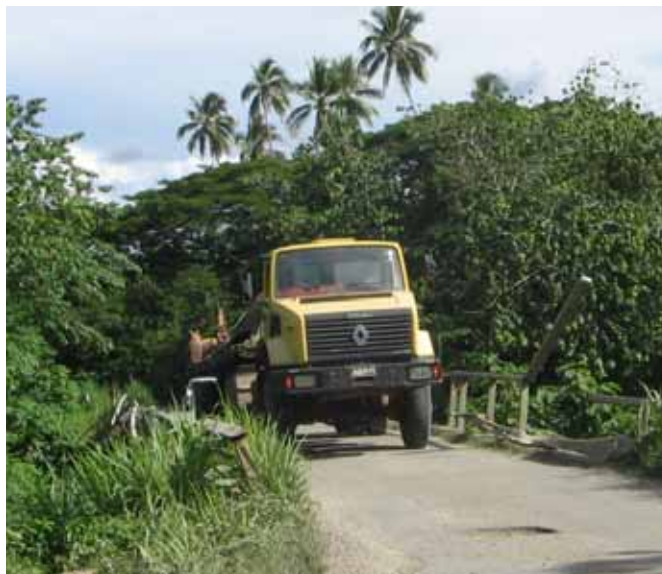
Photo 2.7 Heavy trailer passing Tenaru 2 Bridge

The present Tenaru 1 Bridge and Tenaru 2 Bridge have no sidewalk. Pedestrians are left in a dangerous situation, where habitants from a community adjacent to the site walk over the bridge, and heavy-duty vehicles pass the site increasingly (Photo 2.7).

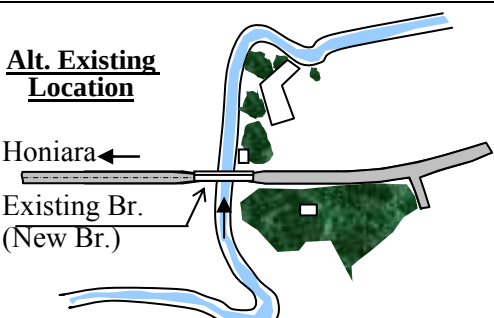
| Alternatives | Construction | Cost | Land acquisition | Road alignment & etc. | Evaluation |
|---|---|---|---|---|---|
| <p><b><u>Alt. Existing Location</u></b></p> | <ul style="list-style-type: none"> <li>• Detour bridge and access necessary during construction.</li> <li>• Existing bridge necessary to be demolished before construction.</li> <li>• Not necessary to construct access roads to the new bridge.</li> </ul> | <ul style="list-style-type: none"> <li>• Construction cost for new bridge</li> <li>• Cost for constructing and demolishing detour bridge and approach</li> <li>• Most costly of the three alternative</li> </ul> | <ul style="list-style-type: none"> <li>• Temporary use of land for detour bridge and approach (Government land)</li> </ul> | <ul style="list-style-type: none"> <li>• Alignment same as the existing road</li> </ul> | No Good |

Table 2.17 Comparison of reconstruction location for Tenaru 1 Bridge

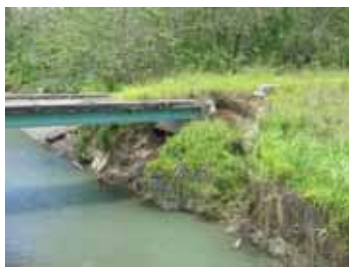
Photo 2.8 Abutment of the Old Ngalimbiu Bridge (1)

Photo 2.8 and 2.9 show the abutment of the old Ngalimbiu Bridge on the west bank, where the steel pipe piles are exposed by scouring and the bearing capacity fell to an extreme extent.

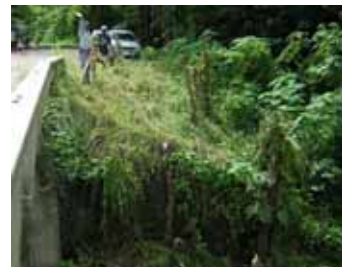
Photo 2.10 Abutment of Tenaru 1 Bridge

Photo 2.10 shows the existing abutment of Tenaru 1 Bridge protected by wire mats.

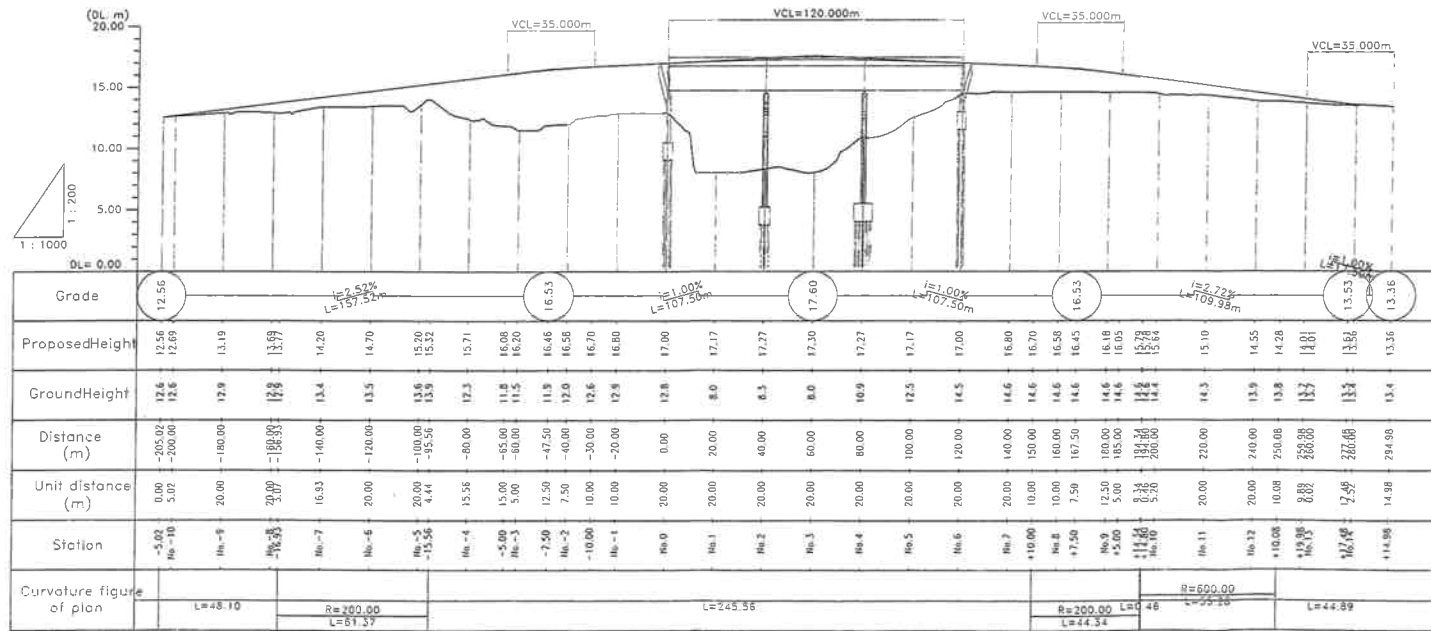
# General Structural View (Ngalimbiu Bridge)

SIDE VIEW SCALE=1/400
