5. Detailed Studies for Selected Landslides

5.1 Gosh village Landslides

5.2 Martuni village Landslides

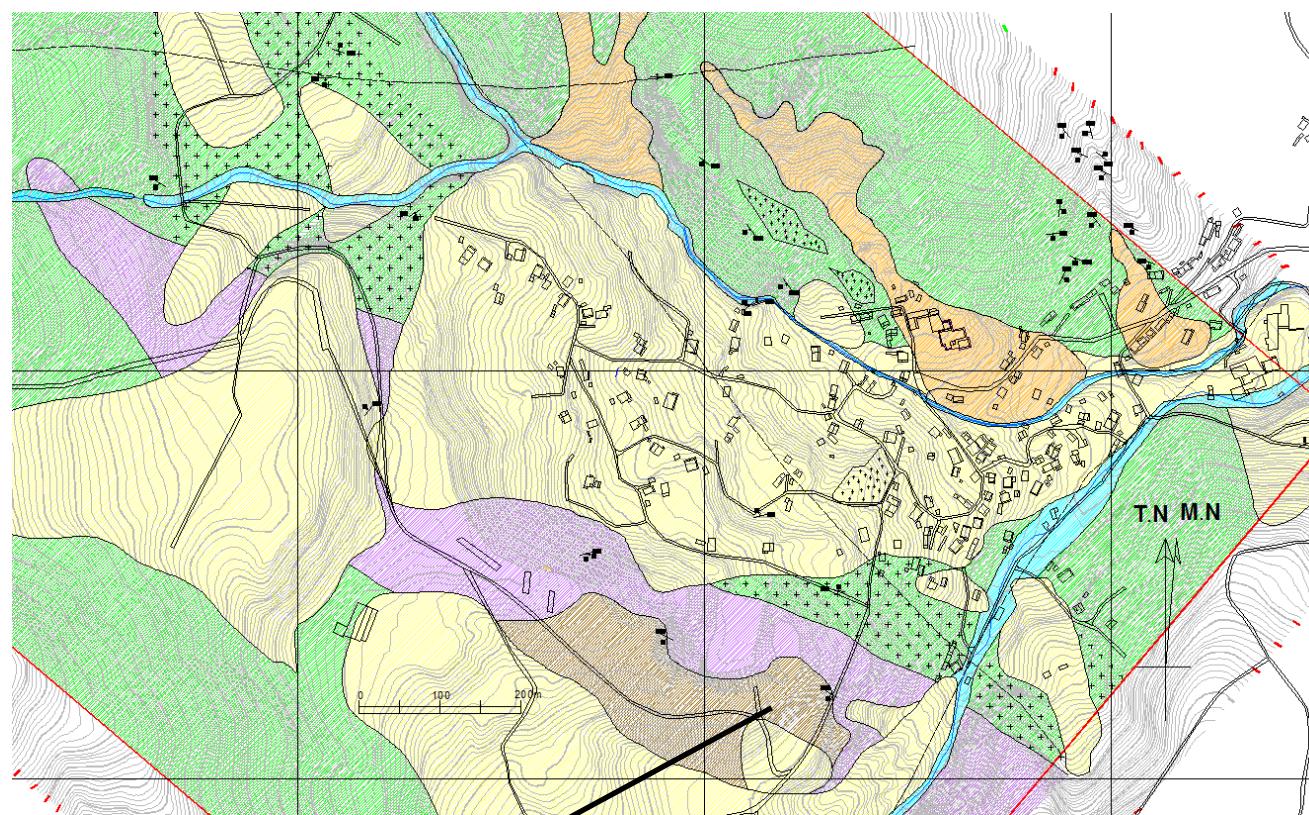
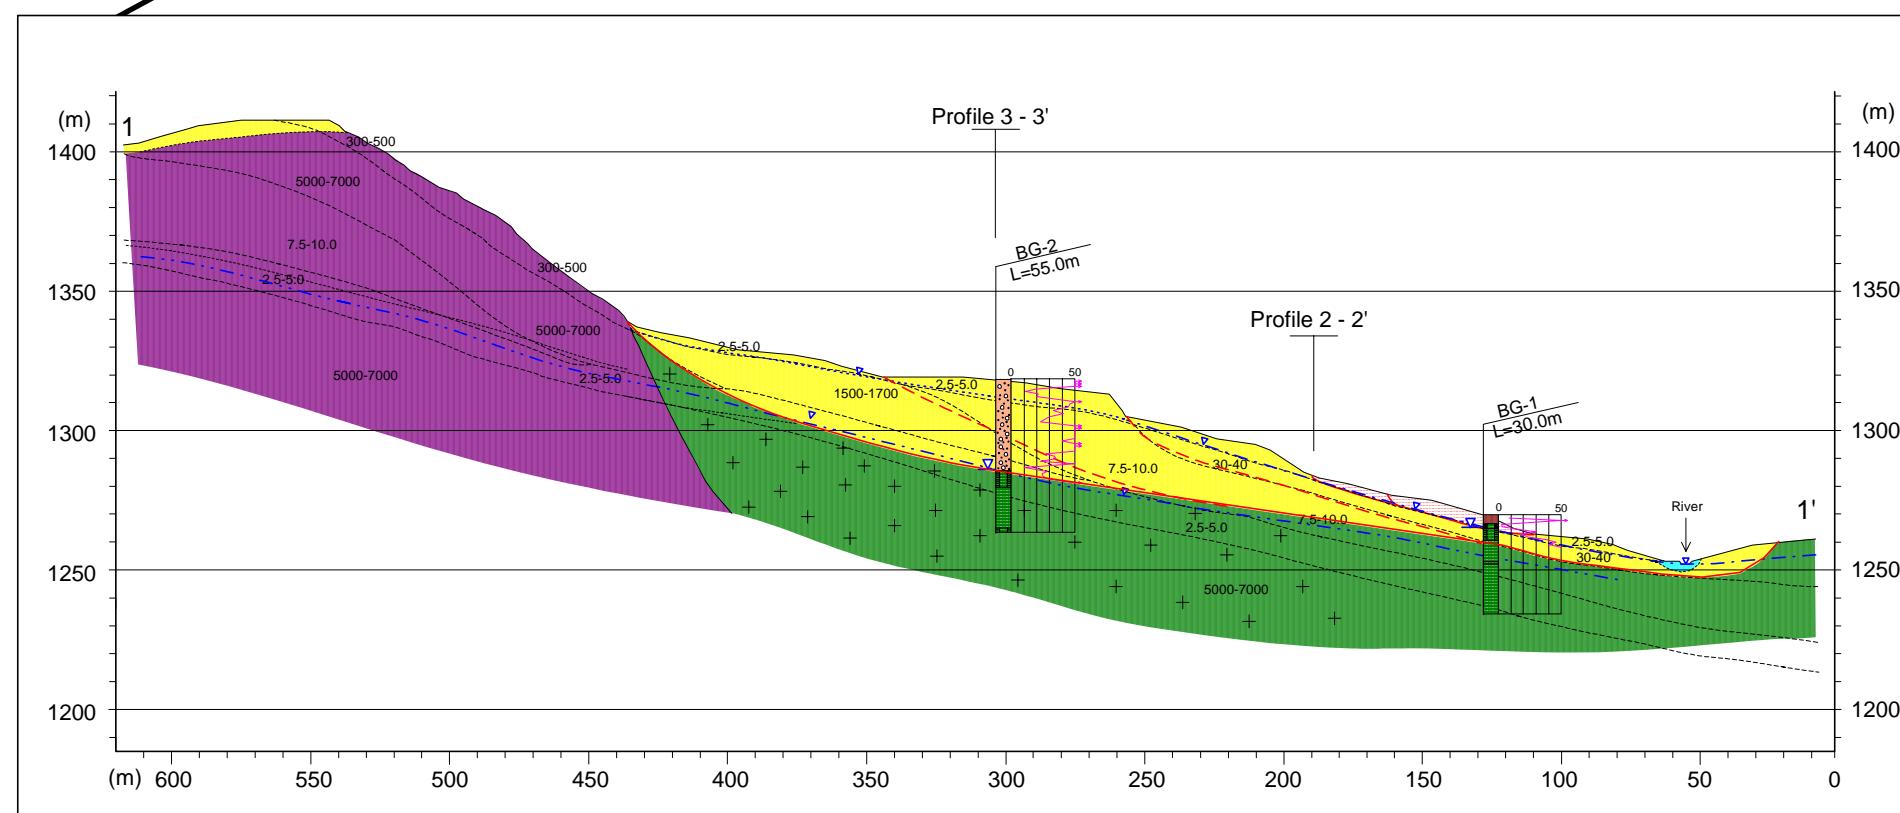
Figure 5.1.2 **ÆÝÁÇÝ»ñ³ Ì³ Ý.-ññ³ ñ³ µ³ Ý³ Ì³ Ý Ø³ ññ »½ .. äñáýÇÉ**
Figure 5.1.2 Engineering Geological Map and Profile

Generally, Paleogene volcanic rock and volcanic sedimentary rock are widely distributed. In the area, basaltic tuff breccia is distributed as basement rock and gabbro-porphyrite is found in the basement rock as intrusive rock.

Gabbro is found in the south-west of the upper village. The gabbro can be observed in old sand mine on the upper village. The gabbro is distributed in the N60W direction. The geological structure of this area shows N40W - 70W. This structure is parallel with Sevan fault that runs through north of Sevan Lake. Landslide deposit that consists of silt sand with 0.5m to 1m boulder covers the basement rock. The rock in the range of 500 m from boundary of the gabbro and the tuff breccia is received hydro thermal alteration. The rock in the zone becomes clayey rock or crystalline rock by the alteration. According to the result of the geological study and aerial photograph interpretation, it is considered that big scale landslide (1,000 m wide * 500 length) happened on the hydrothermal metamorphic zone in the past. After this, secondary landslides have happened in the big scale landslide block. Almost all the houses of the upper village are located on the big scale landslide block, and are damaged by land subsidence.

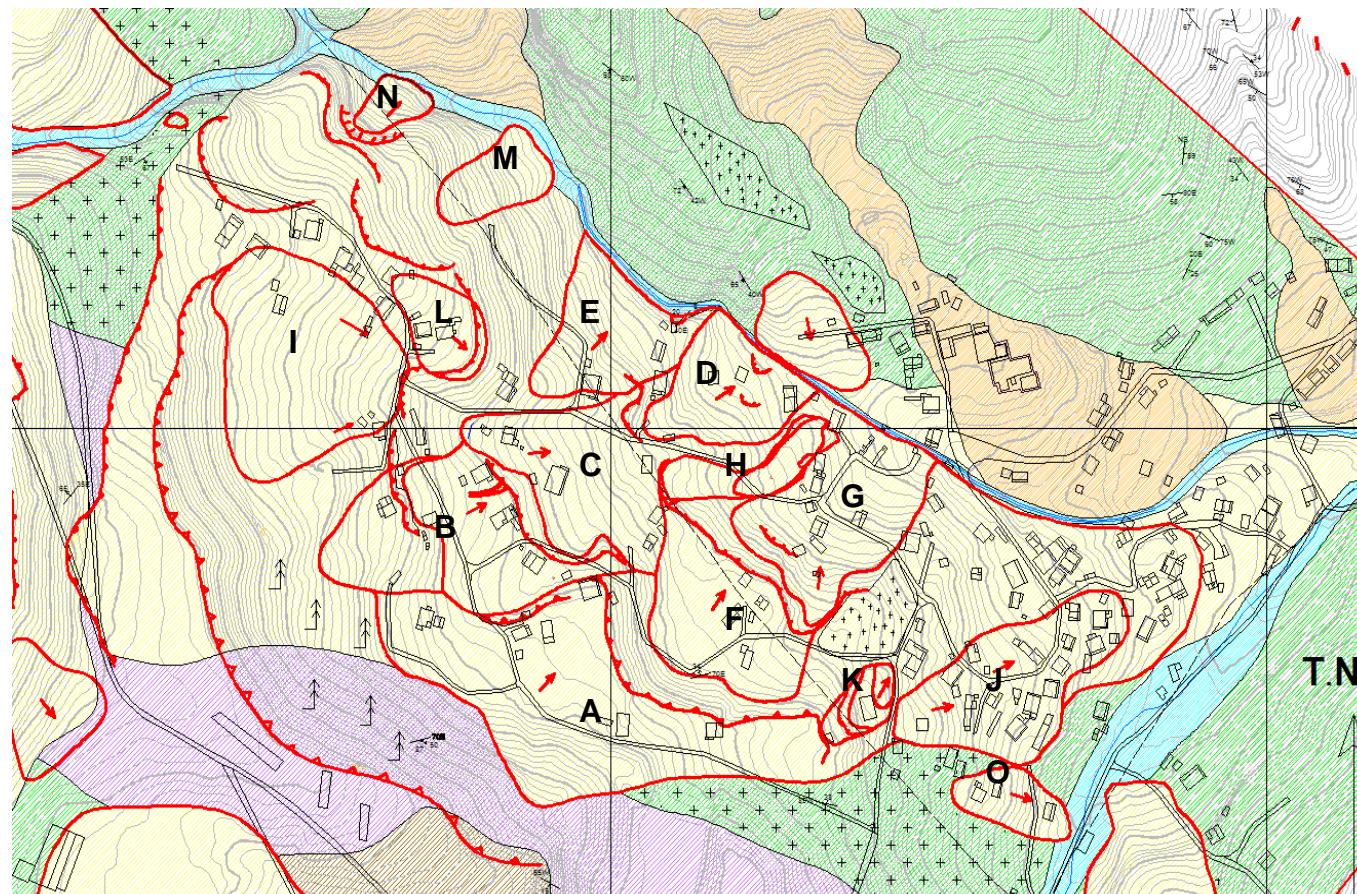
Landslide Block Map is shown in Figure 5.1.3.

Landslide monitoring as extensometer, movable board and GPS point survey is conducted to know landslide activity in the study area. Extensometer is monitoring B, C, F, H, J and K landslide block activity. These monitoring data are obtained about 12 months from December 2004. As the data, movement of the landslide blocks except H and J blocks do not shows striking movement as less than 1 mm per day. There are 5 extensometers on H landslide block. The data of the extensometers show a striking movement as 20 mm per day maximum and 5 mm per day average in March “snow melting” season.

Movable boards are installed for monitoring C, G, H and K landslide block activity. As the result, C landslide block shows 1.5 mm per day movement, and H landslide block shows 20 mm per day average at scarp part and side scarp part. G and K block shows less than 1 mm per day average movement.

GPS point survey is monitoring A, B, C, D, E, F, I, J, L and M landslide block. The points have been installed at places where it is hard to install other monitoring instruments. As the result, all data show less than 2 mm per 2 months. Therefore, striking movement has not been recorded.

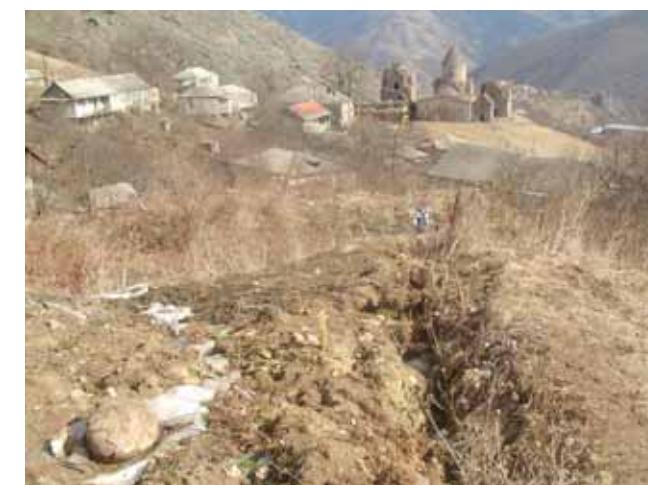
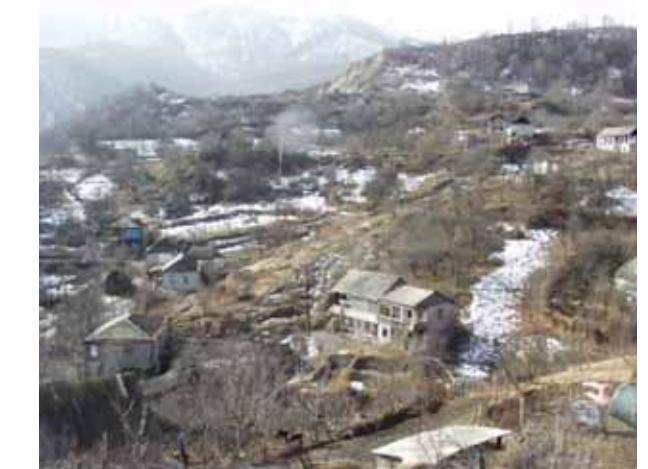
General view of the active landslide block in Gosh Village

Head/scarp of active landslide.

In winter, the resident doesn't close faucet tap for the freeze proofing of water supply pipe and power throw water the garden continuously. The seepage water softens the ground and sliding force grows by saturated depleted mass becoming heavy.

Thus, the seepage water has activated the landslide.

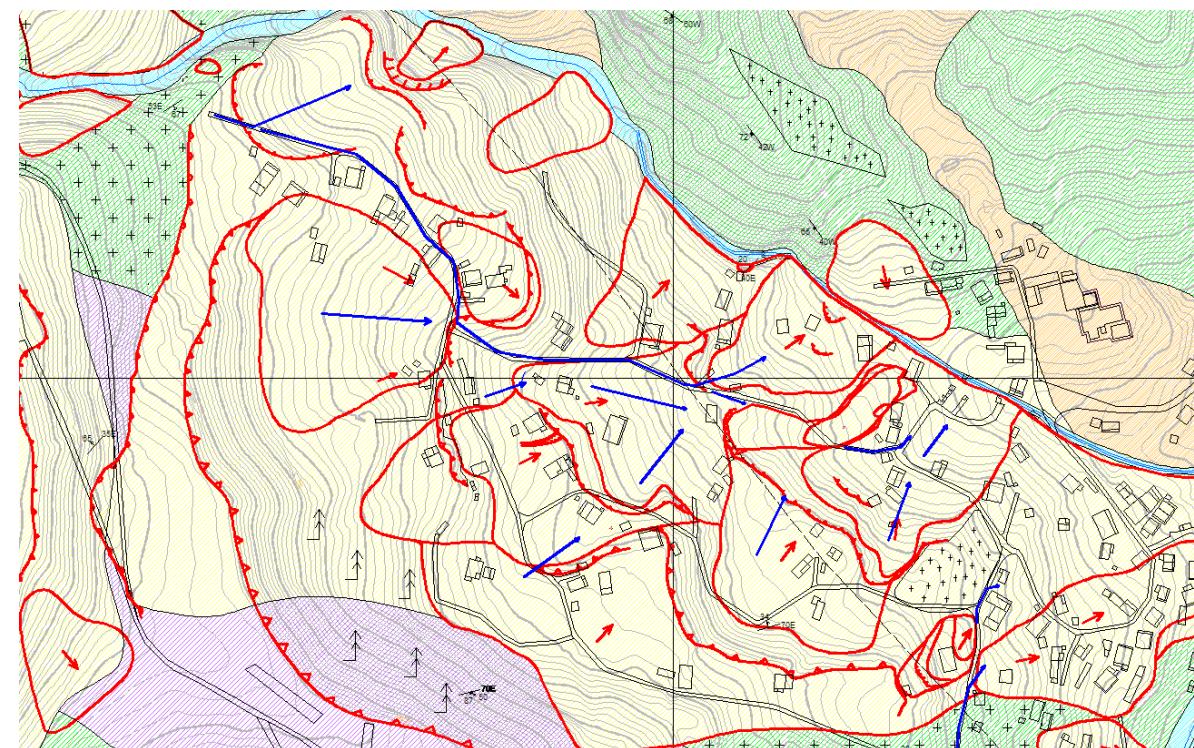
Figure 5.1.4 Water Drainage Condition

Water supply system for all houses in this area had been adopted in 1974 to 1978. In the present, almost all system, however, had not been worked soon after installation due to problem of water supply tank. The water supply pipe is still remained under ground without maintenance.

Drainage system is not maintained to all houses yet so far. Therefore, almost all sewage water from houses and surface water in rainy day flow freely on ground or road. There are some drainage pipes or soil ditch, but these are not enough for conservation of ground or road conditions. There are possibility water leakages from existing drainage pipe. In heavy rainy day or snow melting season, almost water flow down on road due to the old drainage was installed on the road. Therefore, galley is developed on the road. Ordinary water flows down on the galley of road, soil ditch or existing drainage pipe, but the water often overflows on the road or ground in momentary heavy rain time (Figure 5.1.4). The road that is important infrastructures for the village is under the influence by water due to imperfection of drainage system. And also, the water flow is considered to affect landslide activity. Especially, Sewage water from houses, irrigation water and surface water on road are found on catchment area ,behind H block that is evaluated as the highest priority landslide in this area. These water would affect to H landslide block activity.

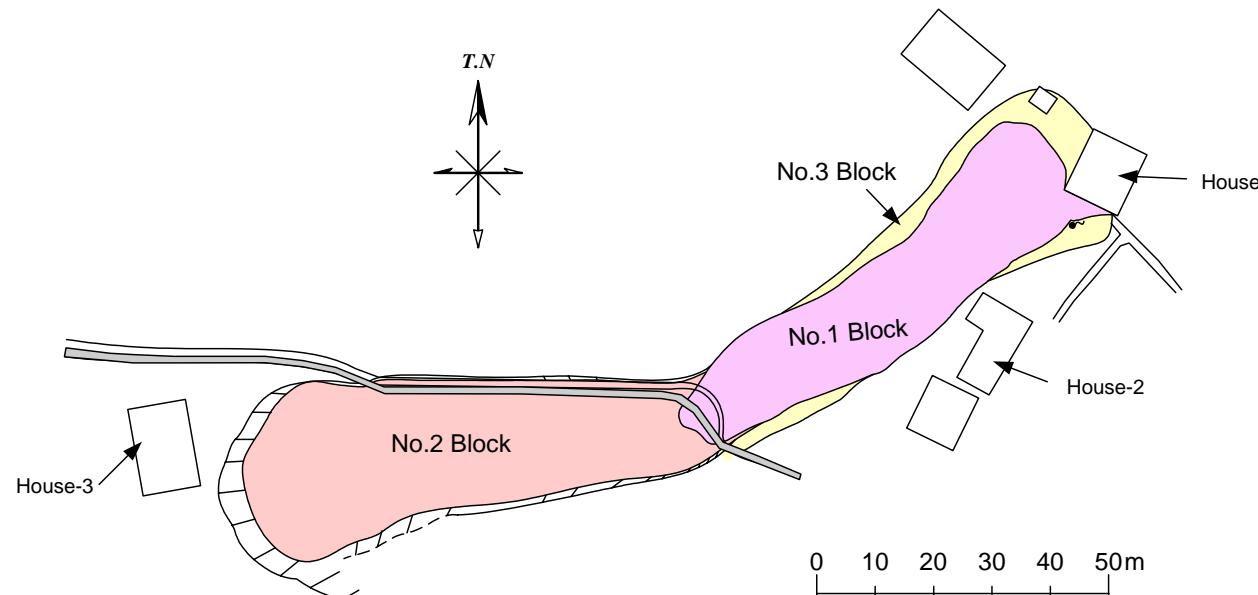
Figure 5.1.5 Active Landslide Block H Block

The H landslide block is divided 3 blocks as shown in figure5.1.

I) Lower Block (No.1 and No.3 block)

The lower block is divided 2 blocks as No.1 and No.3. According to the result of monitoring, No.1 block is more active than No.3. There are many compressive cracks on middle part of No.1 block. The landslide block is contact with House-2 wall in the present. The house-1 that is located on toe part of the block deformed and has many cracks due to pressure of landslide block. Monitoring data of extensometer on toe part of the landslide block shows compressibility movement. Especially, the data shows that the movement becomes active in early spring (snow-melting season).

II) Upper Block (No.2 block)

There are tension cracks and max 2m height scarp in the No.2 block. On the side of the block, scarps are found clearly. Slickenside whose strike shows 15 degrees to valley side is found on the scarps. Scarp on the head part of landslide also is found clearly. The scarp is extending to behind due to landslide activity. In the present, there are not major deformations on house-3. However, the house also will be damaged in near future. Monitoring data of extensometer on head part of the landslide block shows tensional movement. Especially, the data shows that the movement becomes active in early spring (snow-melting season) same as extensometer on toe part of landslide block.

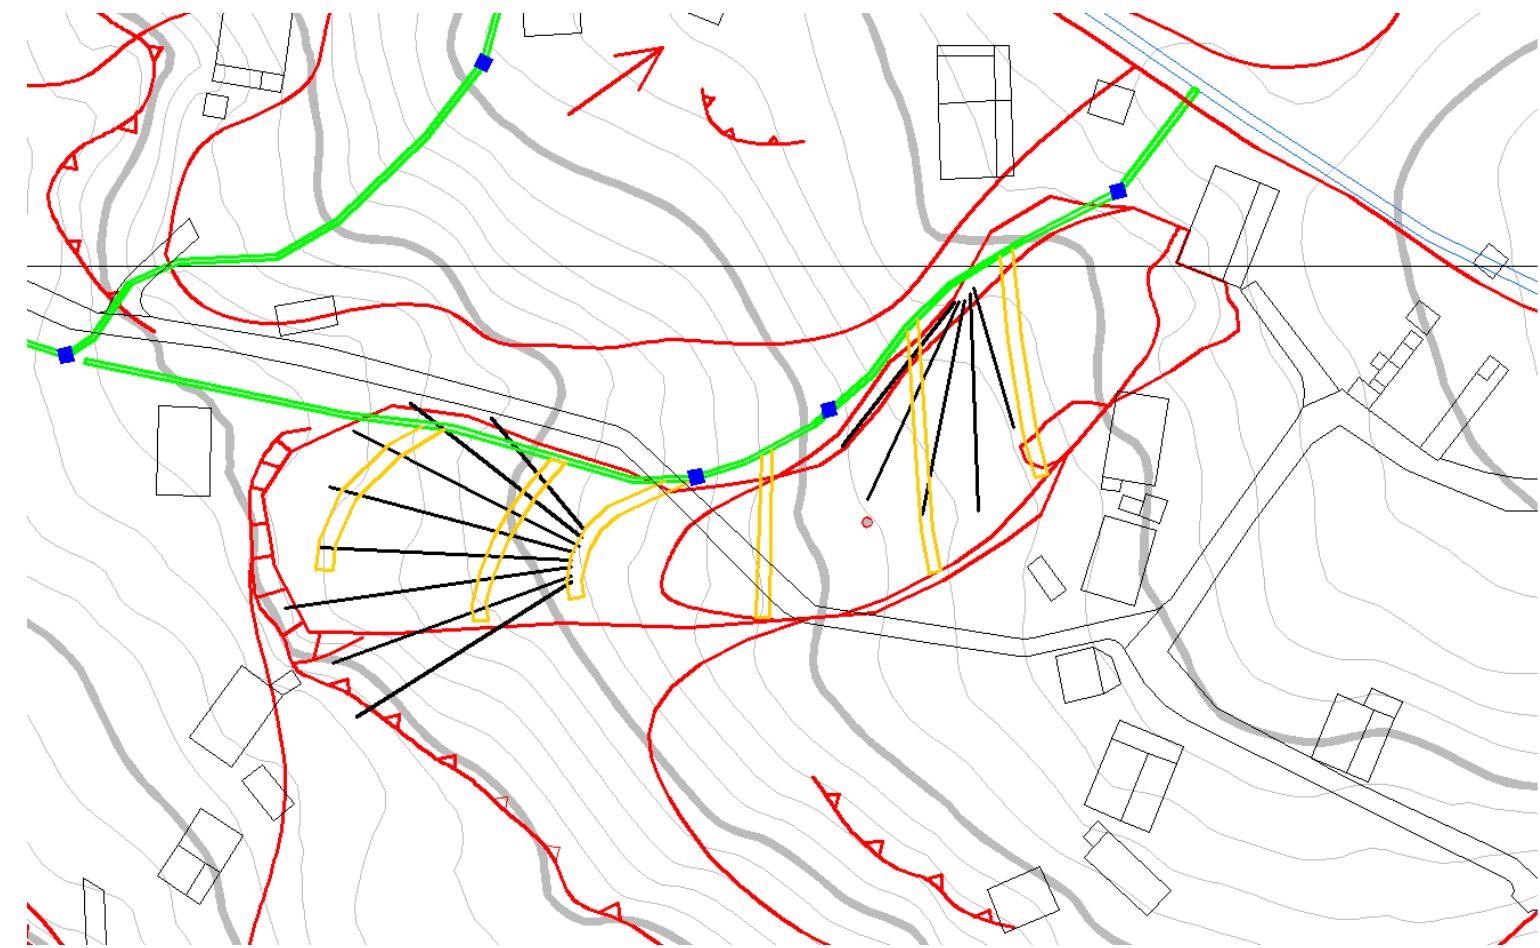
Simple Countermeasure

Therefore, surface drainage to avoid the water that infiltrates into the landslide block, and horizontal drainage to discharge the water that infiltrates into landslide blocks are planned for the countermeasure.

Open Ditch Drainage Culvert

ĐáñÇ½áÝ³ ḥ 3 Ý 1ñ»Ý³ Å³ llÇÝ Náñ³ i ³ Ýóù»ñ Horizontal Drainage Drilling Holes

- The drainage should be of a type that has flexible structure against landslide movement, such as a drainage culvert.
 - Main drainage has been installed on the north part of No.2 block that has water flows during rainy days, and where there are not many deformations compared with other parts. If the main drainage was installed at the center of the block, the drainage would be damaged immediately due to many sub-scarps of landslide at the center of the block.
 - The route of the drainage has been planned taking into consideration the water flow route after rain and the situation of water springs on the block.
 - Catchment pits have been installed of at least each 30 m in diameter.

- The horizontal drainage drilling holes have been installed to avoid groundwater level increase. The drainage has been installed at No.1 and No.2 block that show active movement.
 - The planned length of horizontal drainage drilling holes should be more than 5m after pass through slip surface of landslide.
 - Installation point of horizontal drainage is near the existing water spring point. The point of the drainage for No.1 block is planned north side of the block. The point of the drainage for No.2 is planned near the water spring on the block. Interval of the each horizontal drainage pipe is within 5 to 10m.

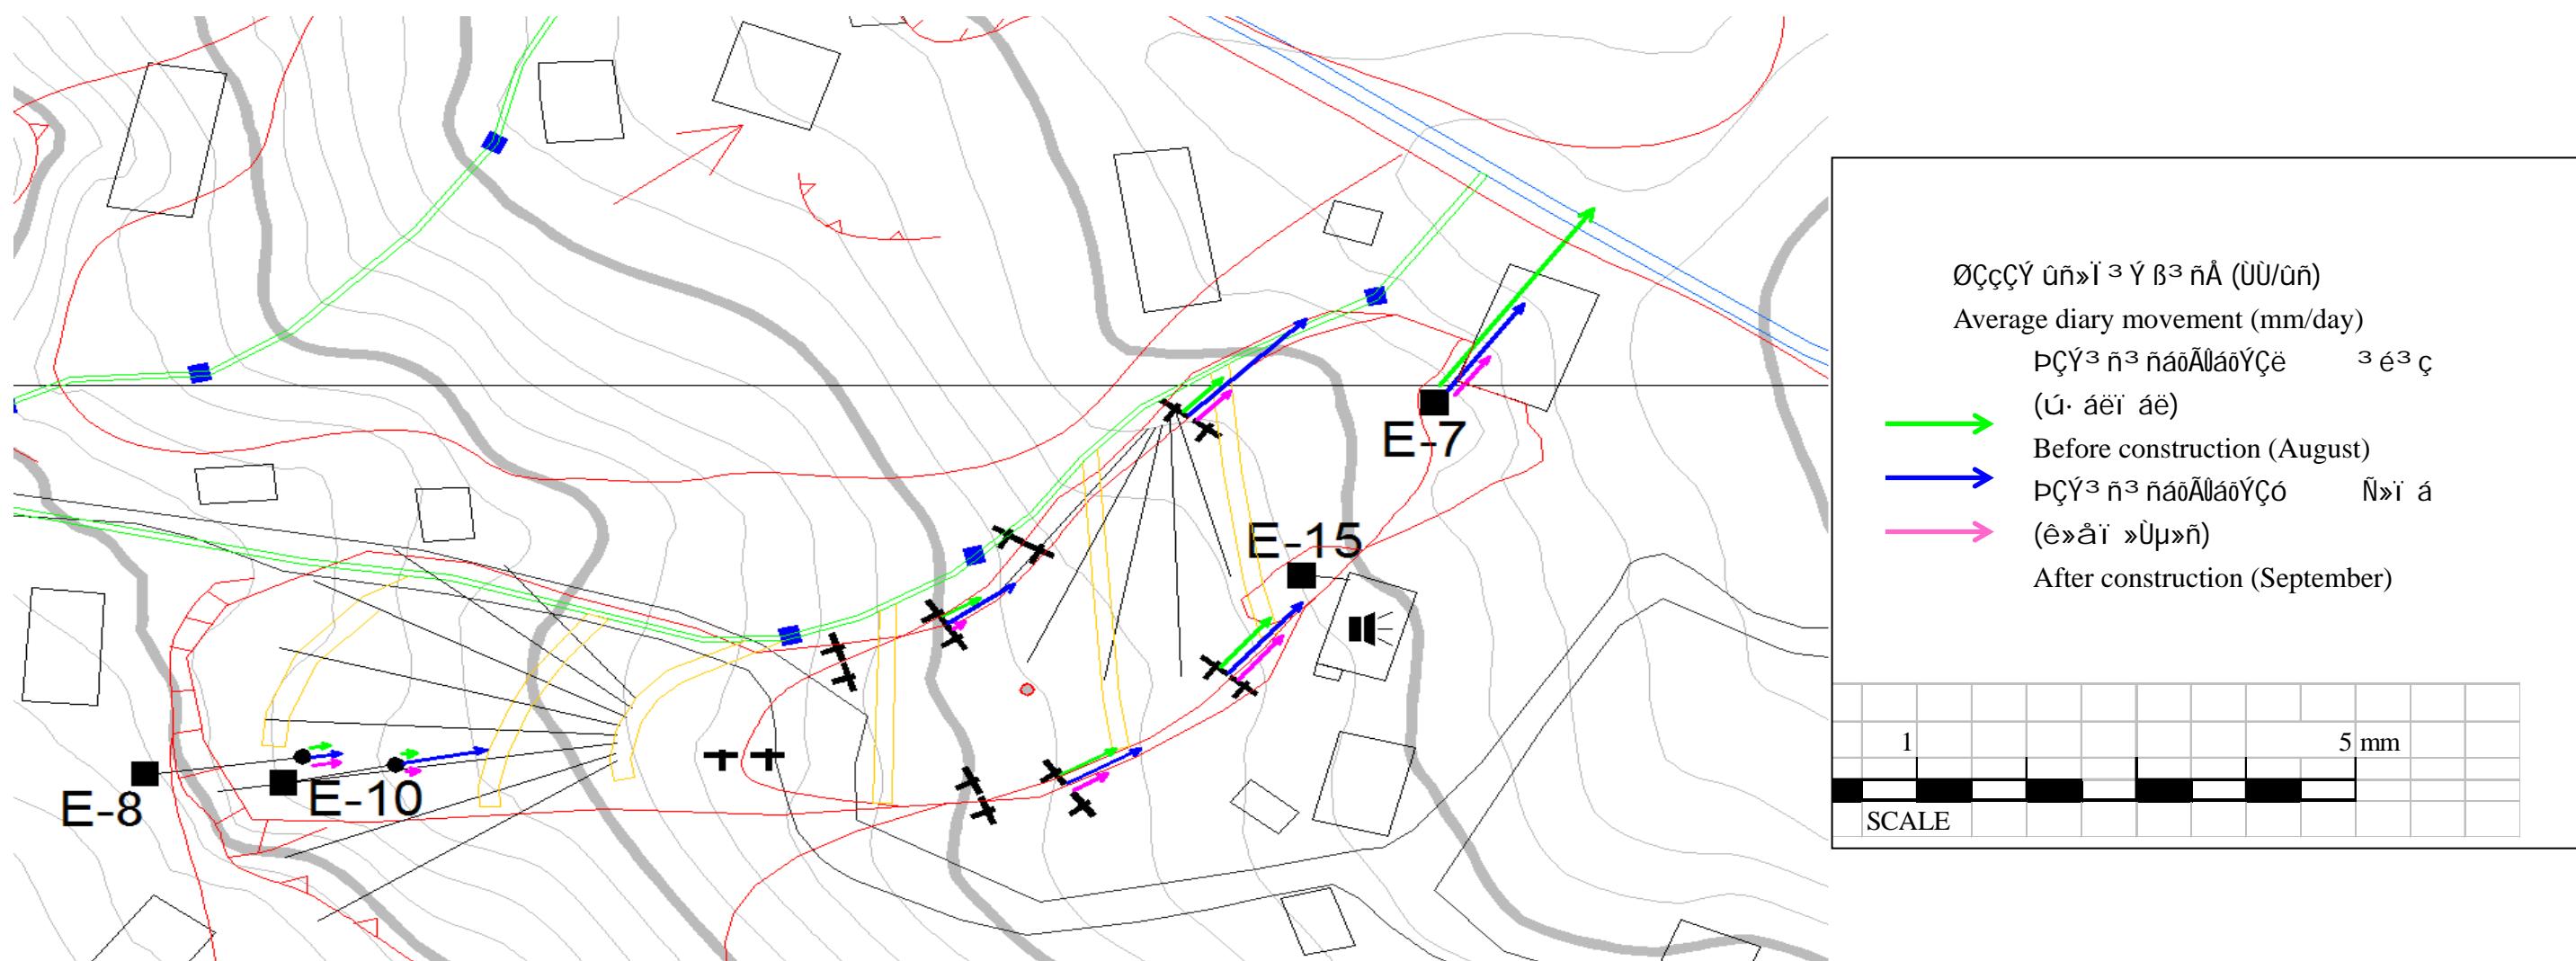
The simple countermeasure is started in September 2005. According to the result of monitoring (Figure 5.1.8), Landslide movement value is decrease even though monthly rainfall data from September are more than 80mm/month. And also, after 1 month from start countermeasure work, the monitoring data shows that the movement value is decrease by slow decrease.

The reason is considered that surface water flow in rainy day is avoided to infiltrate to landslide block.

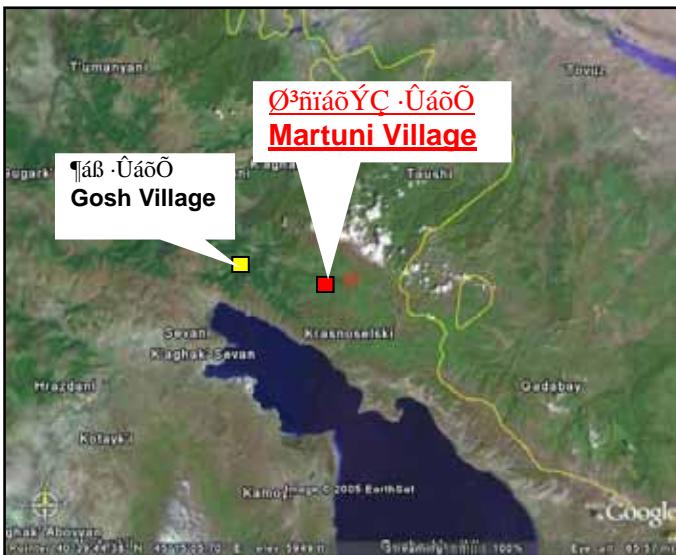
କ୍ଷେତ୍ର ମାପ 5.2.1 ଯେଉଁଳିଏ କ୍ଷେତ୍ର ମାପ

Martuni village is surrounded by Gor, Miavor, and Areguni Mountains which have many landslides. Getik River flows westwards and most of the residences are near the river.

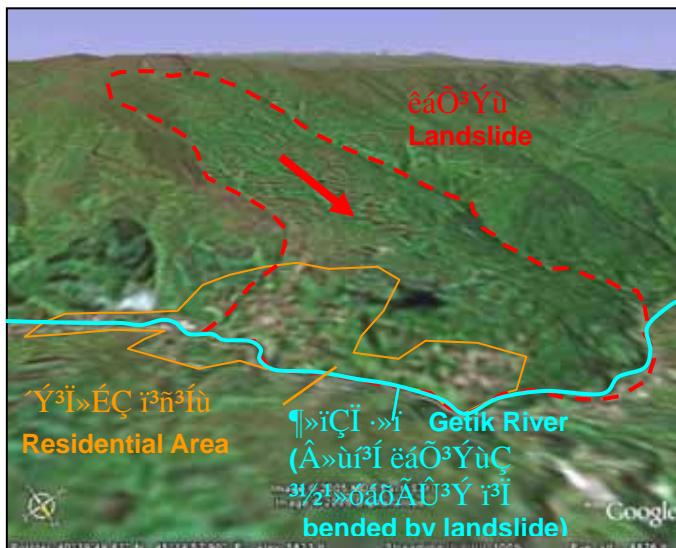
Figure 5.2.2 Schematic View of Martuni village Landslide (view from NE)

Most of the residential areas are located on the toe of huge landslide, whose length is about 8 km and width is about 1.5 km, moving northwards (Figure 5.2.2). This landslide bends the river to the north

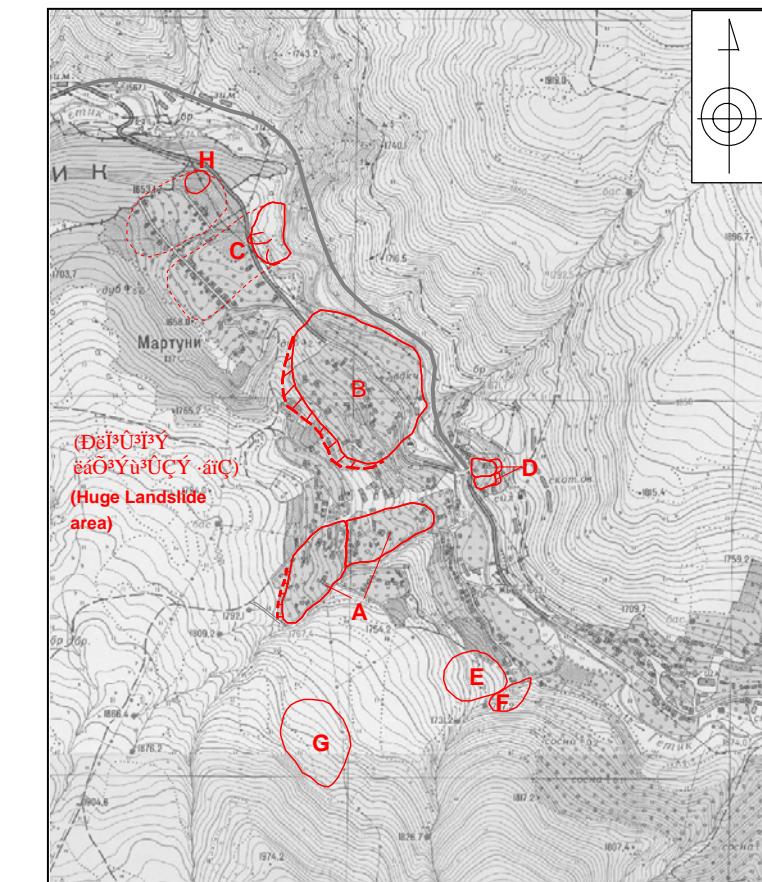
Figure 5.2.3 Landslide Distribution Map

There are ten (10) active landslides included in this field investigation, and they are classified into eight landslide areas due to the similar characteristics (Figure 5.2.3).

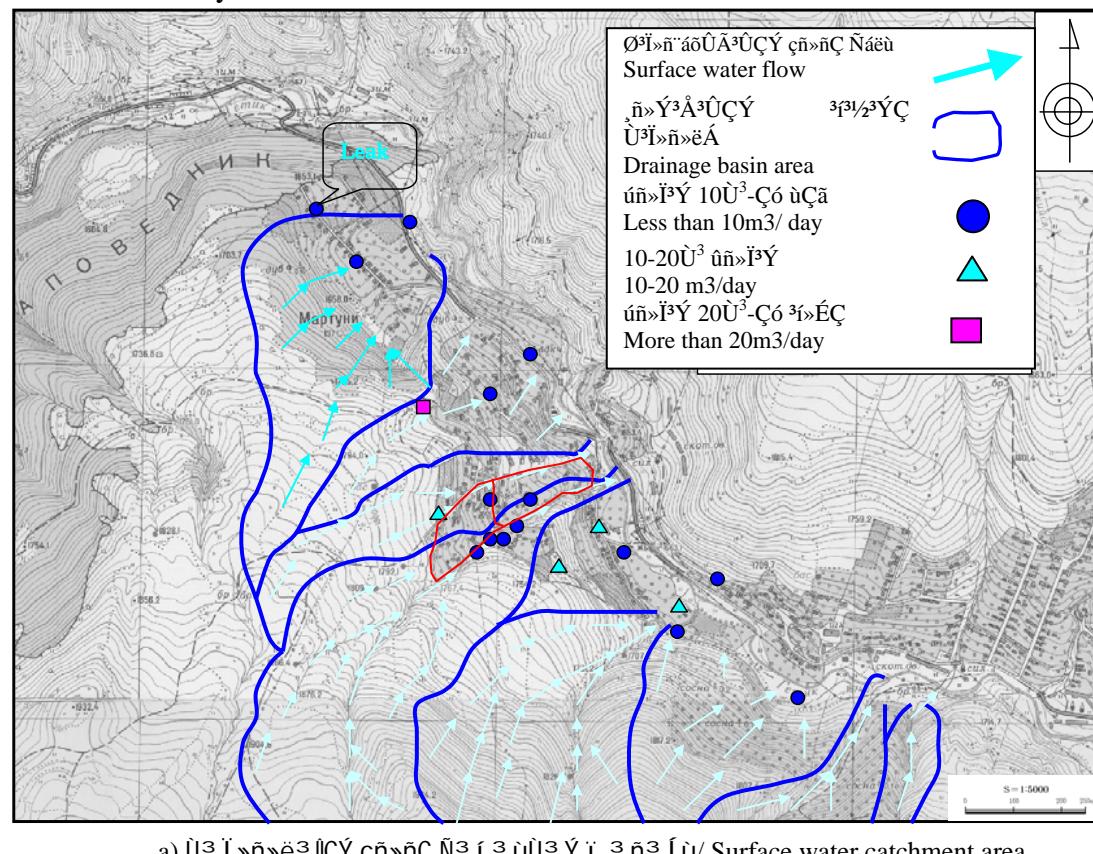
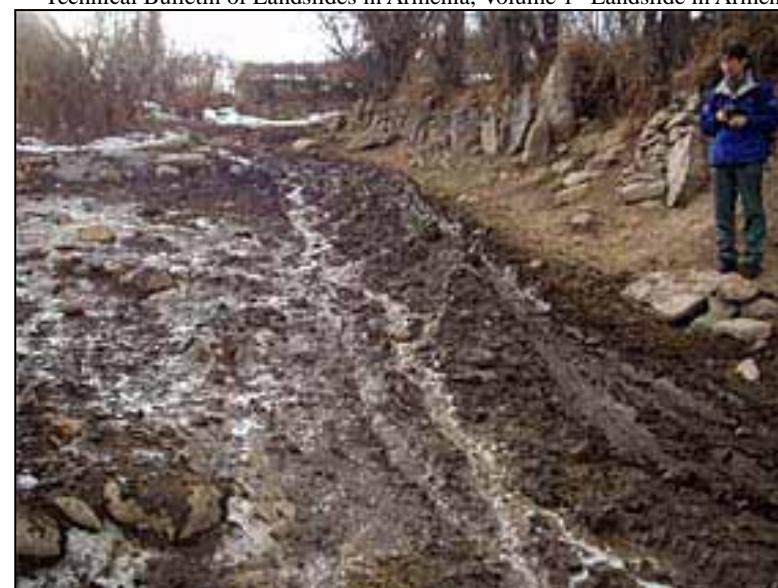
Figure 5.2.4 Drainage of surface water

There are some soil ditches inside the residential area, but these are not sufficient to drain the surface water to the river. Furthermore, during heavy rainy days and the snow melting season, much water comes from upper areas of the village through the village roads (Figure 5.2.4). Thus, a gully is developed on the road, especially the road besides a landslide block. Water flowing on the road is also considered to affect landslide activity.

a) Ü3 İ »ñ»ë3 İçÝ çñ»ñÇ N3 í 3 üÜ3 Ý i 3 ñ3 í ù/ Surface water catchment area

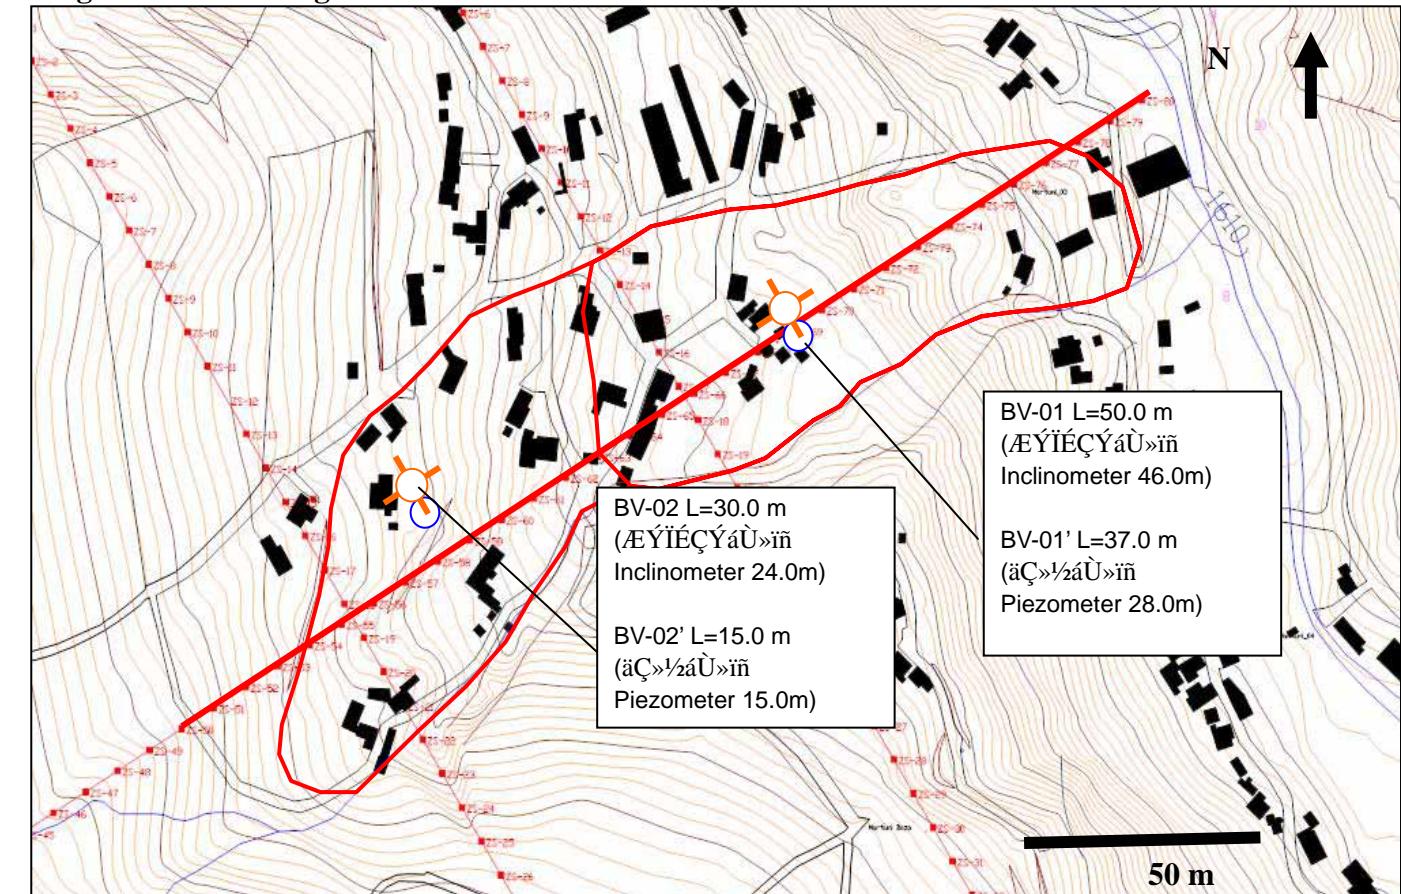
Figure 5.2.5 Location of Section and Drilling sites in A Landslide Block

Landslide investigation was carried out in A landslide block and geology of drilling sites are as follows;

æç»%áÙ»i ñ Piezometer	2	i³ åáóÙi Bñç³ YÁ ä³ i Í»ñ 5.2.5-áóÙ blue circle in Figure 5.2.5	é»åi »Ùµ»ñ 2005Å. - ÜÇÝä Í »ñç»ñë September 2005 - Recent	éi áñ· »i ÝÙ³ Ù³ i ³ ñ¹³ TÁ T³ ÙáÙi, GL-3.9Ù BV01áÙ (Y»ñù'áóÙ), GL-4.4Ù BV02-áóÙ' (í »ñ'áóÙ) Groundwater level is almost stable, GL-3.9m in BV01'(lower), GL-4.4m in BV02'(upper)

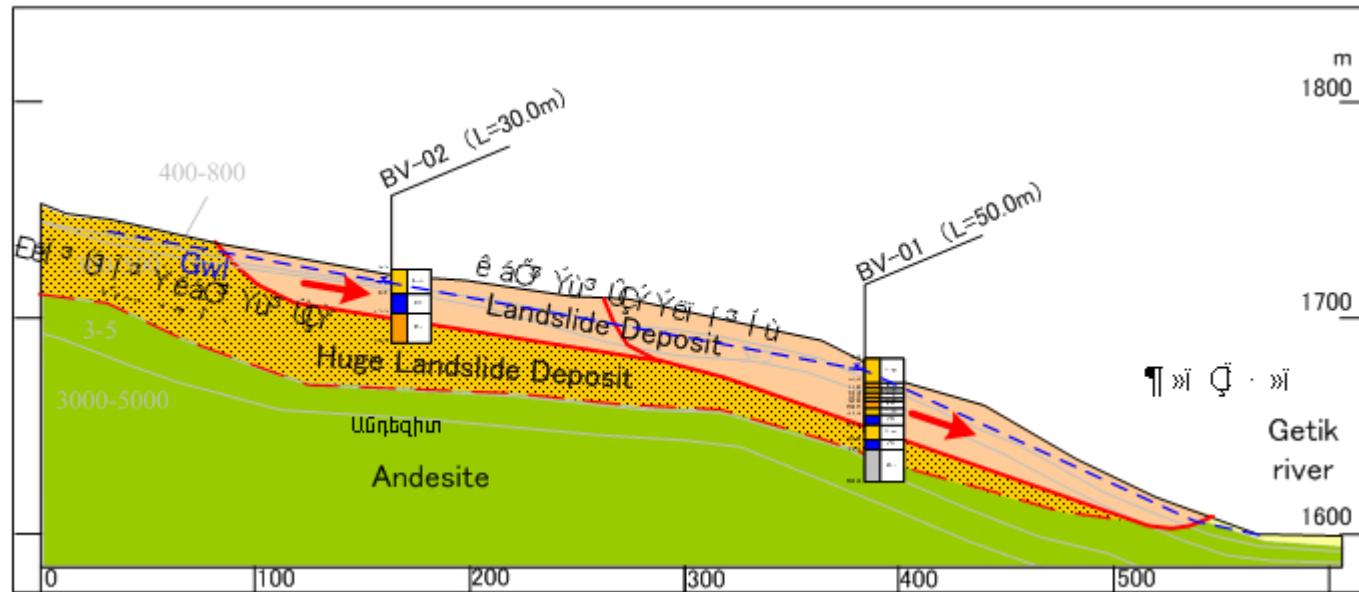
Figure 5.2.6 Geological Cross Section in A Landslide Block

Poorly sorted soil, sand, gravel and boulder deposit can be seen in the landslide body. Boulder and gravel consist of andesite, but not similar to the former one, its color gray to light gray, silicified and rich in plagioclase, indicating that this deposit is not original but emplaced from some other places.
