## 2.2 Geology

THE STUDY ON THE RURAL WATER SUPPLY  
IN MWANZA AND MARA REGIONS

## **3.2 Water Quality Survey (Two stages)**

### **3.3 Existing Water Supply System**

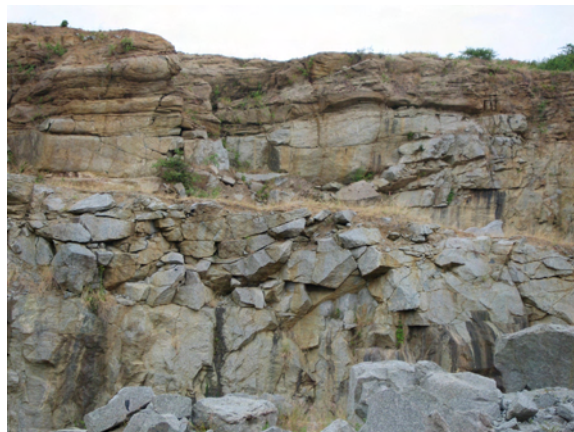
Figure 2.2-3: Granite Outcrop

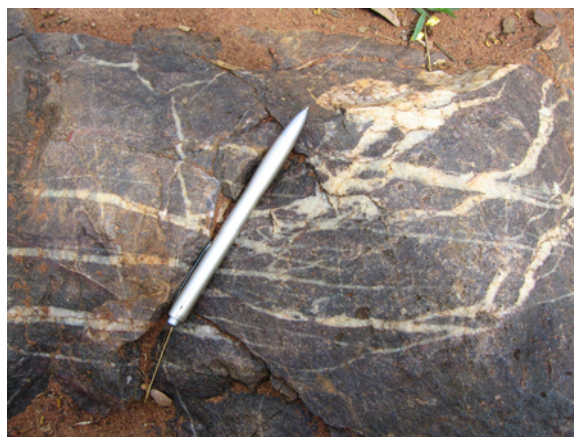
Figure 2.2-4: Gneiss with Quartz Vein

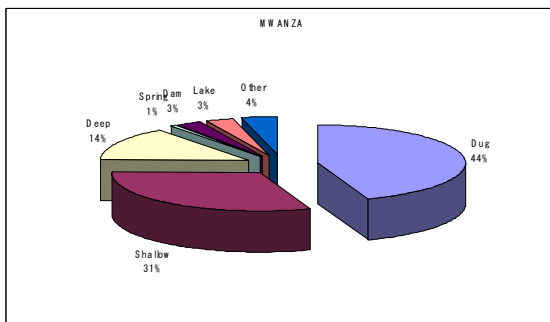
Figure 3.1-2: Water Source in Mwanza

The main water sources in the selected villages are dug wells and shallow wells, accounting for more than 70% of all water sources. In the Mara region, dug wells account for 48%, while only 44% in Mwanza. Mwanza uses shallow wells more than in Mara, with its proportion at 31%. The most significant difference between both regions is the proportion of deep wells, which is 14% in Mwanza and only 7% in Mara. In contrast to deep wells, lake water accounts for a much higher proportion in Mara (9%), and than in Mwanza (3%), despite the fact that the amount of coastline of the lake is much larger in Mwanza. The villages that use springs and dams as water sources are few, with these sources accounting for less than 6%. Others are mainly water from rivers, streams, and ponds and some of them are tapped water supplied by a piped scheme.

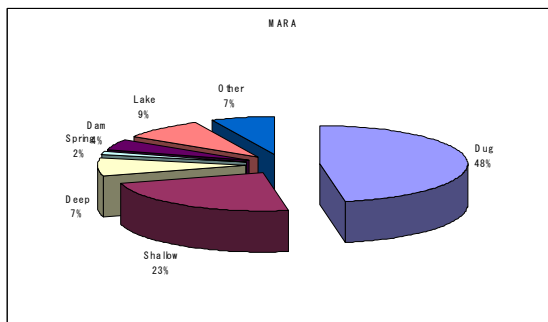
Figure 3.1-3: Water Source in Mara

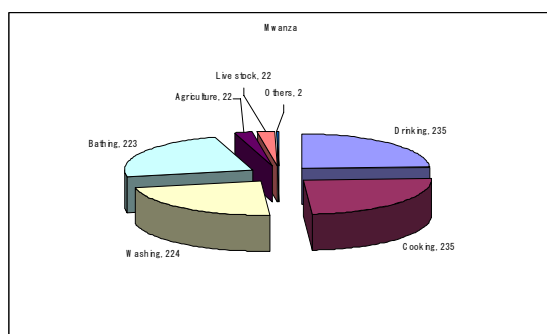
Figure 3.1-4: Water Use in Mwanza

Most of the villages use their water sources for domestic purposes, such as drinking, cooking, washing and bathing. The water sources used for agriculture and livestock vary, but according to the study a portion of the main domestic water is used for farming purposes as well. The number of wells used for various purposes is indicated in Figure 3.1-4 and Figure 3.1-5.

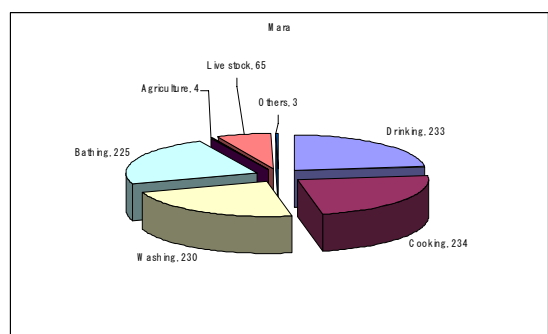
Figure 3.1-5: Water Use in Mara

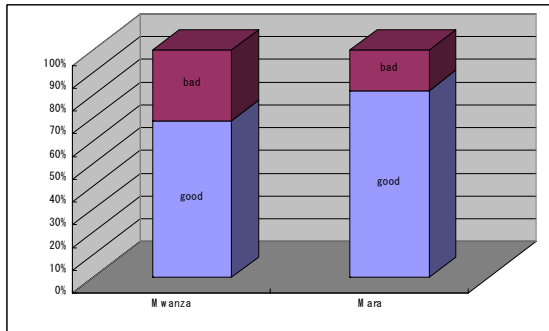
Figure 3.1-6: Water Taste

A significant number of the 201 villages gave answers for the water quality in the study area, and 165 gave answers regarding the condition of the seasonal water availability. Figure 3.1-6 indicates the percentage of villagers who feel the water tastes good or bad. The figure shows that almost 70 % of the villages feel the taste is good, but the percentage of villagers who feel the taste is bad is higher in Mwanza than in Mara. Figure 3.1-7 presents the seasonal availability of the water. A higher proportion of Mara villages get water throughout the year compared with Mwanza.

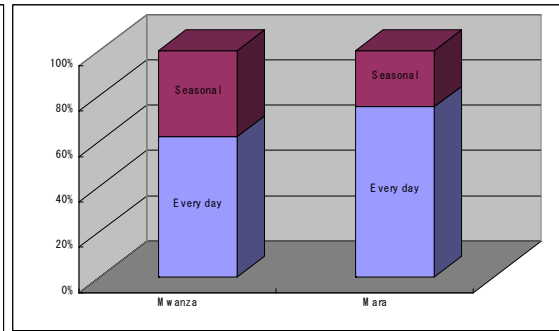
Figure 3.1-7: Water Availability through a Year

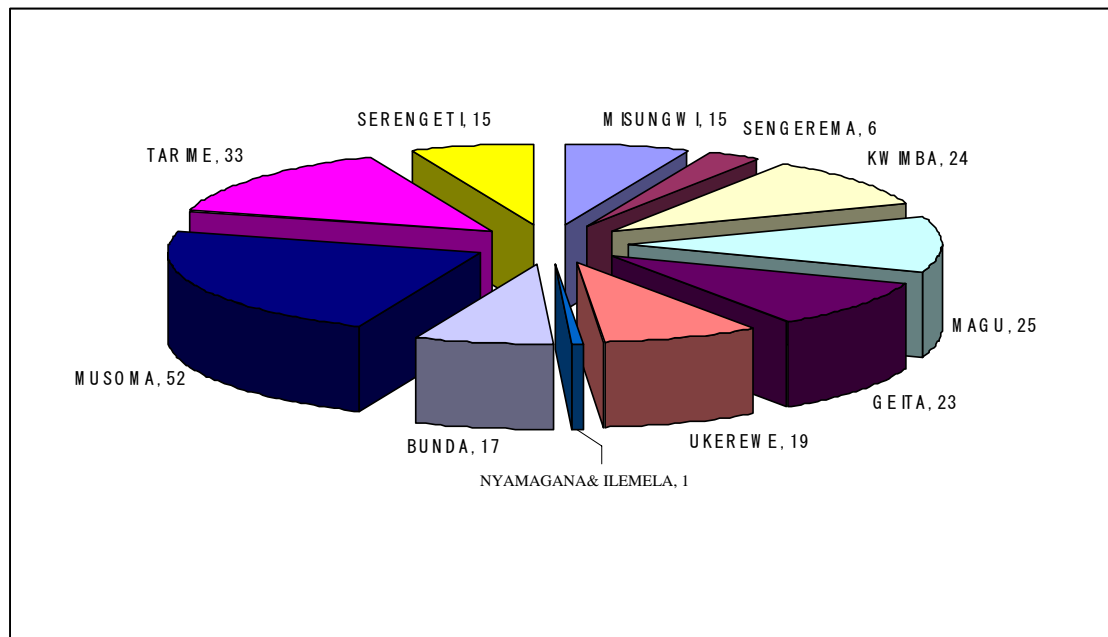
Figure 3.1-9: Surveyed Well Numbers by District

The surveyed wells do not cover all the wells in the district, but they represent the tendency of the existing wells. The total number of surveyed wells in the Mwanza and Mara regions is almost the same, being 112 for Mwanza and 117 for Mara. The maximum number is given in Musoma at 52, and the minimum of 1 in Nyamagana and Ilemela District.

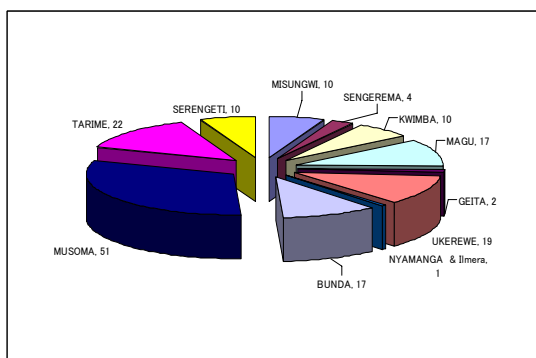
Figure 3.1-10: Surveyed Shallow Wells

The figures show the trend of the source in the district. In general, the mountainside has a greater number of deeper wells and shallower wells are at the lakeside.

In fact, coastal districts of the lake such as Sengerema, Bunda and Ukerewe have few or no deep wells surveyed, while the mountainous areas of Geita, Kwimba and Tarime have a larger number of deep wells.

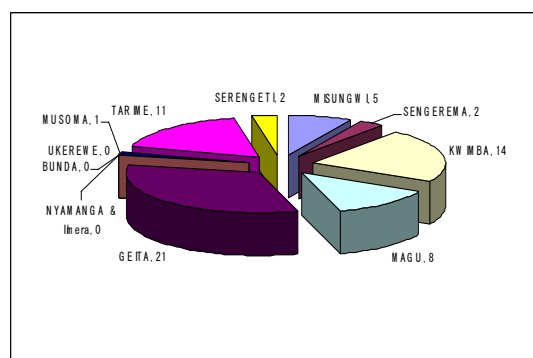
Figure 3.1-11: Surveyed Deep Wells

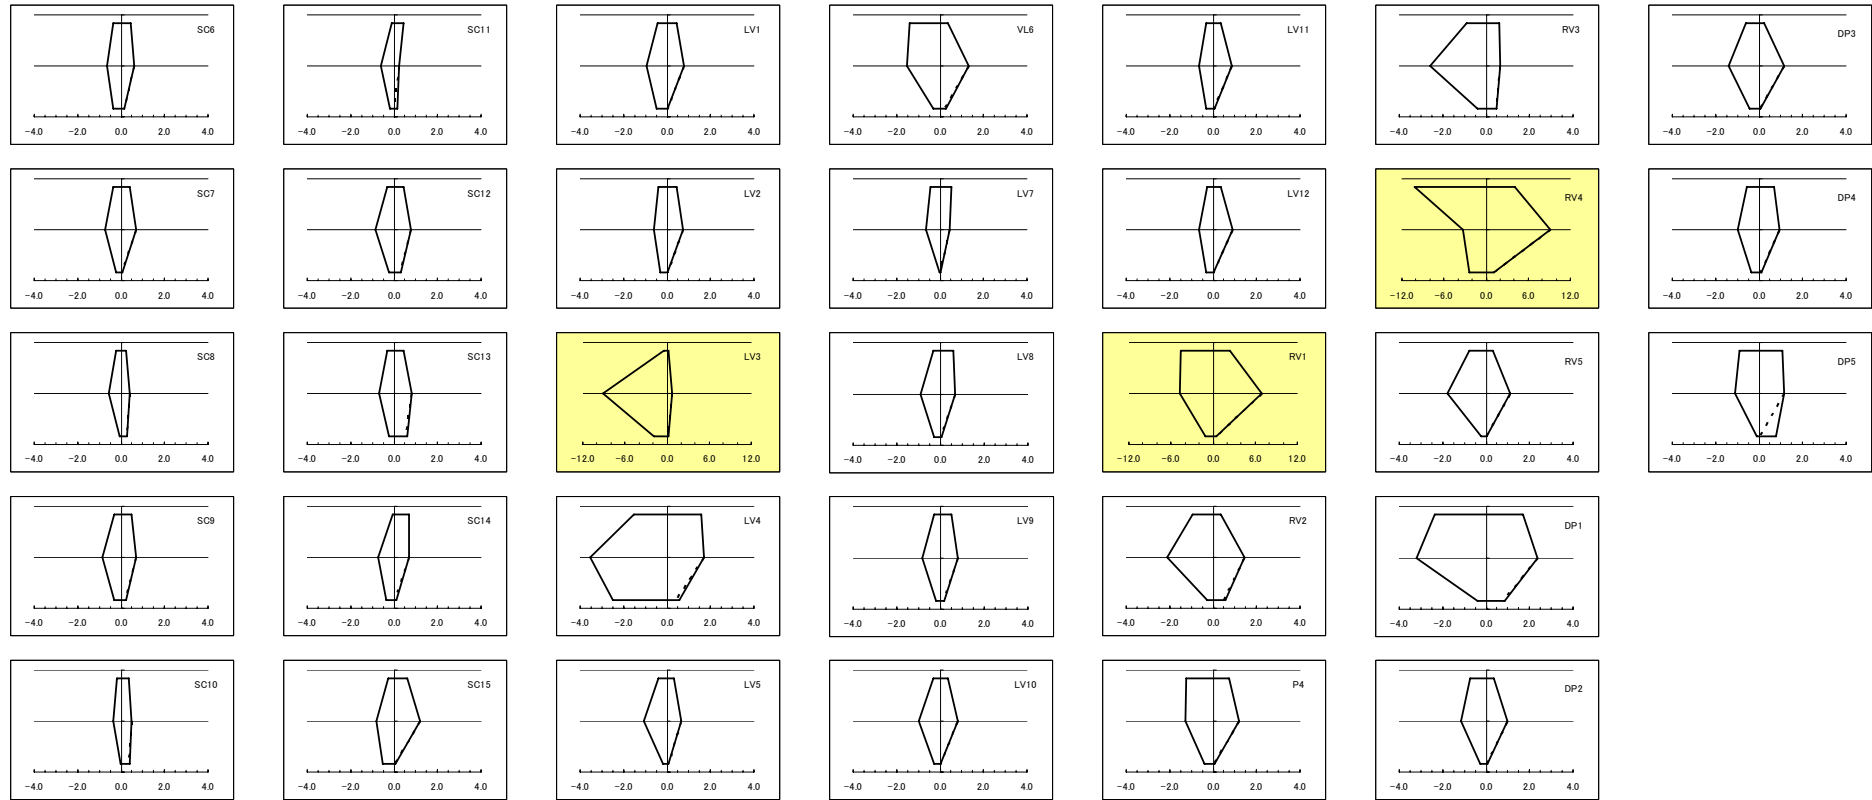
Figure 3.2-4: Hexa Diagram (Dry Season) (1/2)

Figure 3.2-4: Hexa Diagram (Dry Season) (2/2)

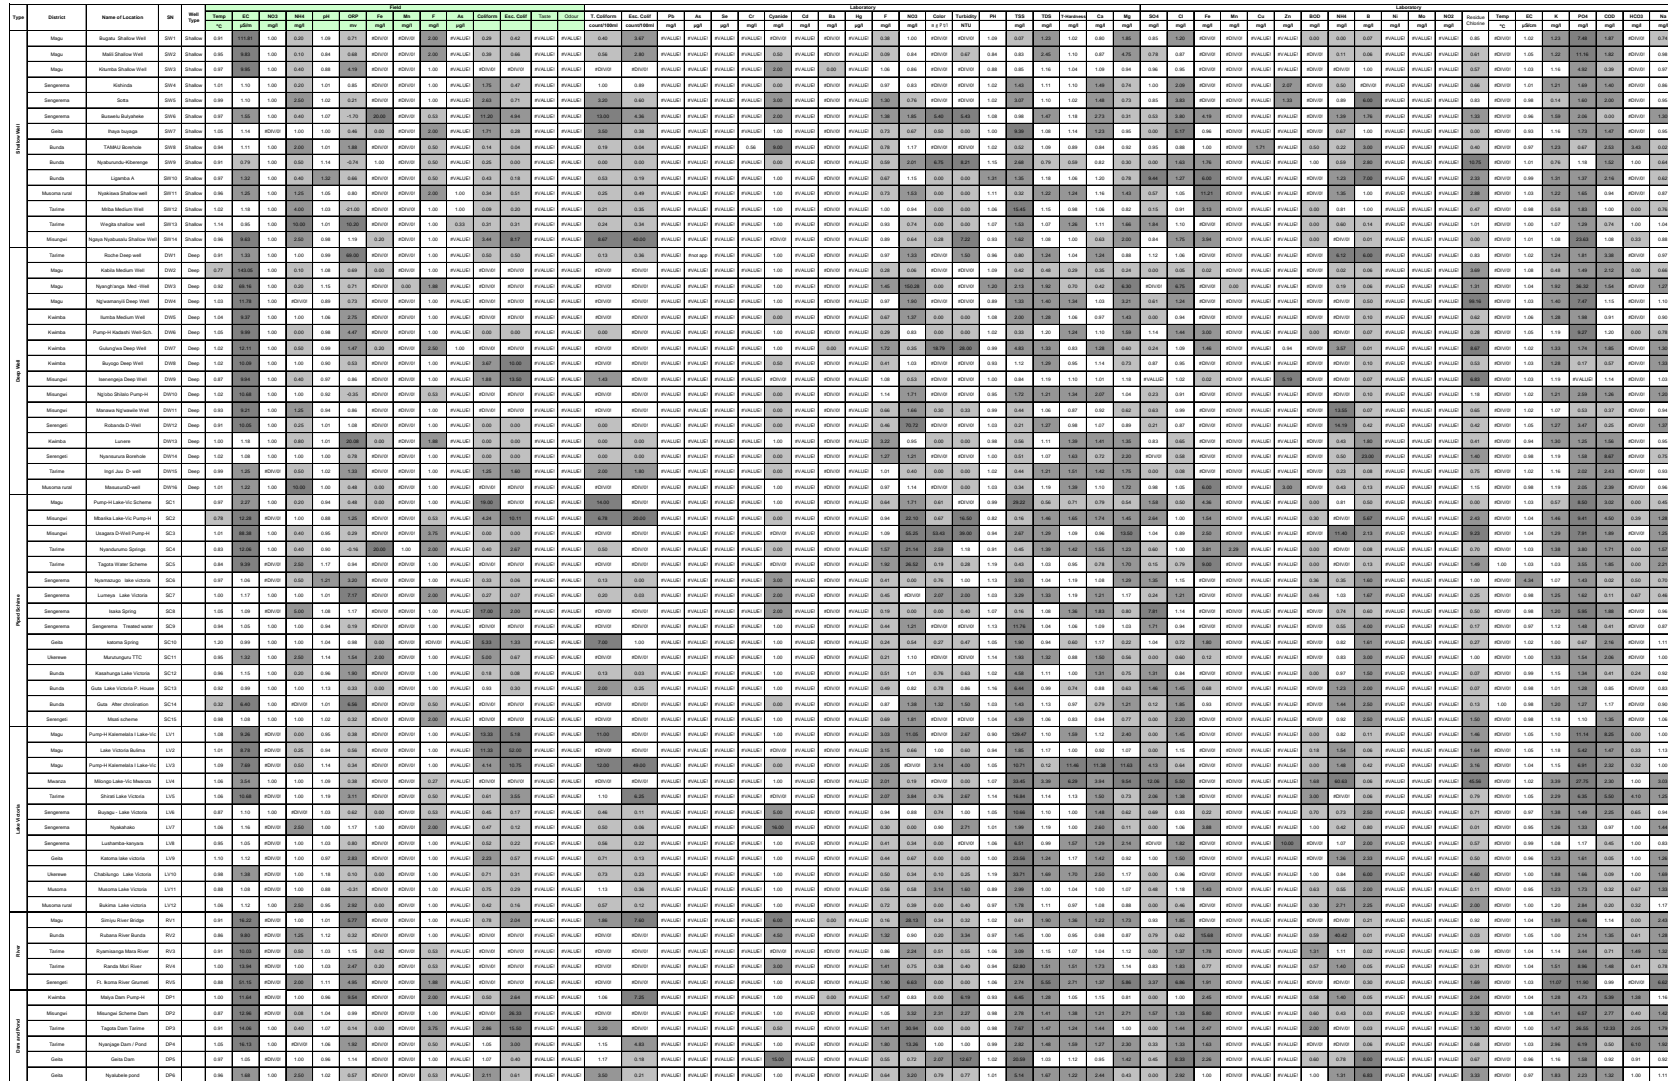
Figure 3.2-6: Matrix of Seasonal Difference of Water Quality

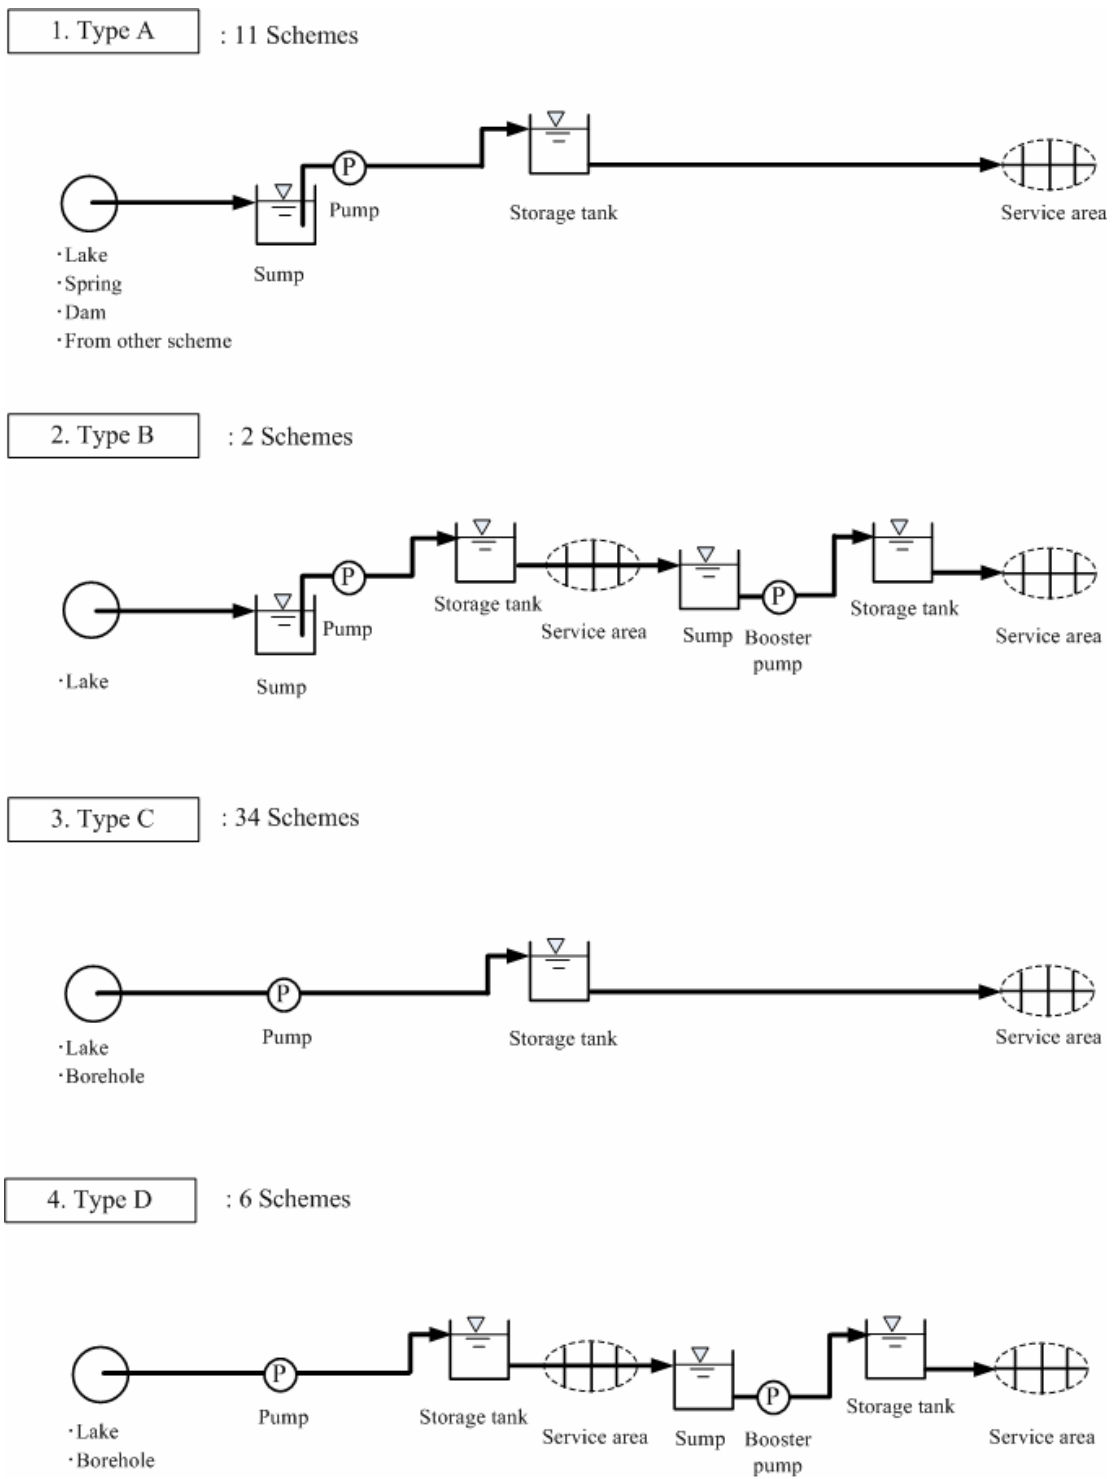
Figure 3.3-1: Facility Types of the Existing Piped Schemes (1/2)

The typical facilities of the existing piped schemes are composed of water sources, intake facilities, pump facilities, transmission pipes, service reservoirs and distribution pipes. Seven facility types classified from A to G based on the form of intake and transmission are shown in Figure 3.1-1. In addition, the number of piped schemes classified by types of facilities is denoted in Table 3.3-3. As per Table 3.3-3, Type “C” is the most abundant type and accounts for about 60% of the 57 piped schemes. This type is a relatively simple structured facility which can provide water without any treatment (Chlorination only for some of the piped schemes) from the water source to the service area through a reservoir that stores raw water directly drawn from the water source. The second most abundant type is type “A”, where raw water is first stored in a receiving chamber, then conveyed to a service reservoir. It is similar to type “C”. Simple structure facilities like types “A” and “C” account for 79% of the 57 piped schemes.

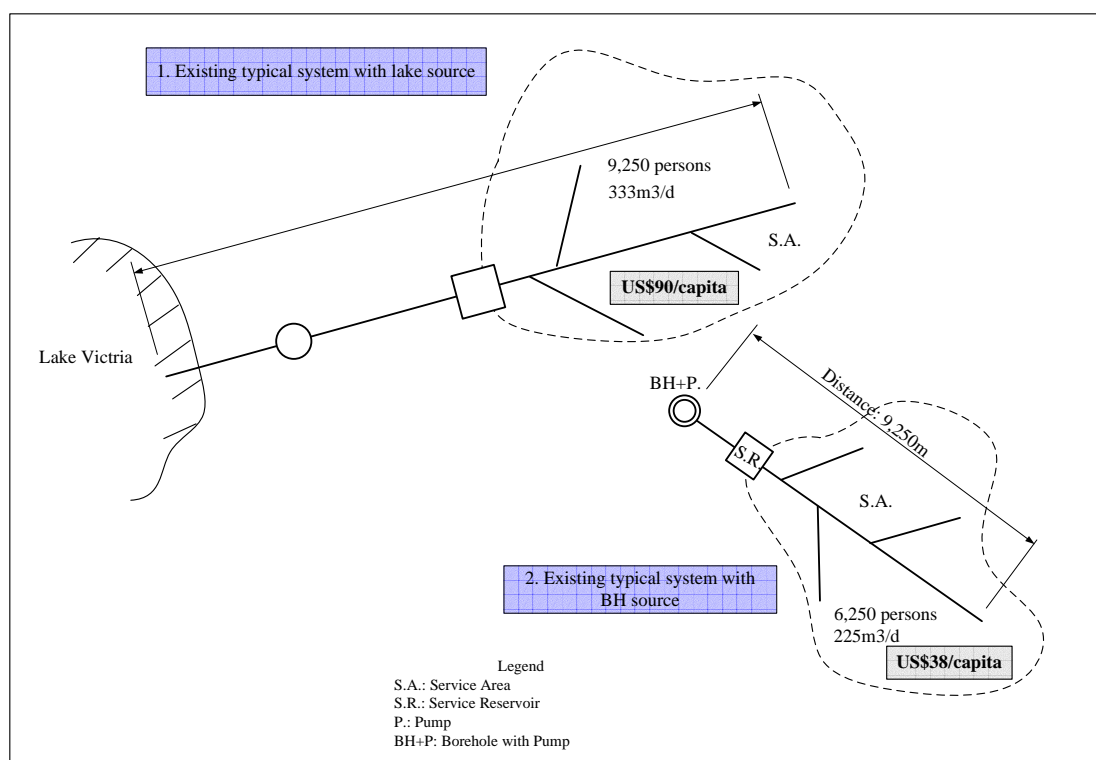
Figure 3.3-2: Modeled System of Existing Piped Water Supply Scheme

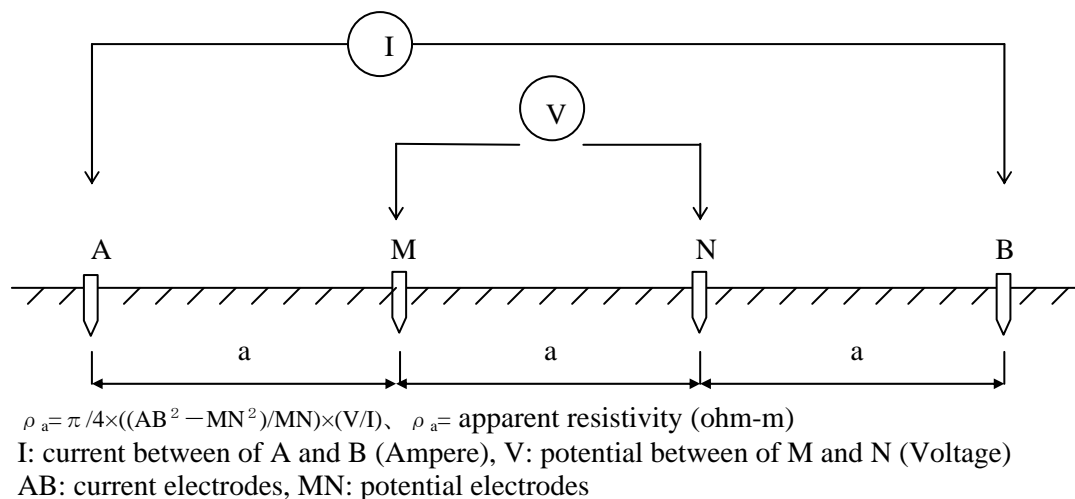
Figure 4.1-1: Wenner Electrode Configurations

Entering the measurement data in the field book, and plotting it as the apparent resistivity curve (apparent resistivity ( $\rho_a$ )—electrode interval (a) on logarithmic graph paper, we identified the abnormal points in the plotted graphs and selected them as the measuring points for the Vertical Electric Sounding.

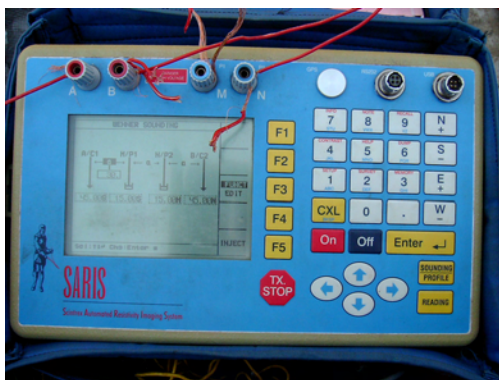
SARIS (Scintrex Automated Resistivity Imaging System) made by SCINTREX, Canada was used for this survey. The appearance of this electrical prospecting instrument and its specifications are as shown in Photo 4.1-1 and Table 4.1-2.

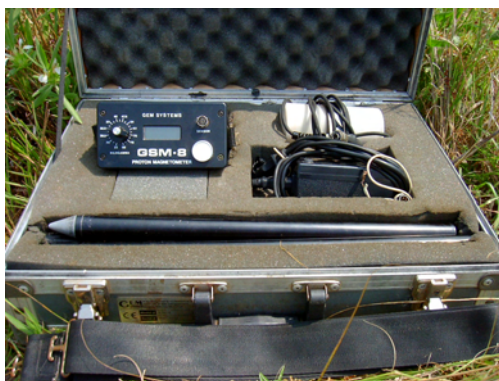
We had no measurement plans to use magnetometers this time. Although there was no magnetic survey plans this time, experimental magnetic prospecting was applied in parts of the areas. The instrument used for these measurements was a portable proton magnetic prospecting instrument, GSM-8 made by GEM Systems, Canada (see Photo 4.1-2 and Table 4.1-3). The magnetic measurement values are affected by regional heterogeneous near survey points, and its observed magnetic anomalies may provide information of the underground structures and the rock condition.

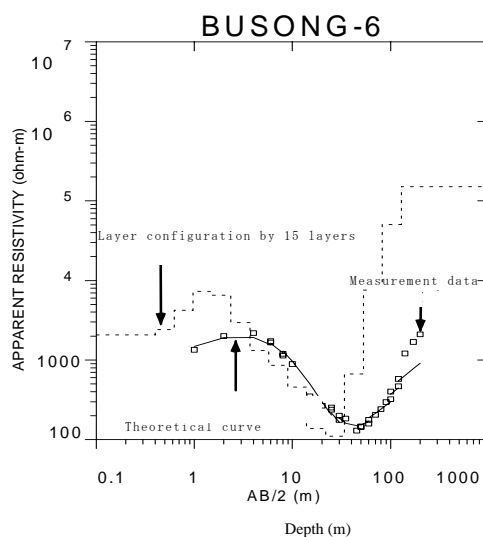
Figure 4.1-3: Occam’s Inversion

The program used in the study can provide layers with a maximum of 15 layers, and calculations can be started with a semi-infinite medium structure. For this reason, appropriate initial values as those used in normal inversion do not have to be provided. Because the layer thickness is fixed in advance, this technique cannot investigate and calculate resistivity boundary depths accurately. Nevertheless, this technique can estimate analysis results without providing initial values and is capable of producing the same results independent of analysis personnel (see Figure 4.1-3).

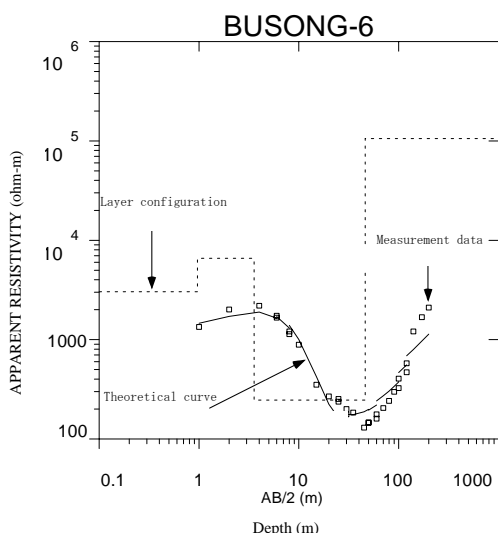
Figure 4.1-4: Layered Earth Inversion

Layered earth structure inversion provides the number of layers, resistivity value of each layer and values of each layer as initial values and analyzes a horizontal multilayer structure that is most suitable to measurement results based on these initial values (see Figure 4.1-4 Layered earth inversion).

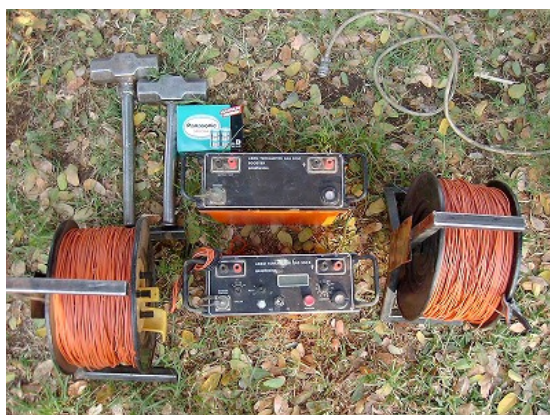
Photo 4.4-2: Electric Prospecting Instruments of Mwanza RWE

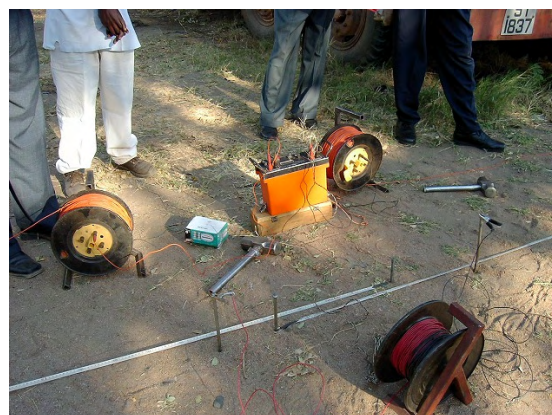
The photo on the left shows a set of electrical prospecting instruments; the main unit can be seen at the lower center of the instruments; the upper center refers to a BOOSTER. The wooden box on the lower side of the main unit in the photo on the right indicates a hand-made battery box which incorporates 10 items of dry cell batteries.

Photo 4.4-1: Electric Prospecting Instruments and Battery

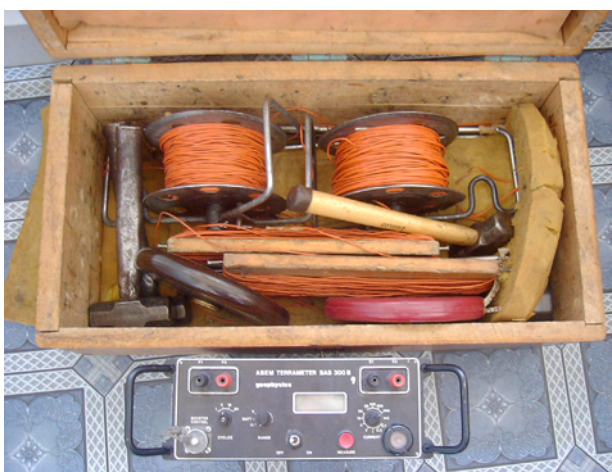
Photo 4.4-3: Electric Prospecting Instruments of Mara RWE

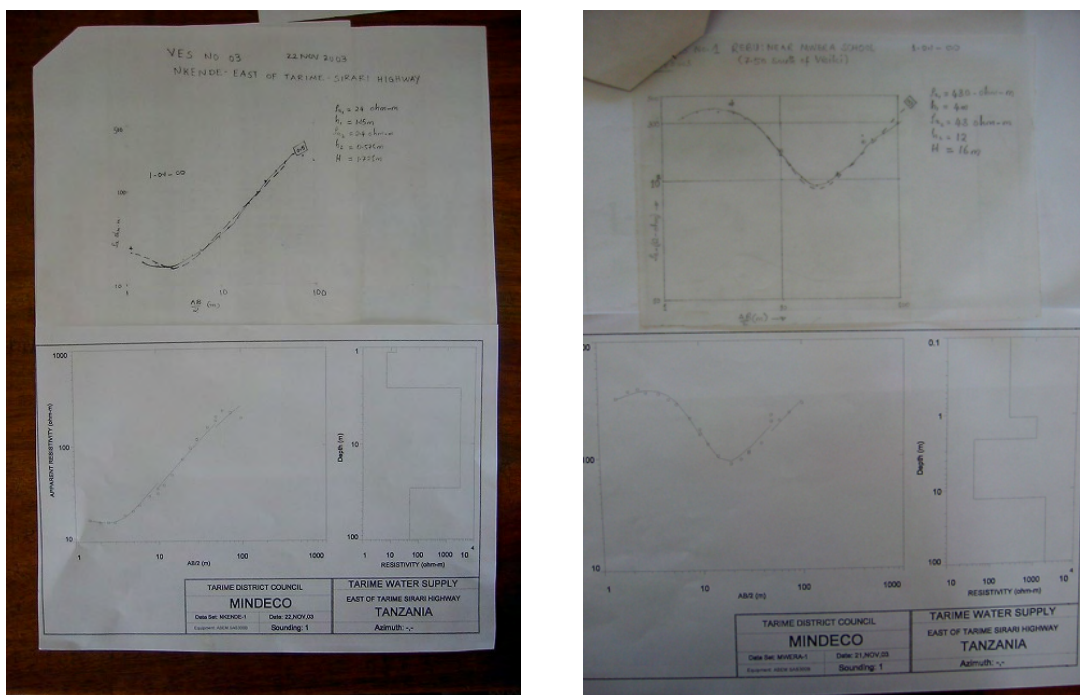
Photo 4.4-4: Comparison of Standard Curve and Analysis Software Interpretations  
(Left: ①, Right: ②)

On the afternoon of August 1<sup>st</sup>, we provided a lecture in prospecting methods for ten unit members, and demonstrated PC analysis. Photo 4.4-4 and Table 4.4-3 show the result of the analysis. The upper side on the photo shows the result of the analysis with the standard curve, while the lower side of the photo shows the drawing of layer structure which resulted from the analysis with analysis software programs. If looking at the VES curve, analysis in four-layer structures is considered appropriate. The result of the standard curve at ① indicates a two-layer structure. However, when analysis software was used, the analysis resulted in a four-layer structure. Moreover, although the result of analysis with the standard curve at ② was even in a two-layer structure, analysis with analysis software resulted in a four-layer structure. When these results are compared with each other, they are similar up to the two-layer structure.
