Final Report

The Study on
Urgent Rehabilitation Program of Ports
in the Republic of Angola

Summary

August 2006

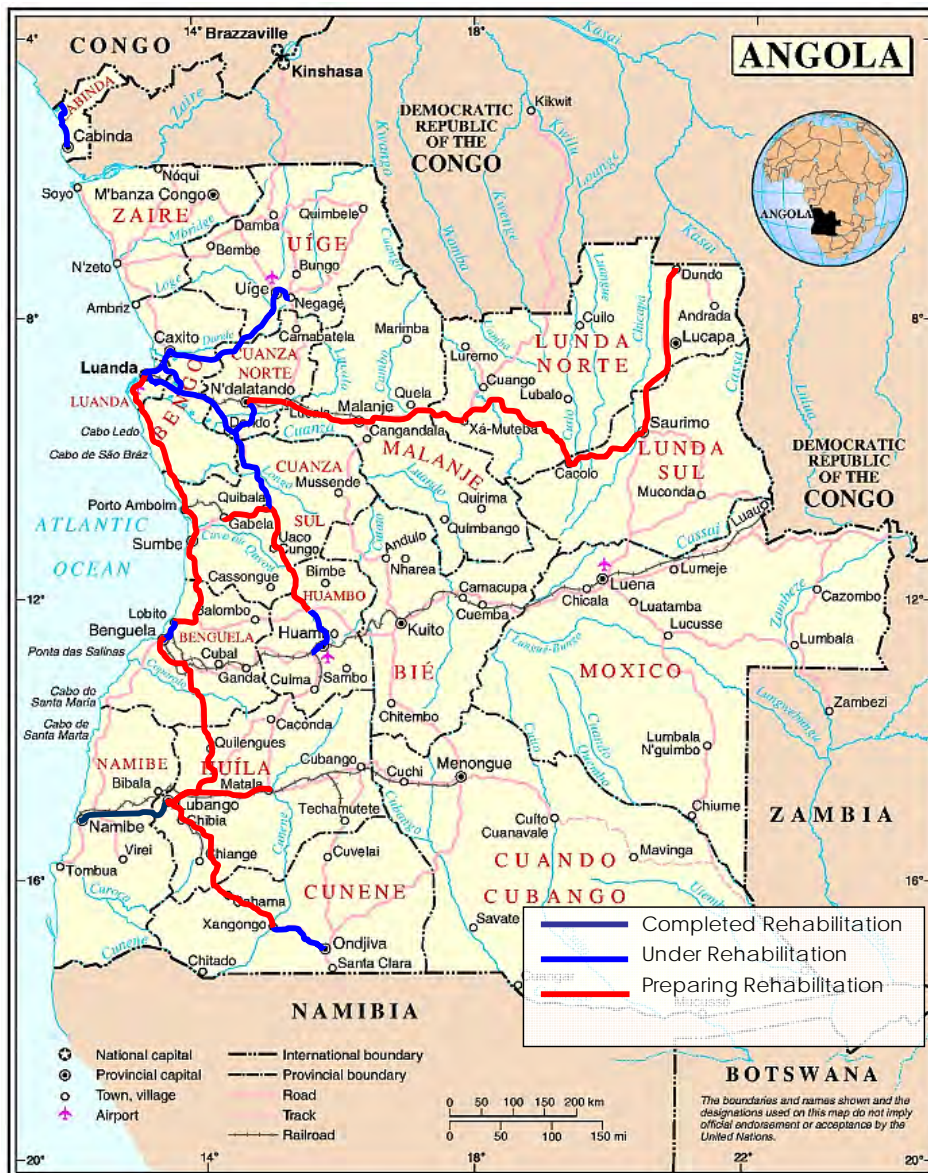
Figure 4-3 Road Rehabilitation in Angola

Total length of main roads in Angola is 15,500 km, including 7,950 km of paved road. Major roads are administrated by the Instituto de Estradas Nacional de Angola (INEA). Figure 4-3 shows main road rehabilitation works in Angola. INEA is rehabilitating 1,200km of principal roads per year.

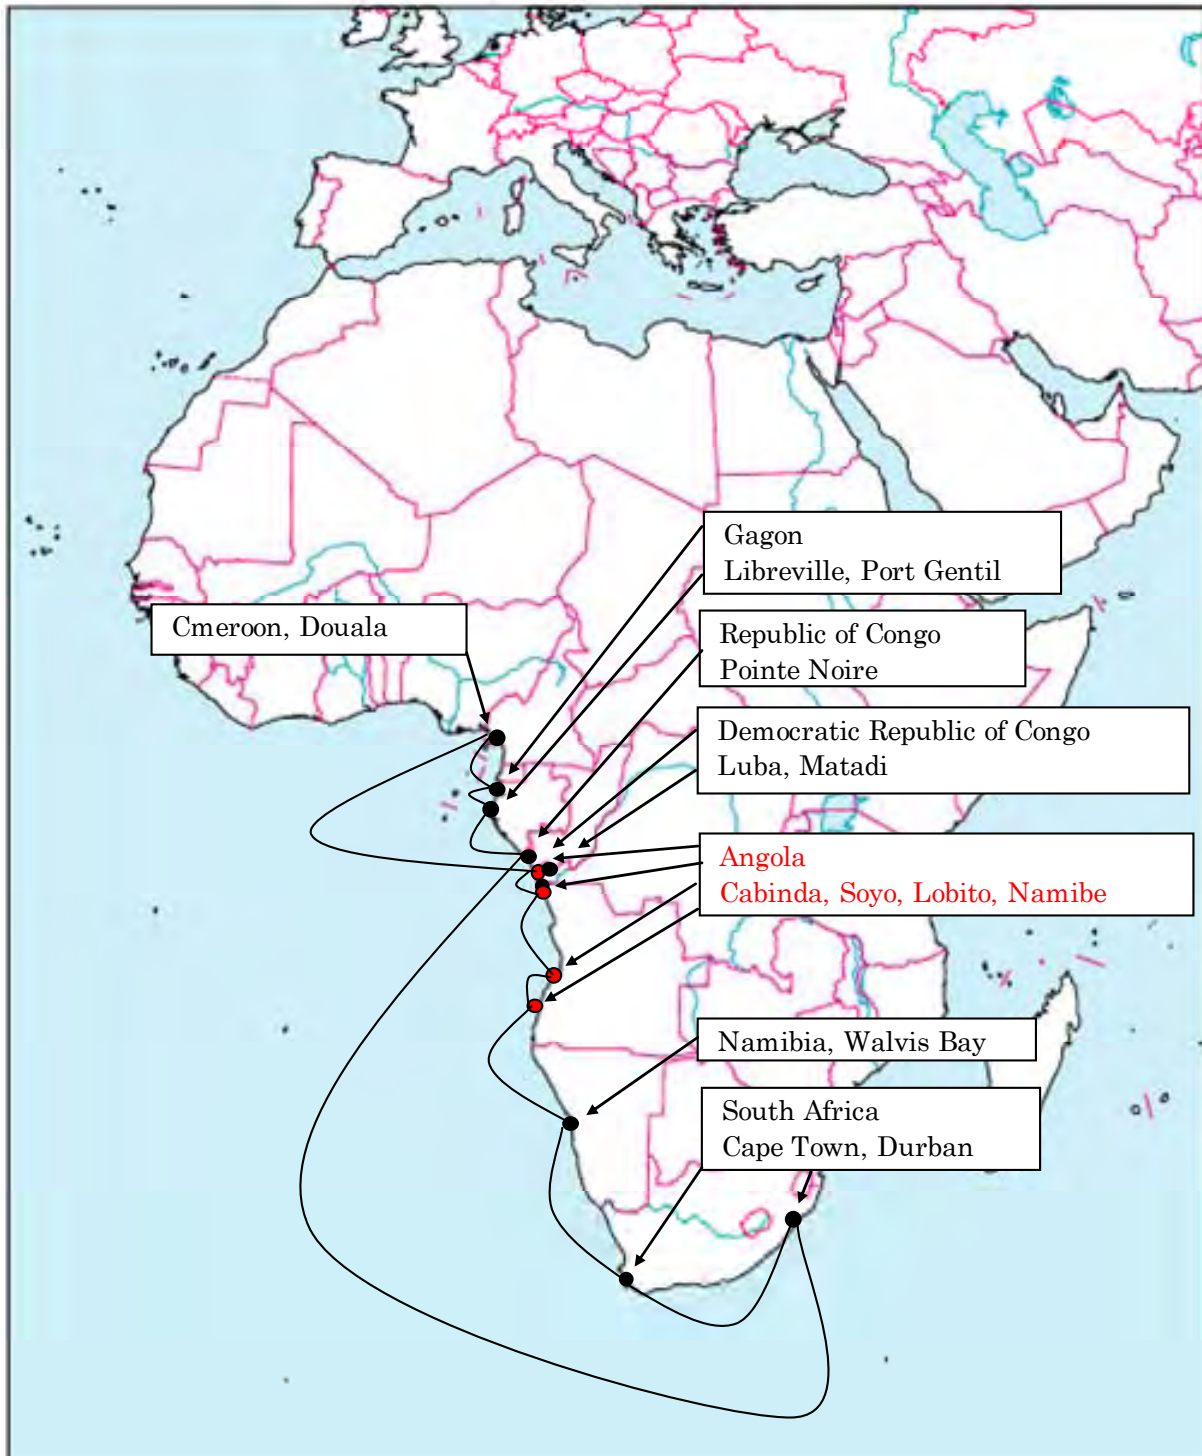
Figure 4-6 MAERSK SEALAND Safmarine Group SAFWAF COMBO Service

Durban(South Africa) – Cape Town(South AFRICA) – Walvis Bay(Namibia) – **Namibe(Angola)** – **Lobito(Angola)** – **Soyo(Angola)** – **Cabinda(Angola)** – Matadi(Democratic Republic of Congo) – Luba(Democratic Republic of Congo) – Douala(Cameroon) – Libreville(Gabon) – Port Gentil(Gabon) – Pointe Noire(Republic of Congo) – Durban
