7.3.2 Environmental and Social Conditions of the Port of Lobito

7.3.3 Environmental Feature around Port of Namibe

7.3.4 Environmental and Social Conditions of the Port of Cabinda

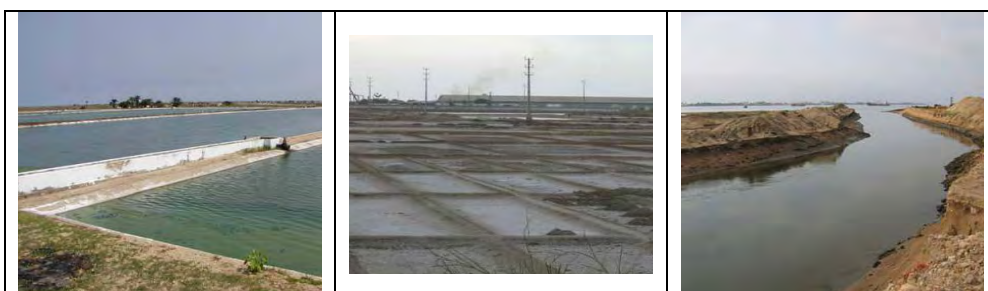
City of Lobito constructed a Sewage Treatment Facility five years ago to treat discharged sanitation. This was for the protection of water quality of the wet land located at the backside of Lobito bay. However, according to water quality tests conducted in the study, COD and Coli form Count were found to be worst at the water channel connecting the wet land and Lobito bay. This is because the sewage treatment facility may not be functioning properly or untreated sanitary water drains.

Photo 7-9 Sewerage facility, Salt pot and water channel to Lobito bay

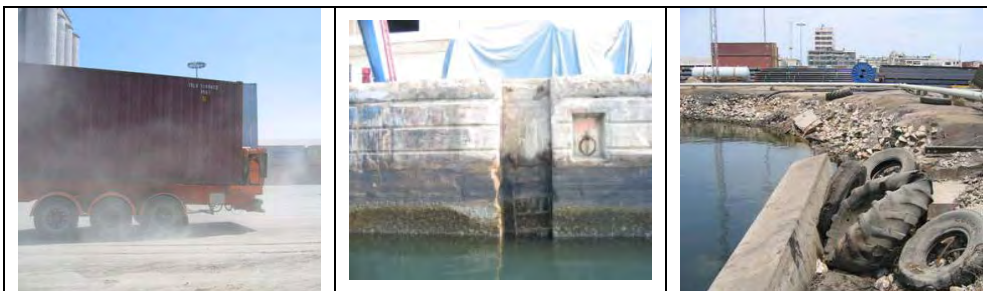
There are unpaved sections in the yard and the dust generated by port vehicles has become a environmental issue. The port is located close to the urban area, therefore, it is import to consider not only the environment of the port but the surrounding area as well. The quays in the port have no rubber fenders which results in damage to the hull of ships as well as the quay itself. Also, existing safety rudders are extremely old.

East revetment of south quay has collapsed and poses a danger to port activities. Chassis vehicles and railway are forward within the port. The urban area is located at the backside of the port, however, the width of road is sufficient and port related traffic is light. According to WFP, the food crisis is over. However still now 900,000 people are suffering from food shortages and about 130,000 ton of food to support them is scheduled to be supplied from January 2006 to December 2008 by WFP. 70% of this food is for Lobito. The main items are oil, cereal, sugar, salt, meat however, the problem is lack of electric power supply facilities for reefer containers in the port.

Photo 7-13 Dust in unpaved yard, Damaged safety rudder, and South quay

Environmental Issue	Desirable environmental consideration
Securing navigation safety	Repairing unworkable navigation aids Dredging for top of sand bar
Dust control	Pavement for yard and road
Improvement of water quality	Preservation of salt pan and the area where flamingo makes habitat and protection of water channel
Poverty support and support system to accept food supply	Electric supply source facility for refer container
Securing safety of port activities	Installation of Rubber Fenders and Bollard Installation of safety rudder and car stop Recovery of destructive South Quay
Conservation area around port	Restriction of deforester and promotion of forestation

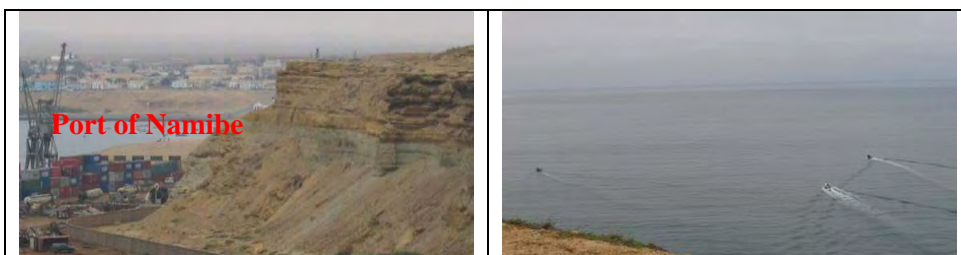
Port of Namibe was constructed by cutting off sandstone terrace. There is an approx. 40m difference between the height of port level and the backside of the port thus landslides are a potential problem during rainfall. In fact, north side of this area was experienced a landslide due to heavy rain in 2004 and the concrete block wall was damaged.

Photo 7-17 Sandstone terrace

Environmental Issue	Desirable environmental consideration
Securing safety of port activities	Improvement of quay and apron Installation of rubber fender, safety rudder and car stops Pavement of port yard and road
Dust control	Pavement of port yard and road
Poverty support and support system to accept food supply	Electric supply source facility for reefer container Renovation of CFS
Slope protection for landslide area	Cutting earth of sandstone terrace to prevent landslide
