4.3 Existing Road Conditions Based On Inventory

4.3.2 Road Inventory and Condition

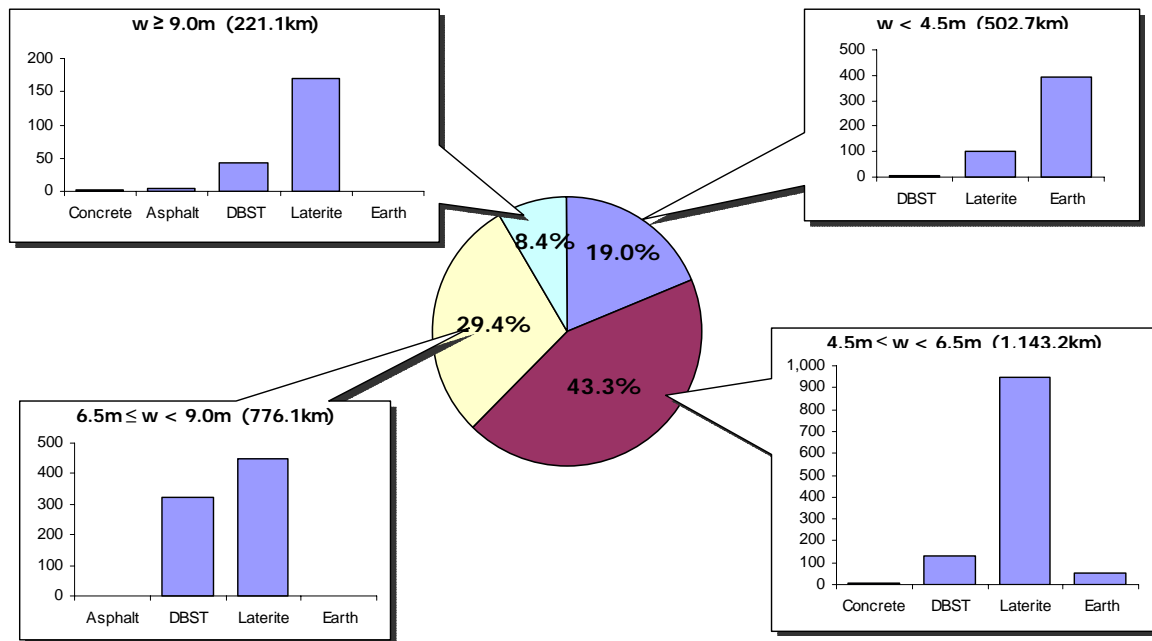
As presented in the **Table 4.3.4**, only 19.9% of the 2-Digit national roads are paved with the remaining sections either with laterite or earth road structure. Moreover, 62.3% of the roads are still less than 6.5m wide with only 8.4% of the roads greater than 9.0m wide.

Figure 4.3.3 Road Width and Pavement Type Distribution for 2-Digit National Roads

The road width and pavement type distribution for the 2-Digit national road is shown in **Figure 4.3.3**.

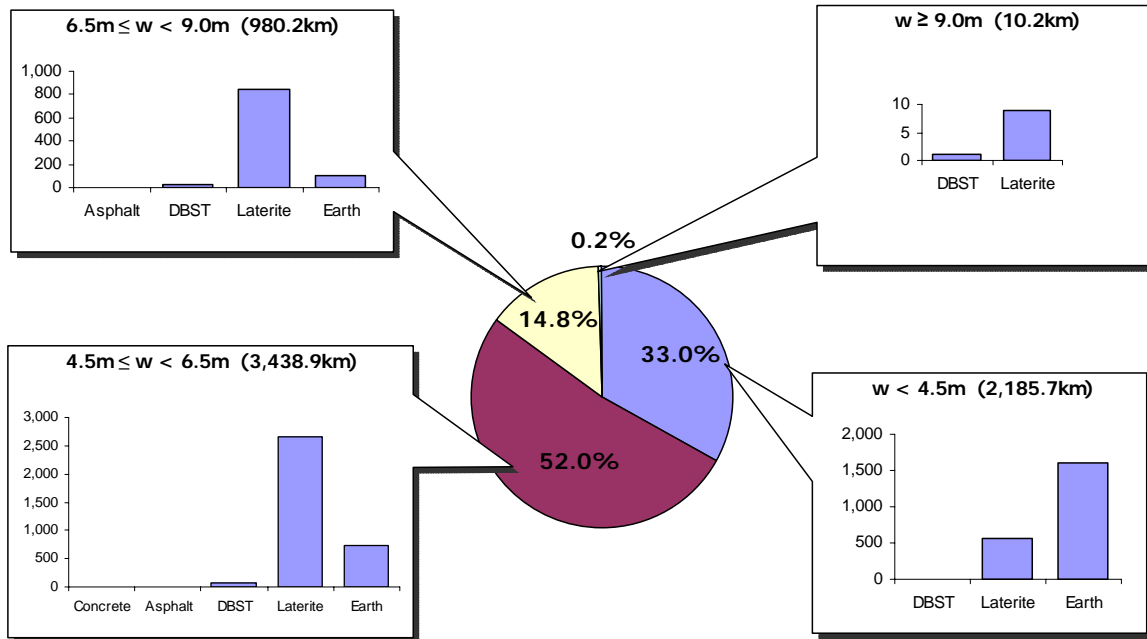
As presented in the Table 4.3.5, only 1.7% of the 2-Digit national roads are paved with the remaining sections either with laterite or earth road structure. Moreover, 85% of the roads are still less than 6.5m wide with only 15% of the roads greater than 6.5m wide.

Figure 4.3.4 Road Width and Pavement Type Distribution for Provincial Roads

The road width and pavement type distribution for the provincial road is shown in Figure 4.3.4.

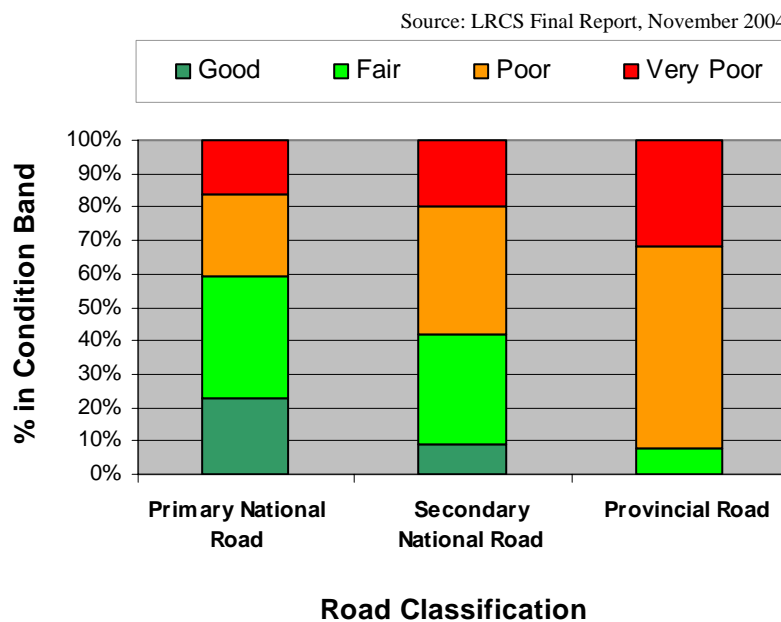
The condition of the road network, as reported by LRCS is shown in **Figure 4.3.5** for the national and provincial roads. The primary national road condition, as shown, varies from good to very poor but is expected to change from good to fair following completion of on-going and committed projects. However, although some secondary national roads have either been rehabilitated or is undergoing rehabilitation, a large percentage of the road (about 60%) still have poor to very poor condition. Much more for the provincial roads, where more than 90% of the network's conditions are poor to very poor.

Figure 4.3.5 Relative Condition of Road Network

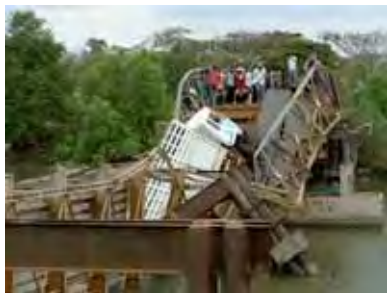
Collapsed Bailey Bridge (NR.33)

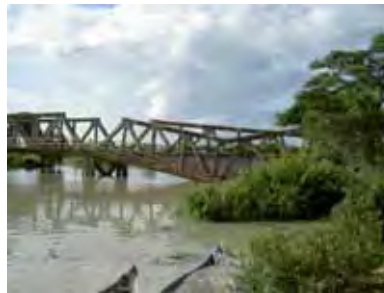
Collapsed Concrete Truss Bridge (NR.6)

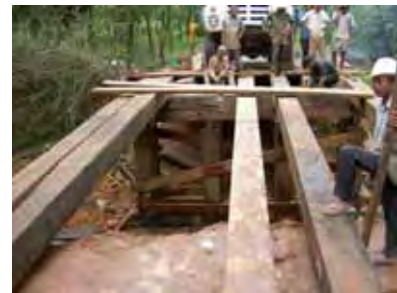
Timber Bridge under Repair (NR.78)

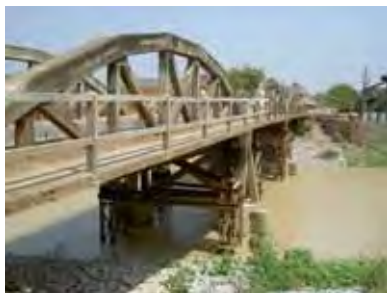
Concrete Truss Bridge (NR.31)

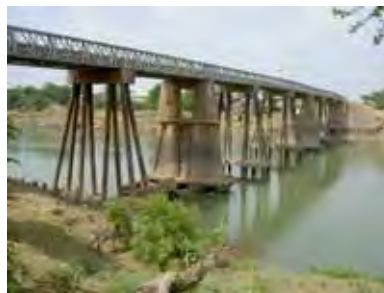
Bailey Bridge (NR.11)

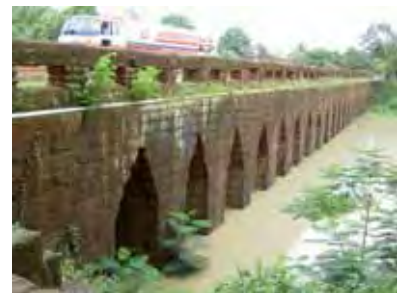
Historical Laterite Bridge (NR.6)

At least 17 historical bridges (laterite stone bridges with a total length of 364.8m) are found to exist along 2-Digit national roads. These bridges, with historical significance, are not designed for the requirements of the present live load and will require construction of new bridges. Such historic bridges may need preservation and may require road realignment for new bridge construction.

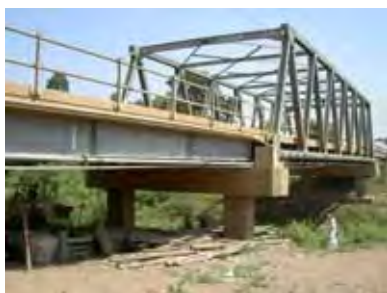
Steel Girder + Truss (NR.5)

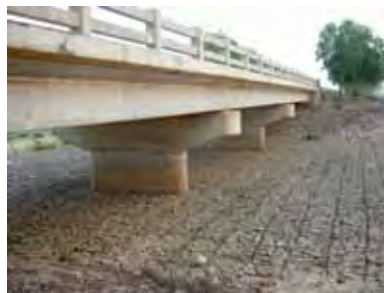
Concrete Bridge (NR.6)

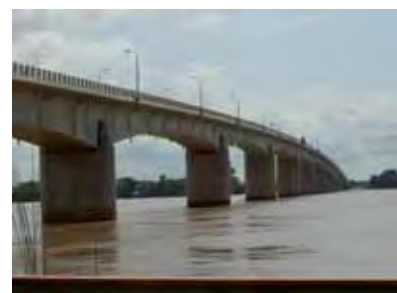
Kizuna Bridge (PC Box)(NR.7)
