**THE STUDY ON FLOOD AND DEBRIS FLOW  
IN THE CASPIAN COASTAL AREA  
FOCUSING ON THE FLOOD-HIT REGION  
IN GOLESTAN PROVINCE**

**FINAL REPORT  
VOLUME IV  
DATA BOOK III  
PHOTOGRAPHS**

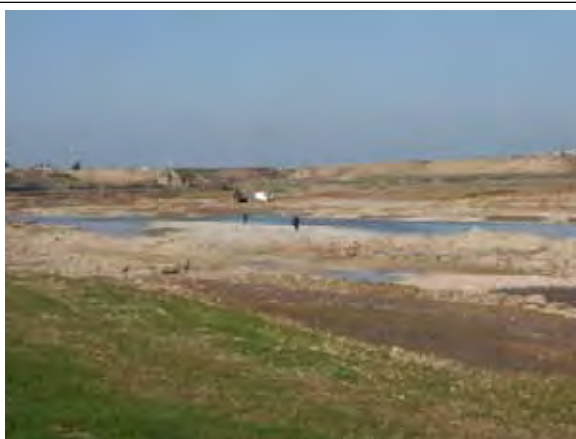
Opposite Bank of Lower Madarsoo from Left Bank and Lower Terrace (downstream of Kalaleh Bridge). Two-staged terraces can be clearly distinguished from this photo.

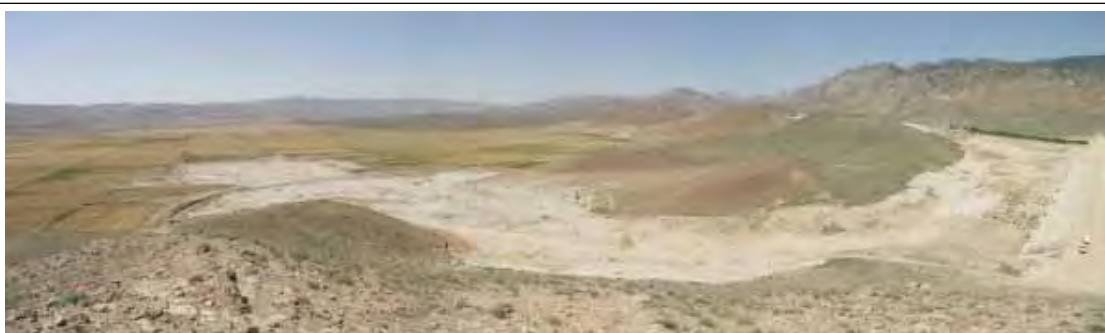
Ghyz Ghaleh River and Polder Dike. The sediment runoff deposited along the dike and in some part of agricultural land.

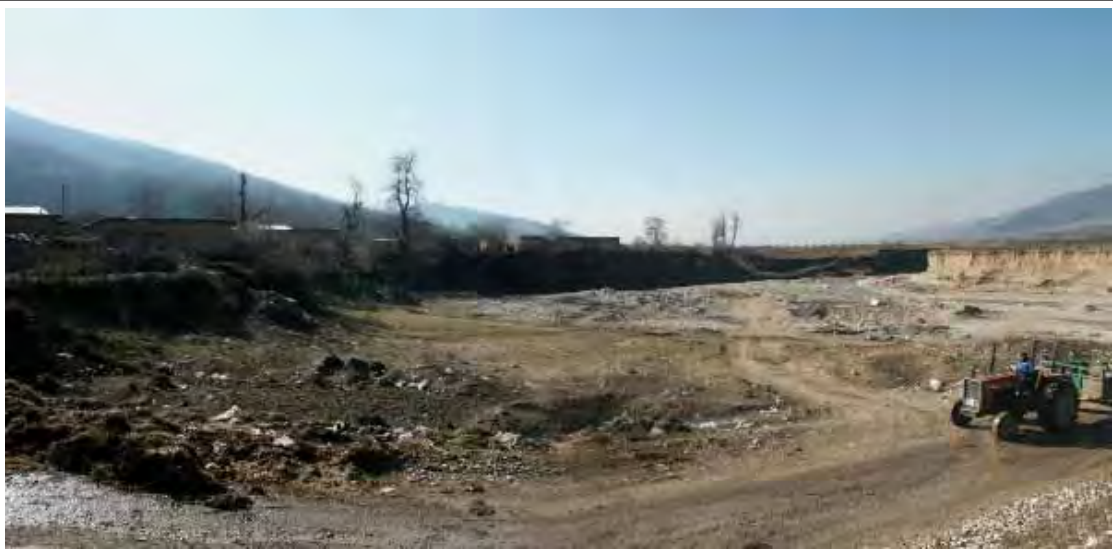
#### Loveh Village

Loveh Bridge was washed out, and serious bank erosion occurred along the downstream bend.

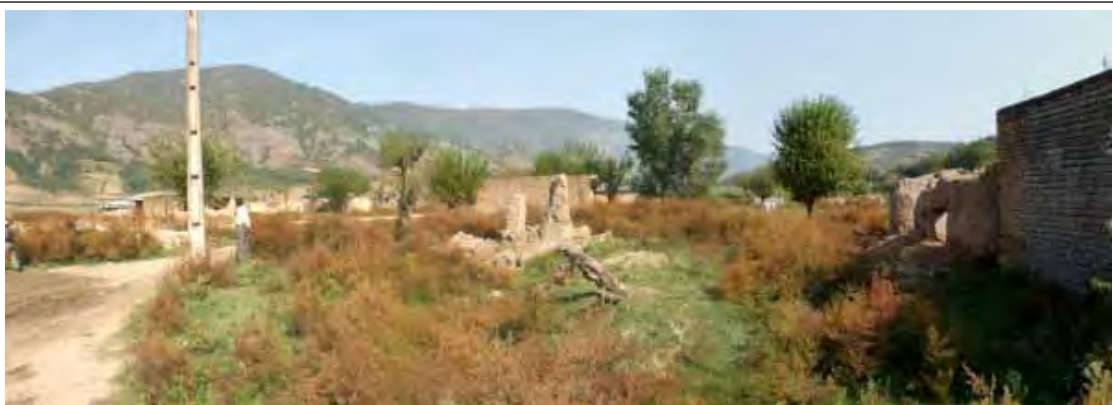
#### Beshoily Village

Houses made of soil and clay were washed out by the 2001 Flood.

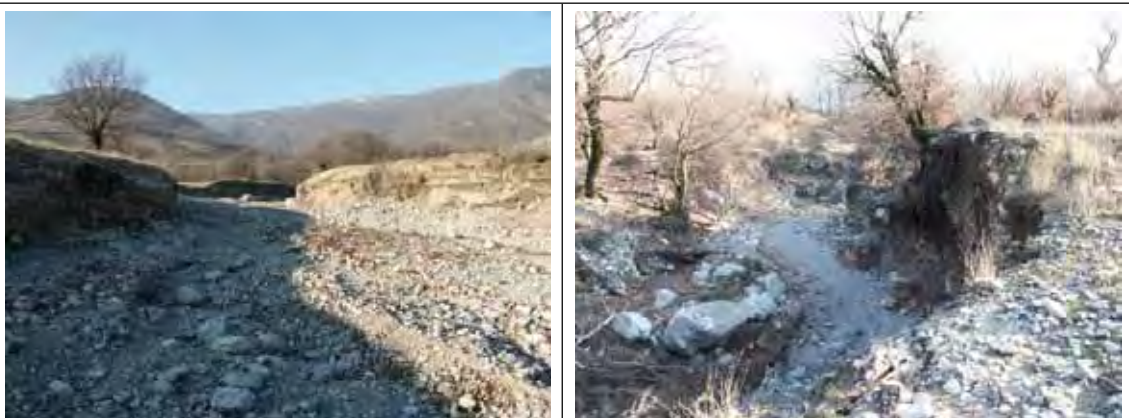
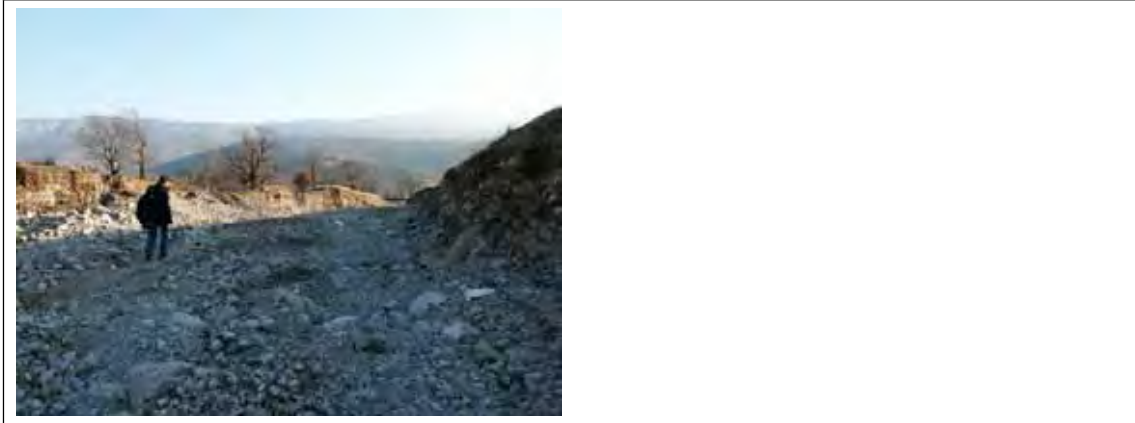
#### New Beshoily Village

Near the new Beshoily village, debris flow occurred with channel scouring.

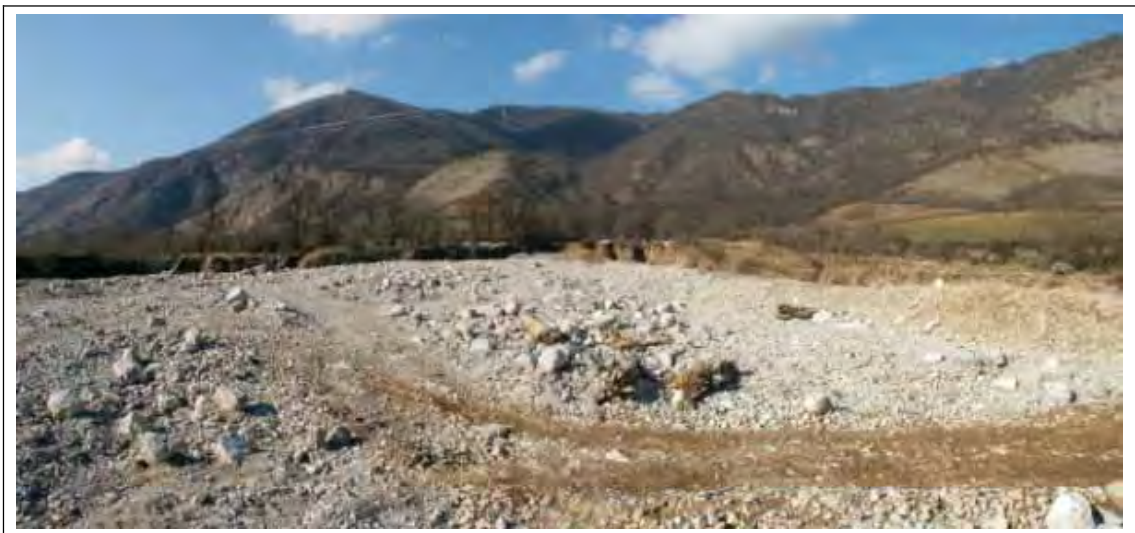
Beshoily - Terjenly

In between Beshoily and Terjenly villages, debris flow also occurred in a mountain stream.

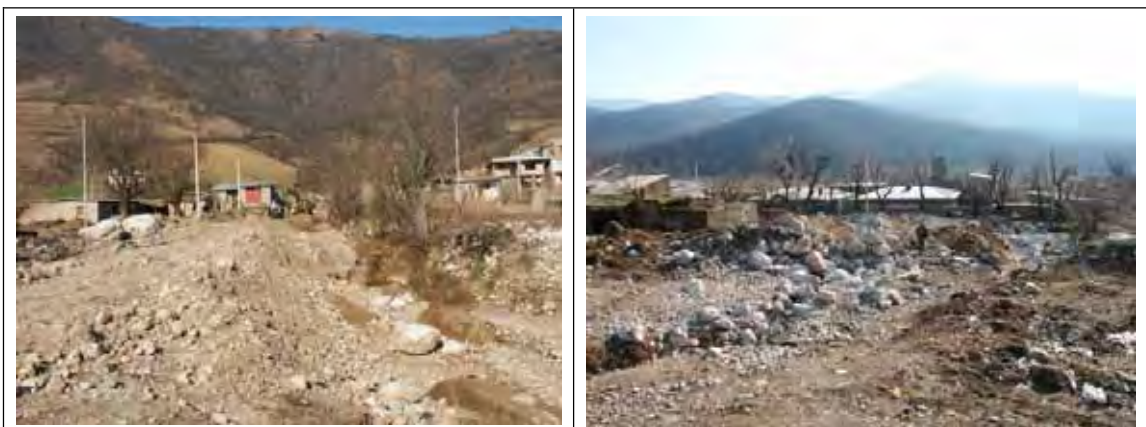
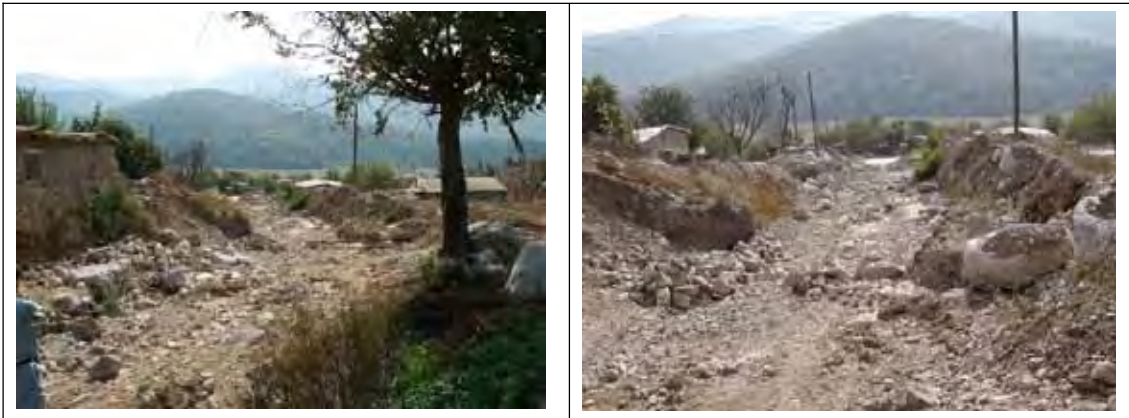
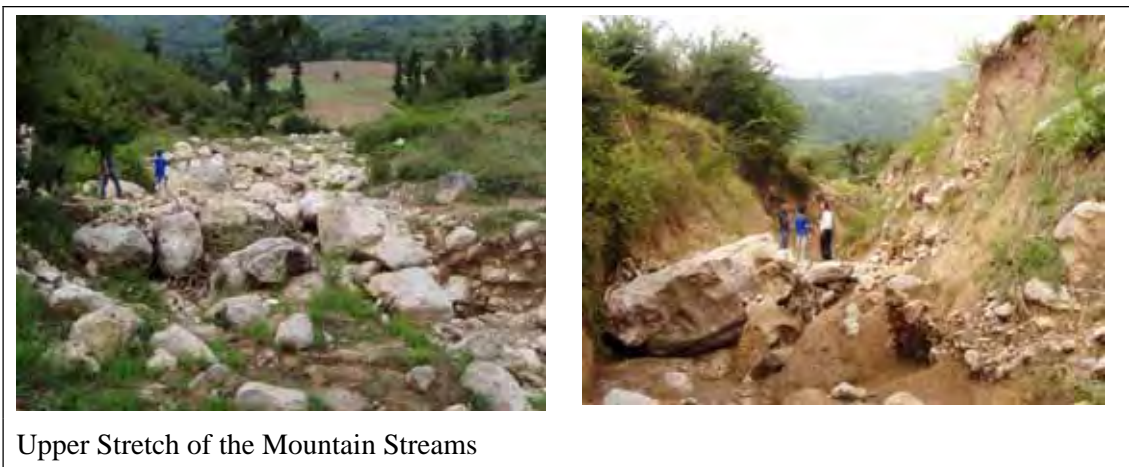
Terjenly Village

Debris flow attacked Terjenly village, which occurred in the two mountain streams.

Upper Stretch of the Mountain Streams

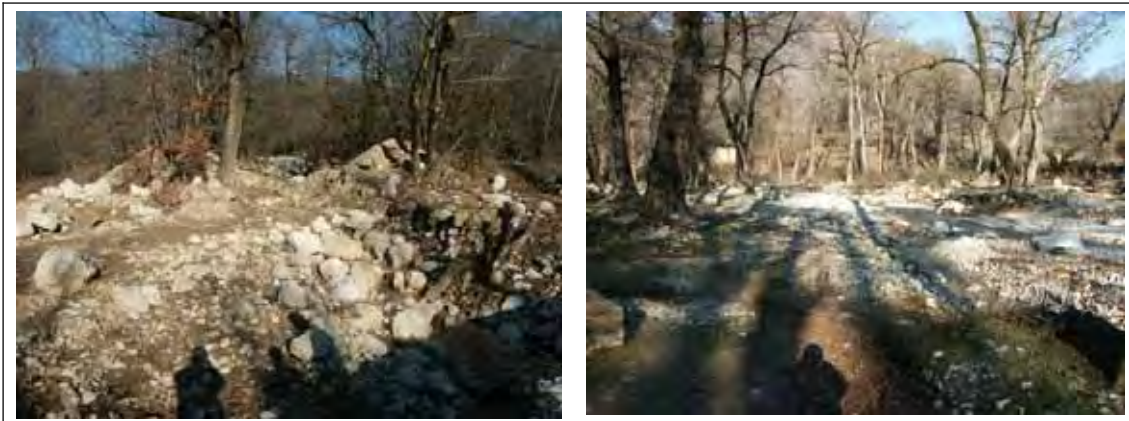
Tangrah Village

Debris flow occurred along a mountain stream in Tangrah village. Numerous boulders deposited in a upper part of village.

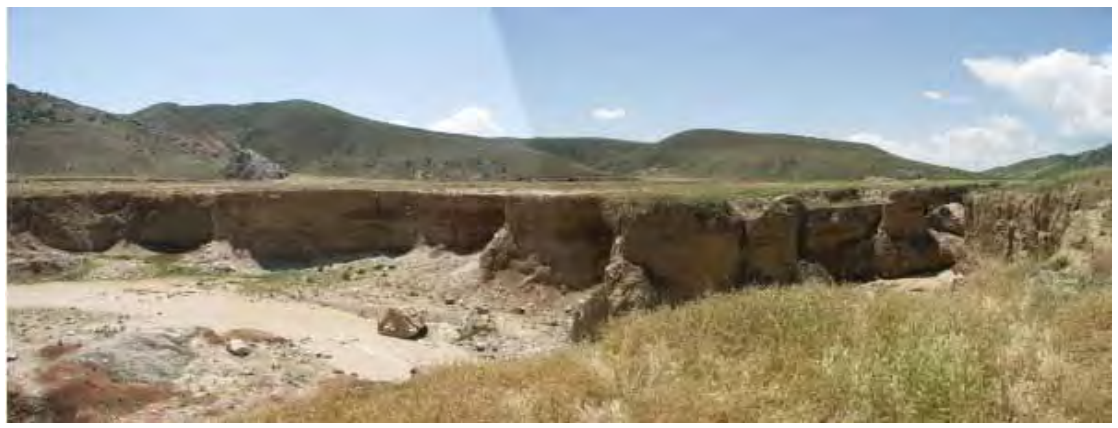
Dasht Village

Wide valley-head erosion occurred just upstream of confluence with Cheshme Khan along the Madarsoo.

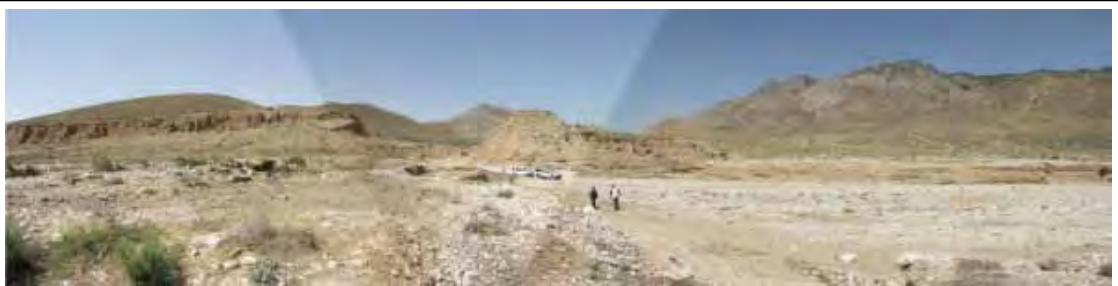
Breached Earth Dam viewing from Lower Point

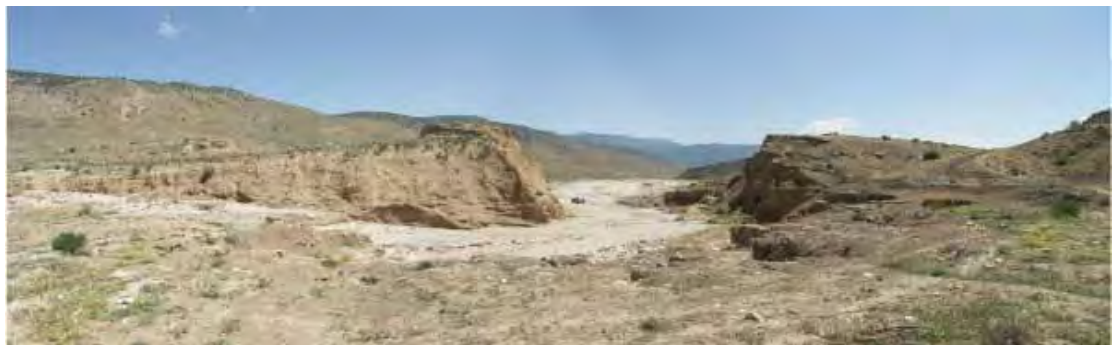
Breached Earth Dam viewing from Upper Point

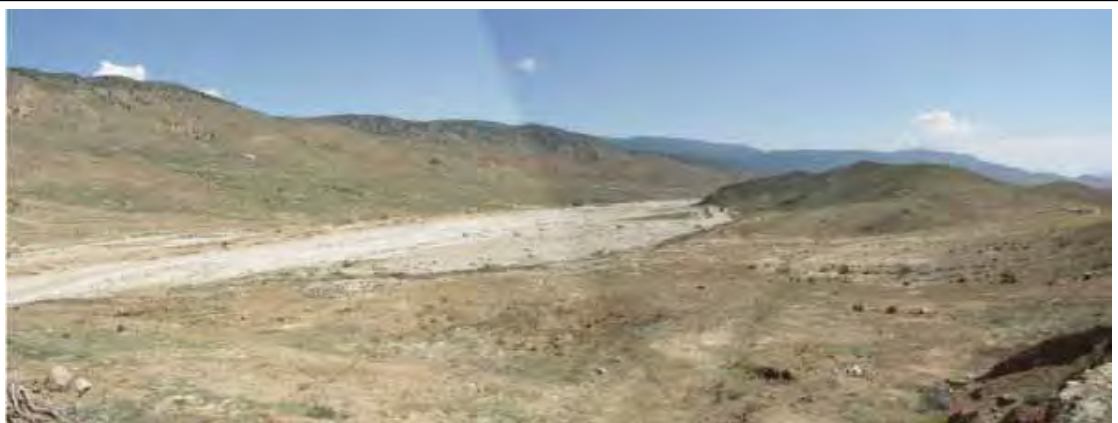
Downstream Stretch of Breached Earth Dam

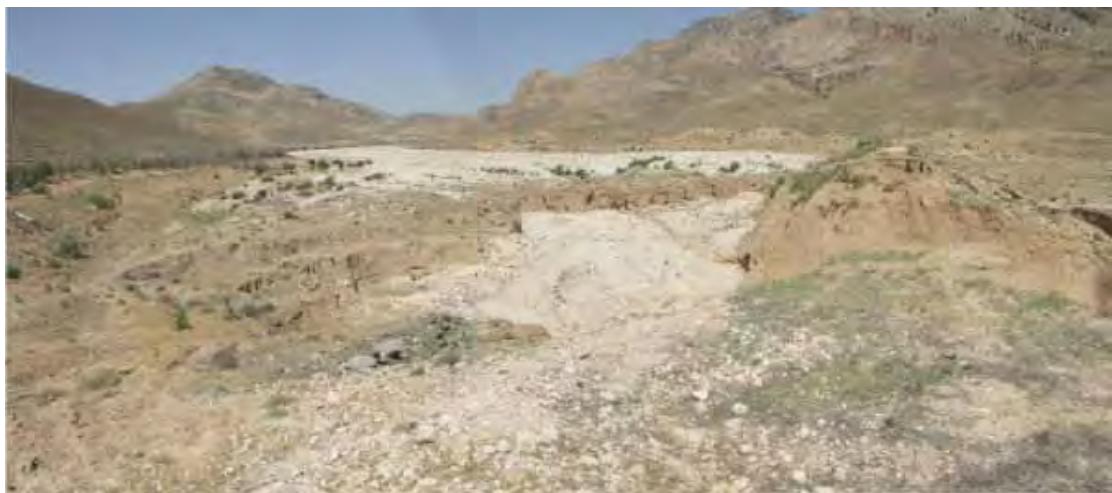
Stored and Eroded Sediment in the Basin of the Earth Dam

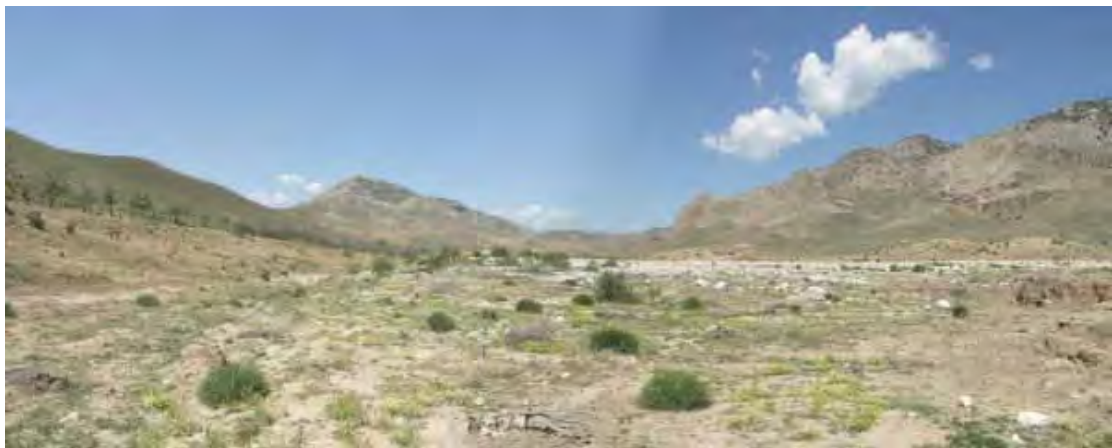
Stored Sediment in Upper Stretch of the Earth Dam

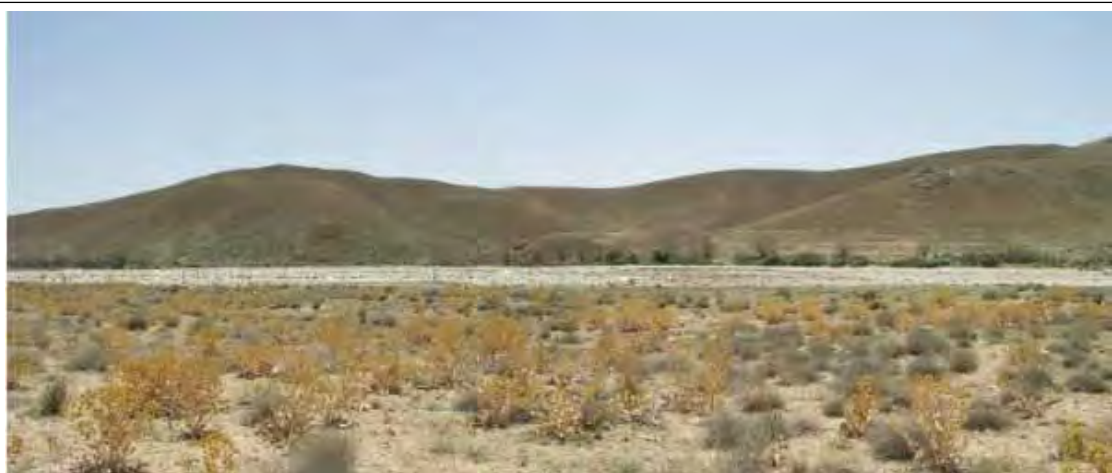
Longitudinal View of Stored Sediment in Upper Stretch of the Earth Dam

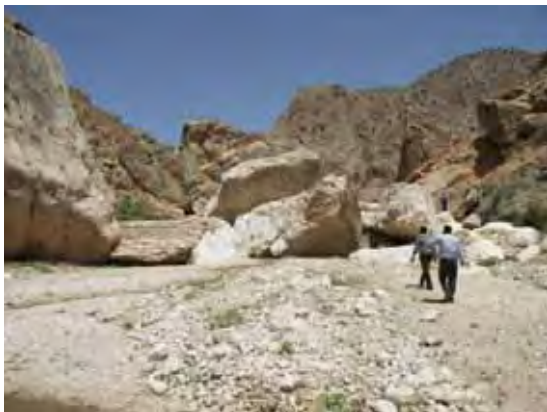
Broken Intake Structure

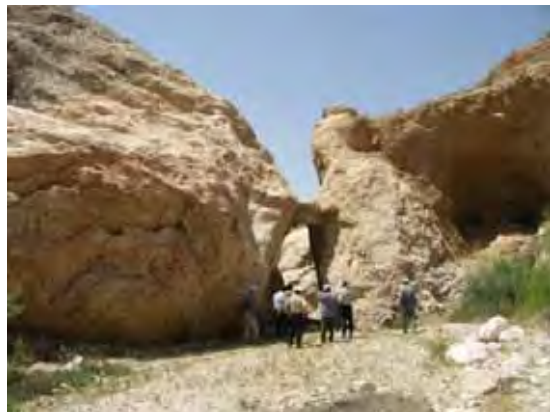
Breached Upper Sabo Dam

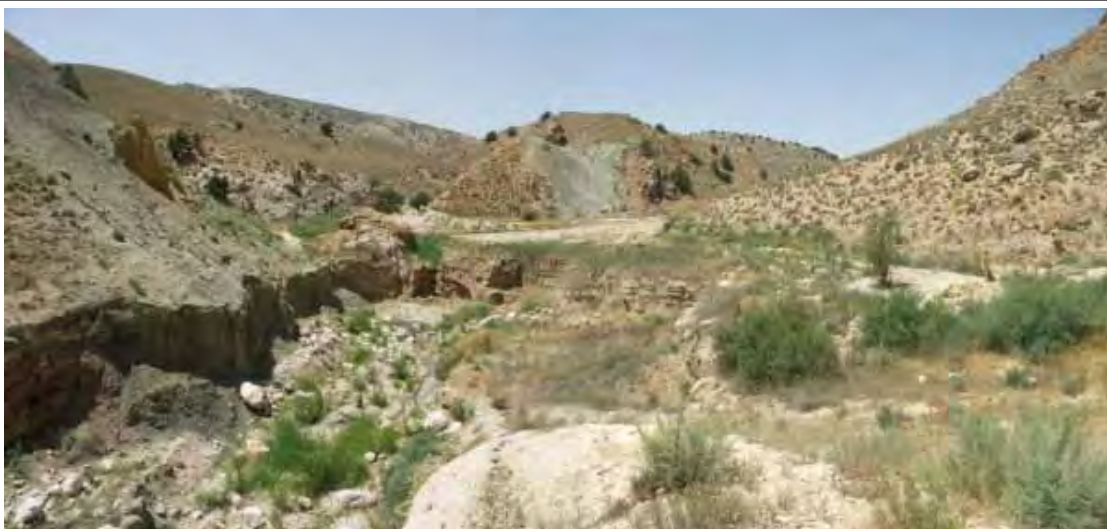
Sediment Accumulated in the Upper Basin of the Upper Sabo Dam viewing from the Dam Embankment

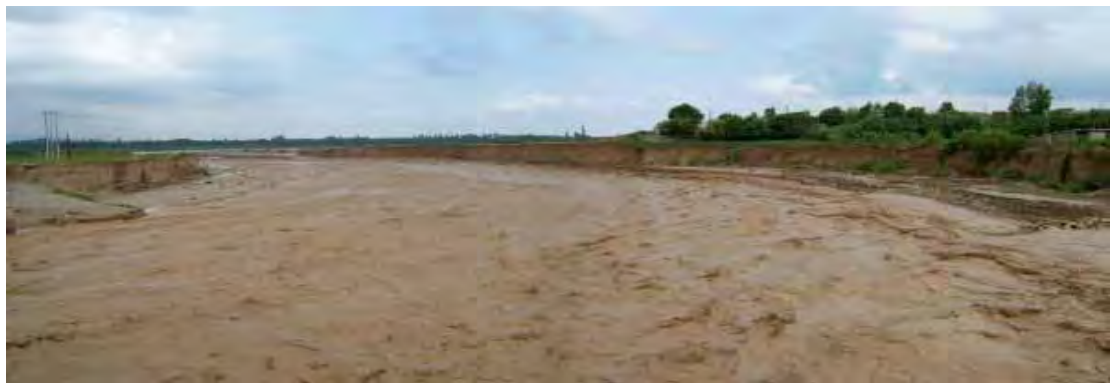
Downstream Bend of Kalaleh Bridge

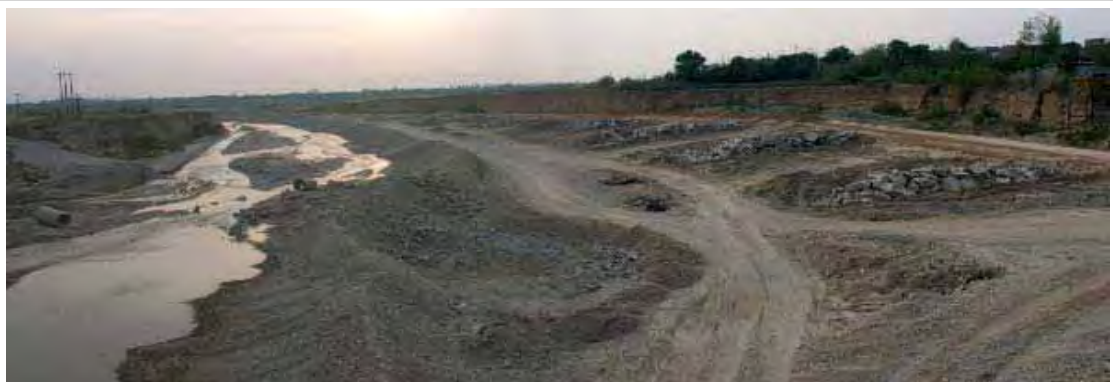
Before the 2005 Flood, Placement of Riprap Spur Dike

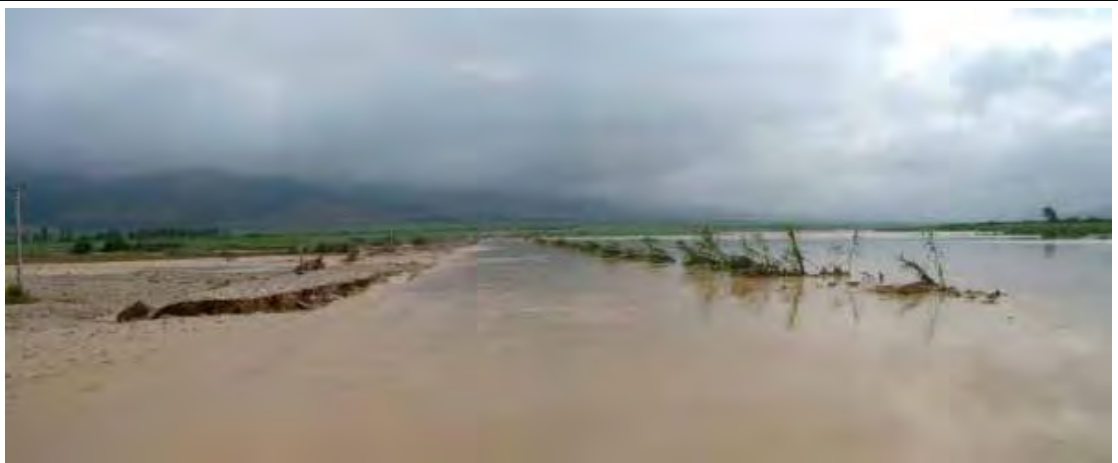
Flooding upstream of 14 Metry Bridge

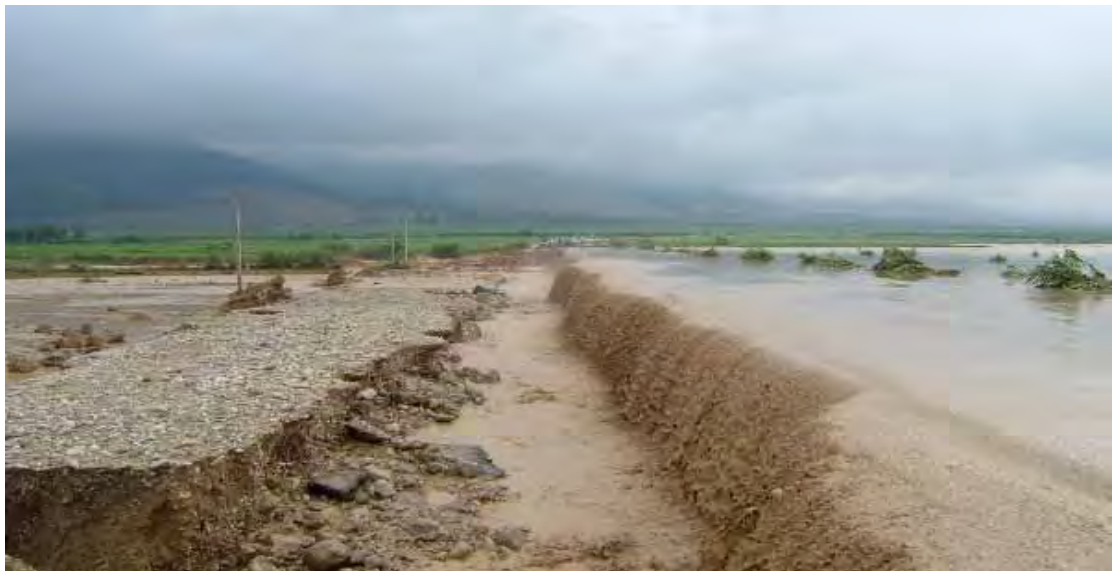
Overtopping the Gorgan-Mashhad Road

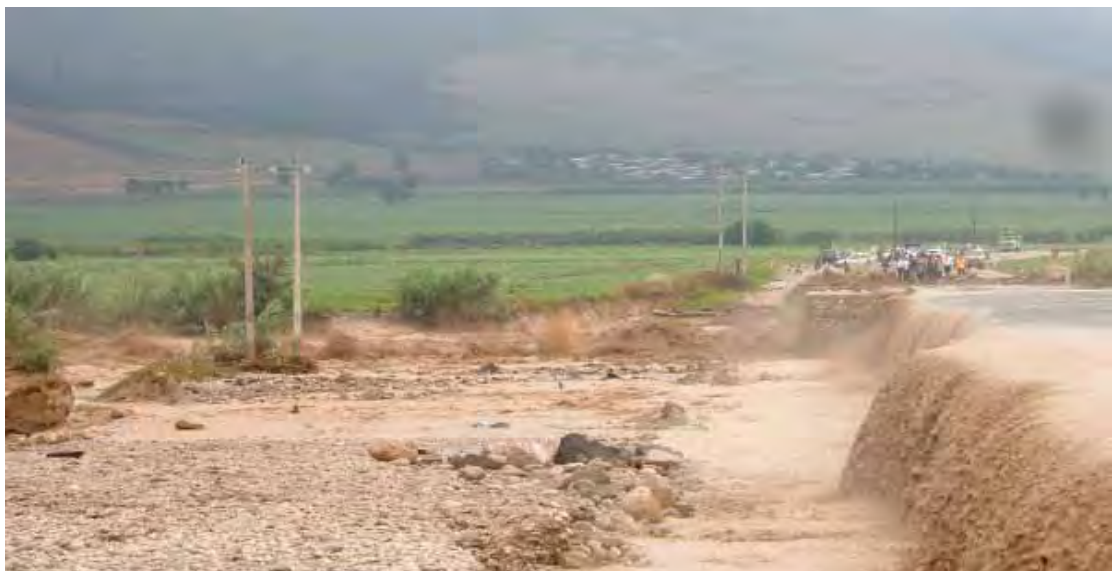
Overtopping the Gorgan-Mashhad Road

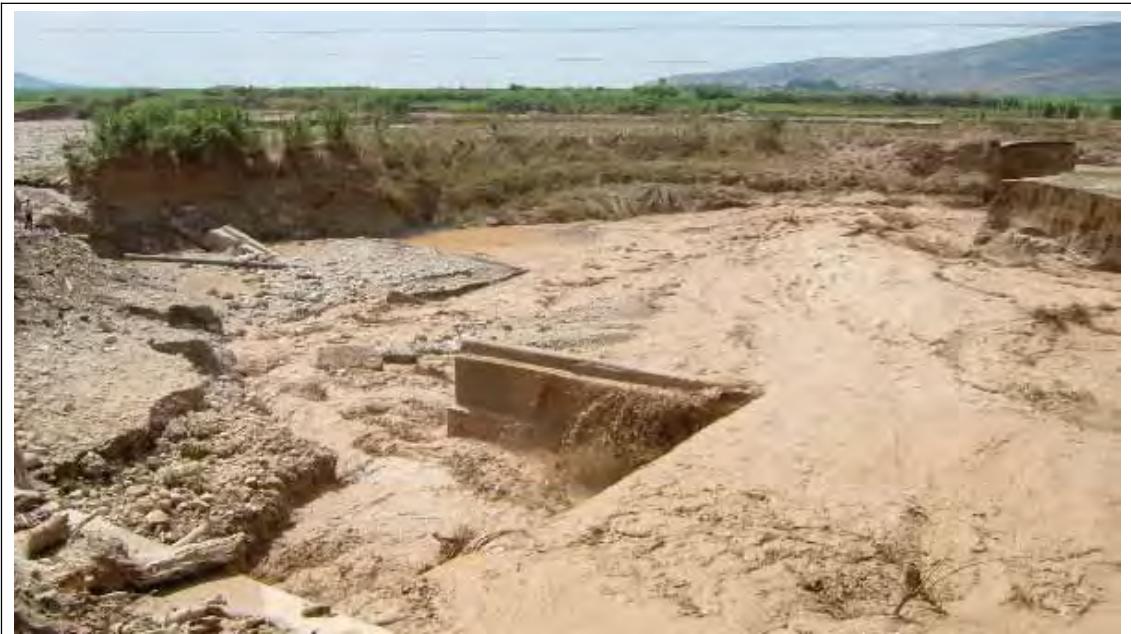
Floodwater through the 14 Metry Bridge

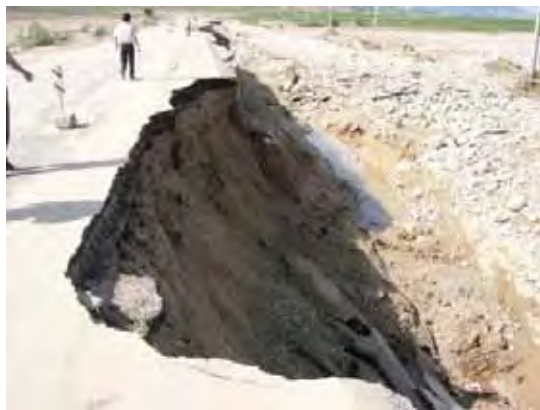
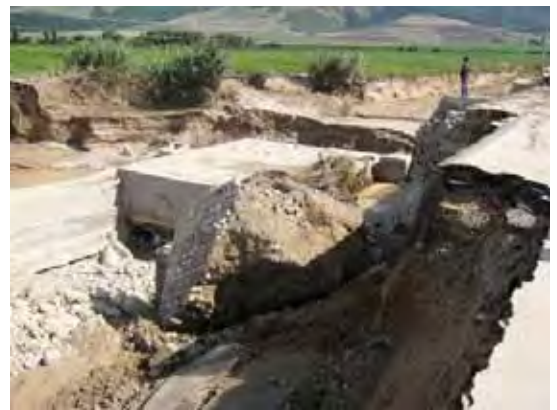
Damage on the road Embankment

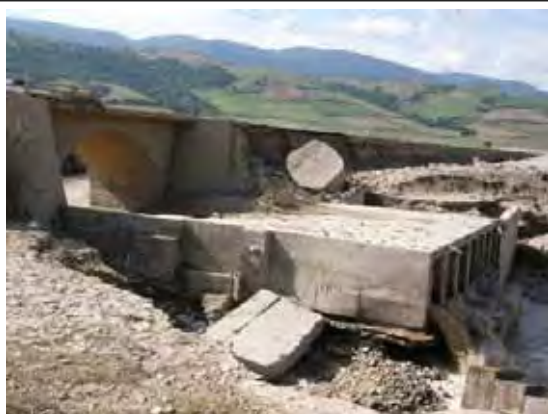
Damage on the 14 Metry Bridge

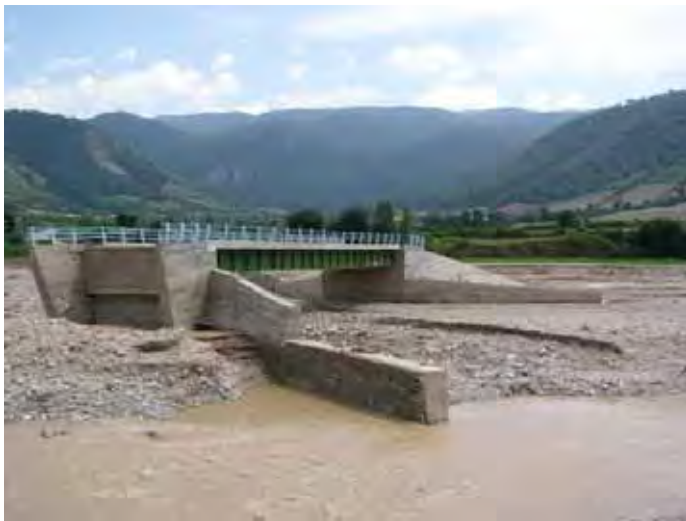
Korang Kaftar Bridge

Both sides of approach were washed away.

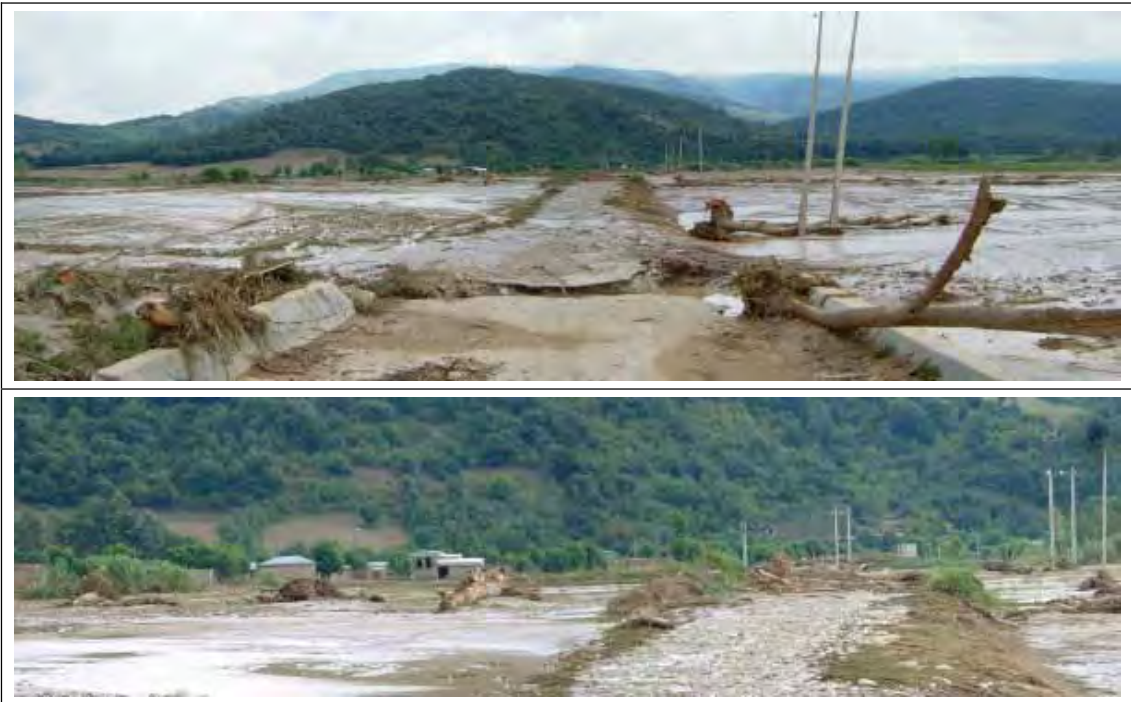
Old Beshoily village was flooded due to constriction of river channel by a connection bridge.

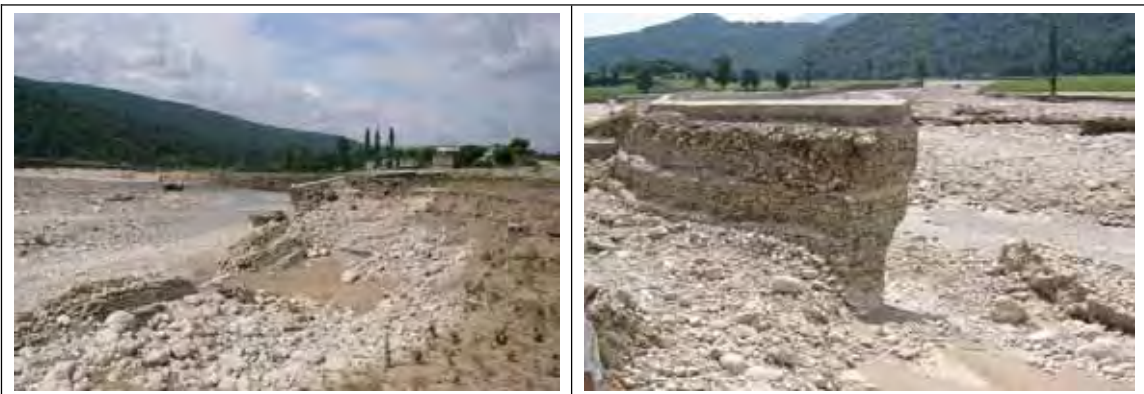
The retaining wall was destroyed by local scouring along the concave bank of the Terjenly bend due to improper foundation of the wall.

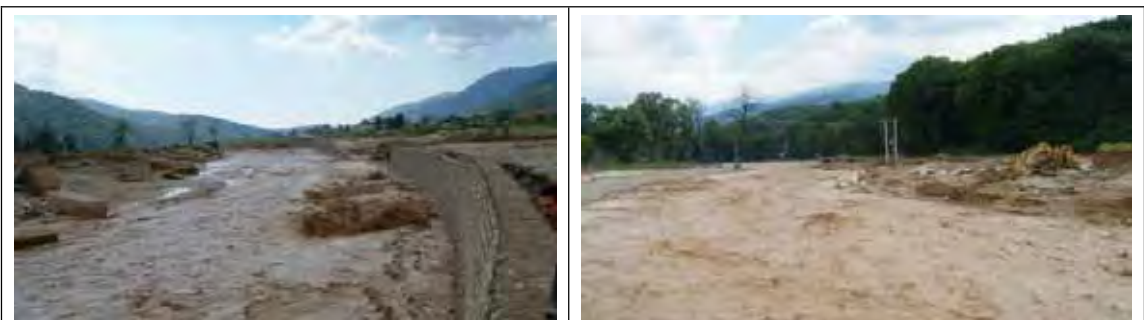
Along the Tangrah bend, the wall was also destroyed under the similar mechanism to the Terjenly bend.

Above: Flood Trace of Drift Weeds on the Fence

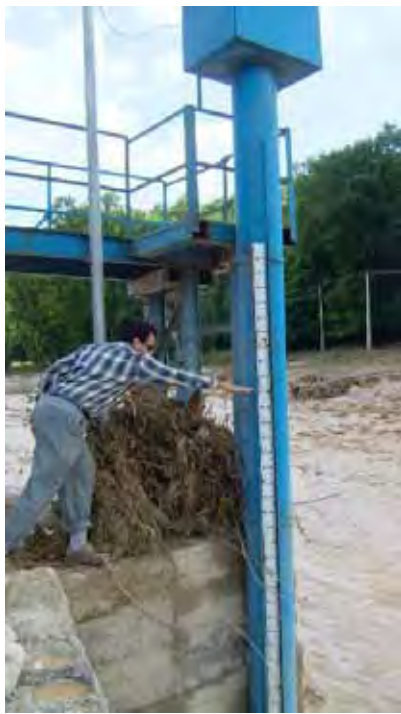
Left: Flood Trace at Tangrah Station

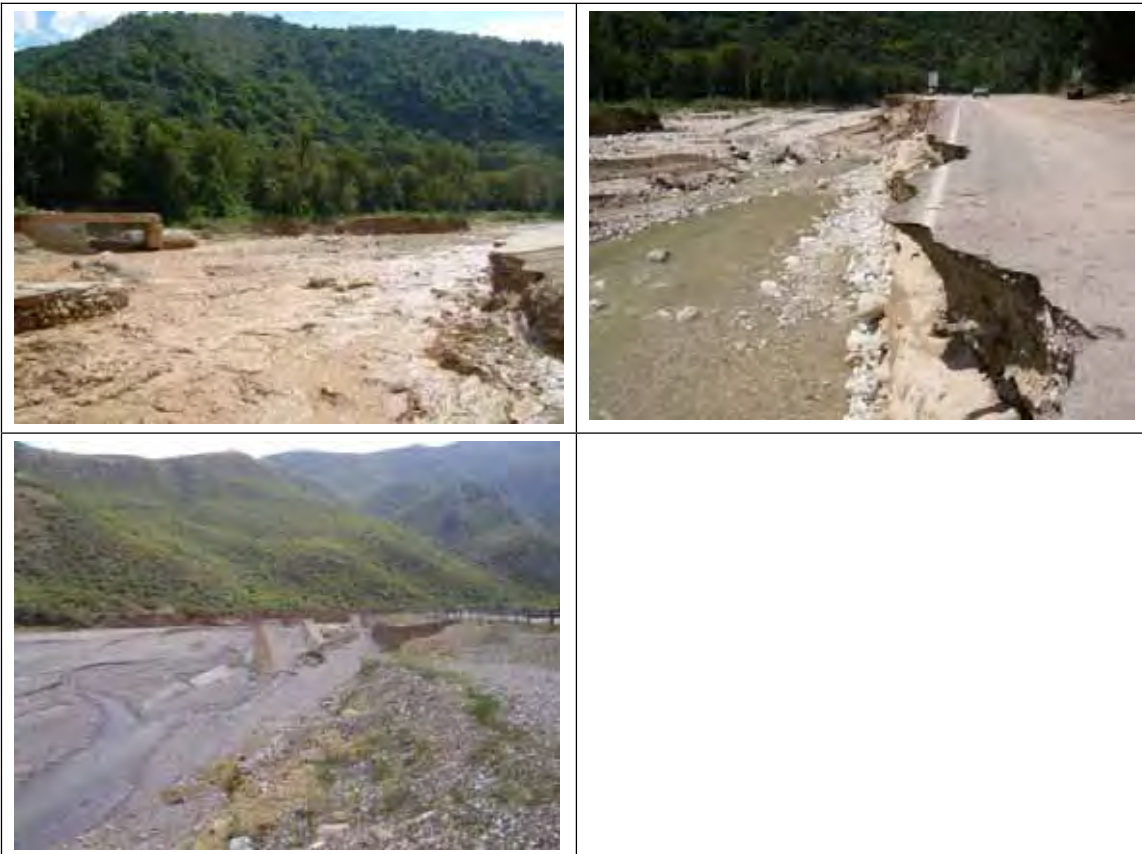
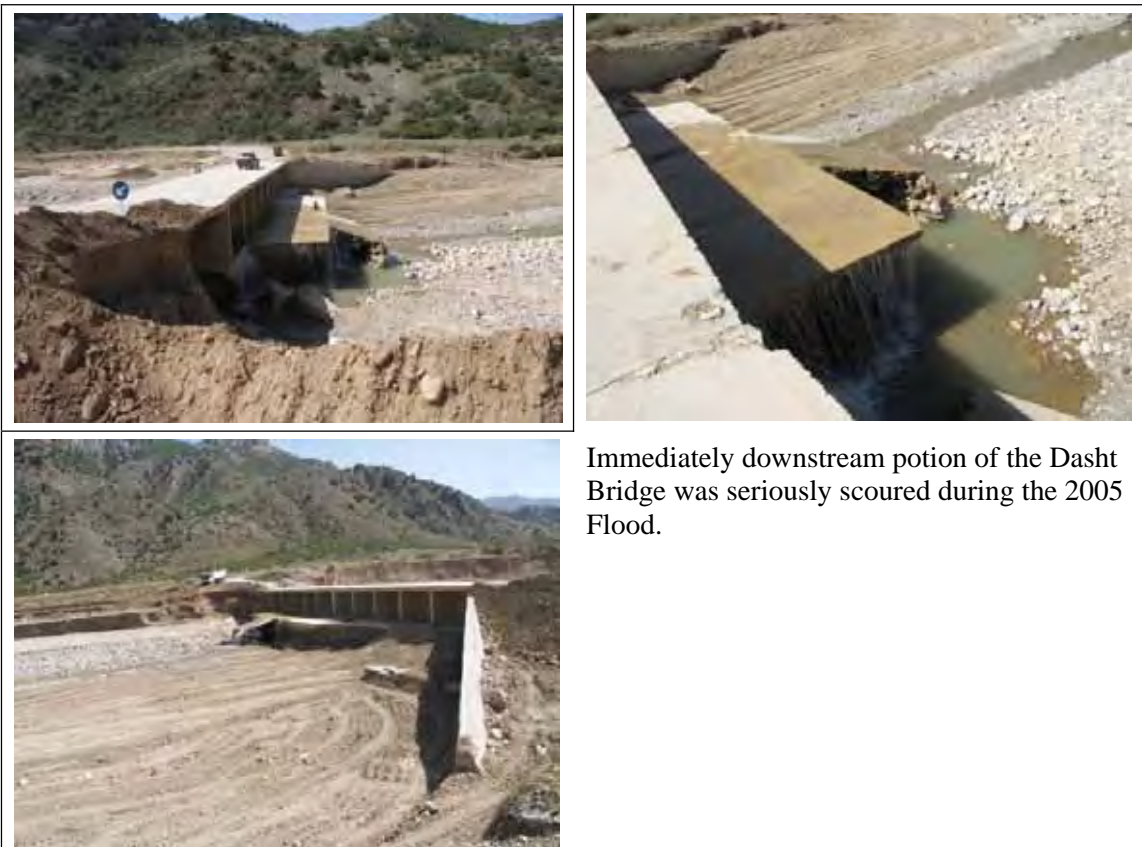
### Golestan Forest

In the Golestan Forest, the 2005 Flood destroyed the infrastructures of temporary bridges, road and flood retaining walls, which were restored after the 2001 Flood.

Dasht Bridge and Valley-Head Erosion

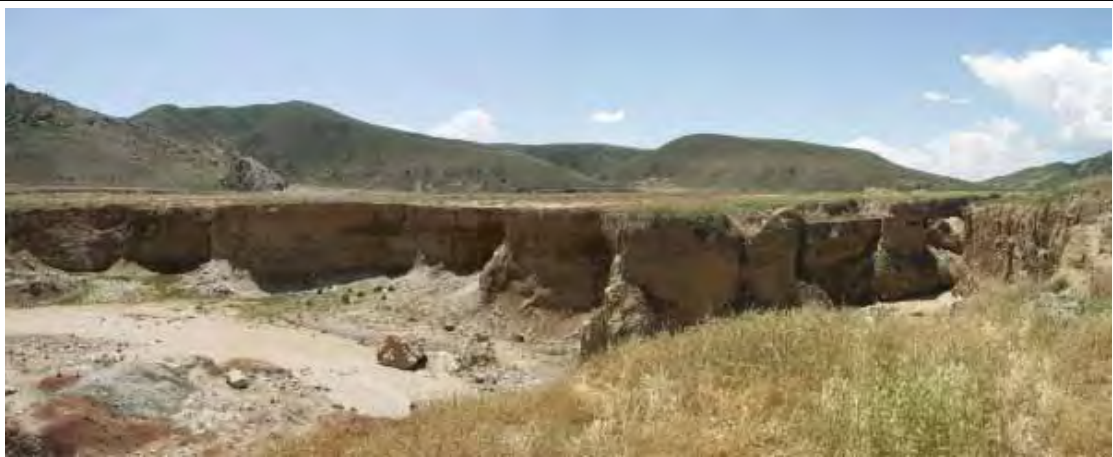
Before the 2005 Flood

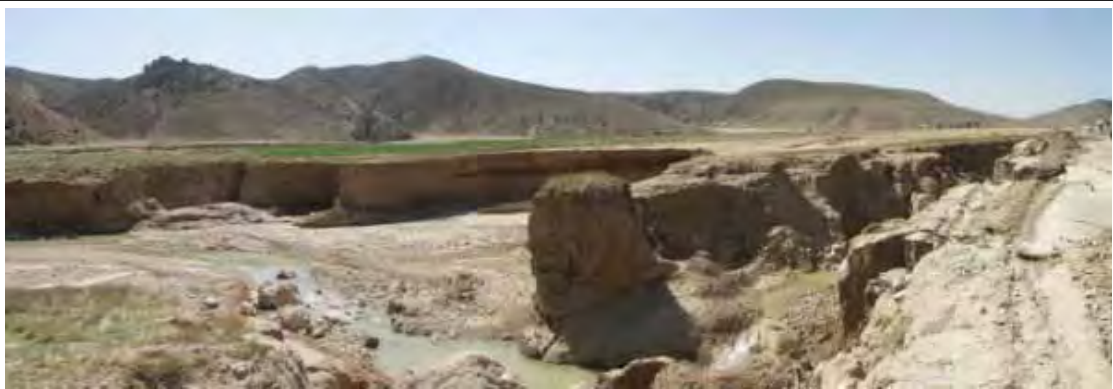
After the 2005 Flood. Erosion was progressed upwards in 30 to 50 m by the 2005 Flood.
