CHAPTER 6

DAMAGE ESTIMATION

6-1 Damage to Buildings

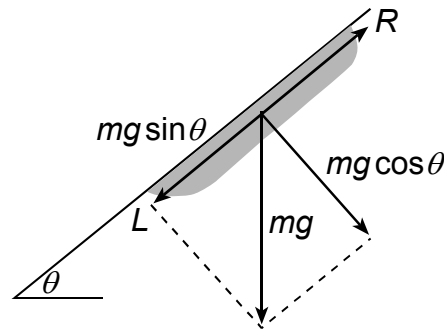
Wilson et al. (1979) assumed that in a thin layer, as shown in Figure 5-28, sliding occurs due to inertial loading. Equating sliding and resisting forces gives:

Figure 5-28 Model of Potential Landslide Mass (Tanaka, 1982)

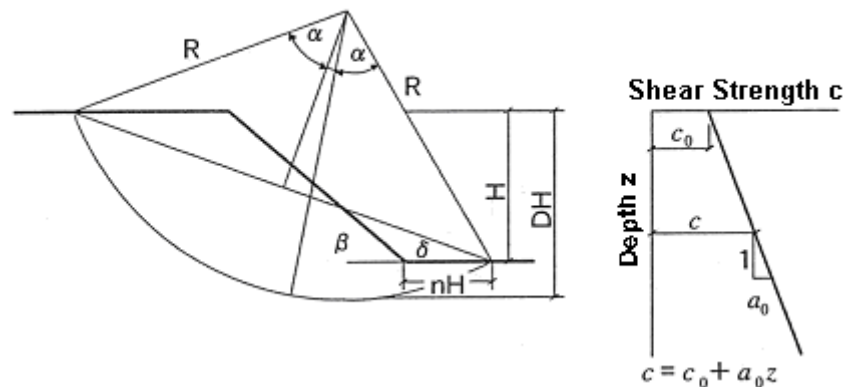
Ansal and Siyahi (1994) developed a zoning method for slope instability by modifying a method proposed by Koppula (1984). The method originally proposed was a pseudo-static evaluation of slope stability utilizing a seismic coefficient A to account for the earthquake induced horizontal forces. The variation in shear strength with depth is assumed to be linear and the potential failure surface is taken as a circular arc as shown in Figure 5-29.

Figure 5-29 Typical Section of Slope (Koppula, 1984)

Parameters α , β , δ , and n are related to the geometry of the slope and the configuration of the sliding surface. As given below, the safety factor, F_s , can be defined as :

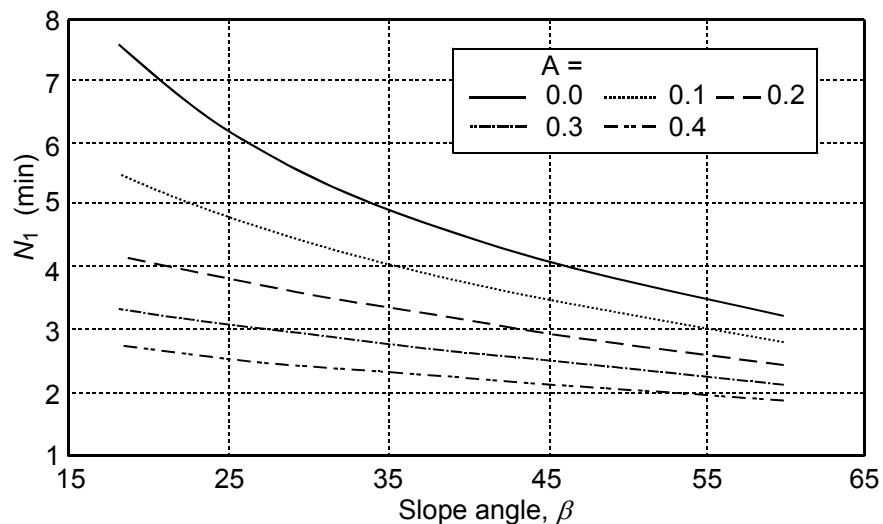
Thus, the safety factor depends on the angle of shear strength and stability number, N_1 representing the configuration of the slope and failure surface. The minimum values of the stability number are determined by carrying out a parametric study in terms of α , δ and n to find the most critical failure surface as given in Figure 5-30. The variation of minimum N_1 can be expressed as a function of β (slope angle) and A (earthquake acceleration). It becomes possible at this stage to calculate the minimum safety factor F_s using Figure 5-30 if ϕ (shear strength angle) can be determined or estimated.

Figure 5-30 Variation of N_1 (min) (Ansal and Siyahi, 1994)

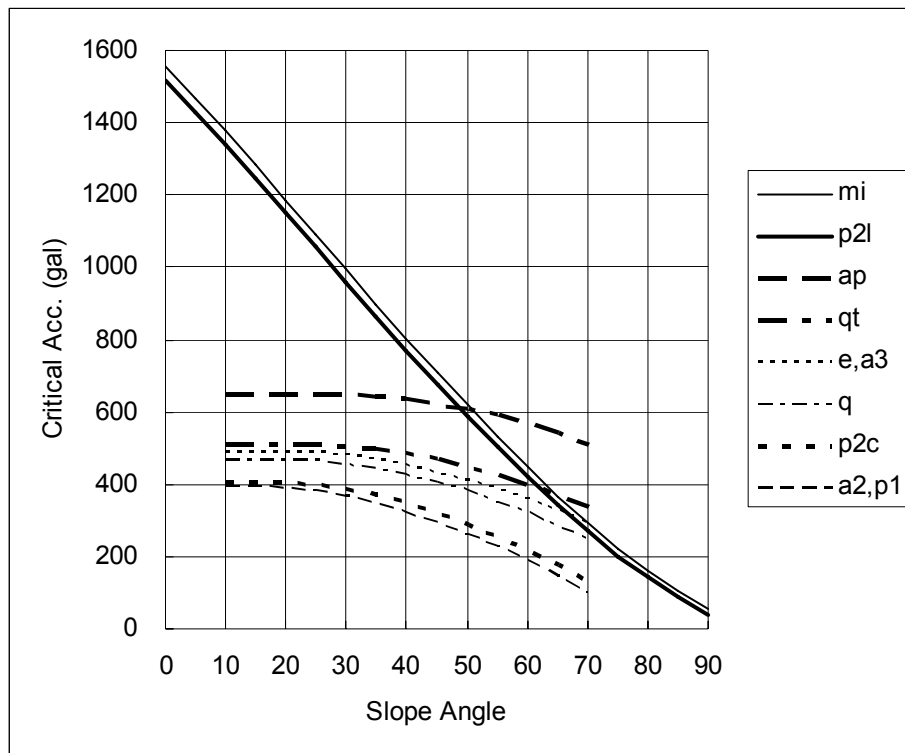
Figure 5-31 Relationship between Slope Angle and Critical Acceleration

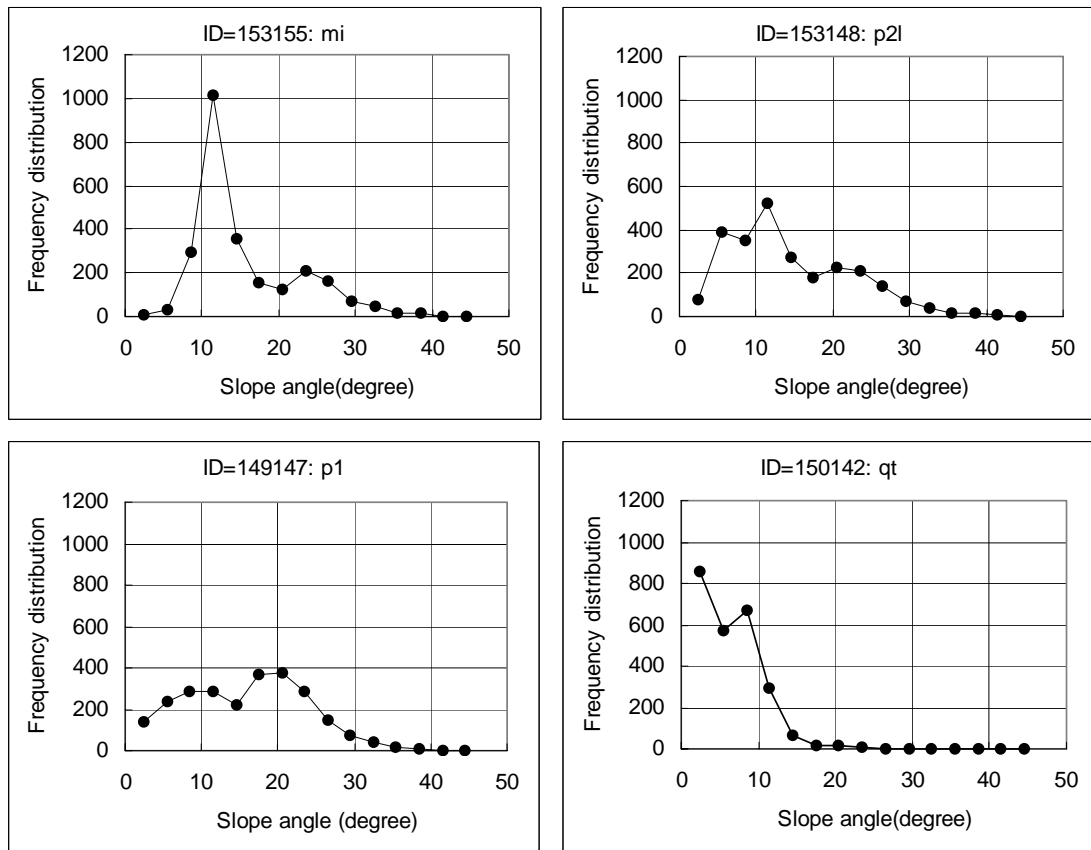
There are 2,500 DEM data points in one 250 m grid section, therefore 2,500 slope angles are calculated in each grid section. The frequency distribution of 5 m pitch slope angle in each 250 m grid section was analysed. Figure 5-34 shows the example of grids in BOUZAREAH.

Figure 5-34 Example of the Frequency Distribution of Slope Angle in the Grid

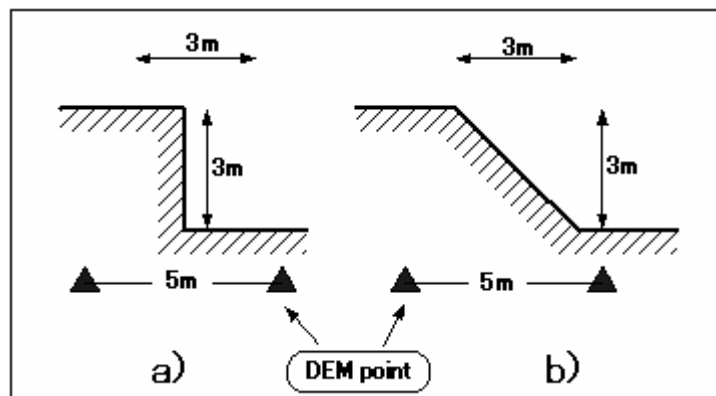
In using the DEM data for slope analysis, the limitation of accuracy based on the sampling interval should be considered. For example, the slope angle of a) (90 degrees) and b) (45 degrees) in Figure 5-35 are not the same; however if the interval of the DEM is larger than 3 m, the elevation in the DEM may be identical for a) and b). The difference between actual slope angle and calculated slope angle from the DEM increases as it becomes steeper. Slope correction was carried out based on the properties of 5 m interval DEM data.

Figure 5-35 Actual Slope and DEM Data

Height of Slope (m)	Width of Slope (m)		Slope Angle (degrees)		Remarks
	Actual Condition	in 5 m DEM	Actual Condition	in 5 m DEM	
3	0	5	90.0	31.0	a) in Figure 5-35
	1		71.6		
	2		56.3		
	3		45.0		b) in Figure 5-35
	4		36.9		
	5		31.0		
	6	10	26.6	16.7	
	7	23.2

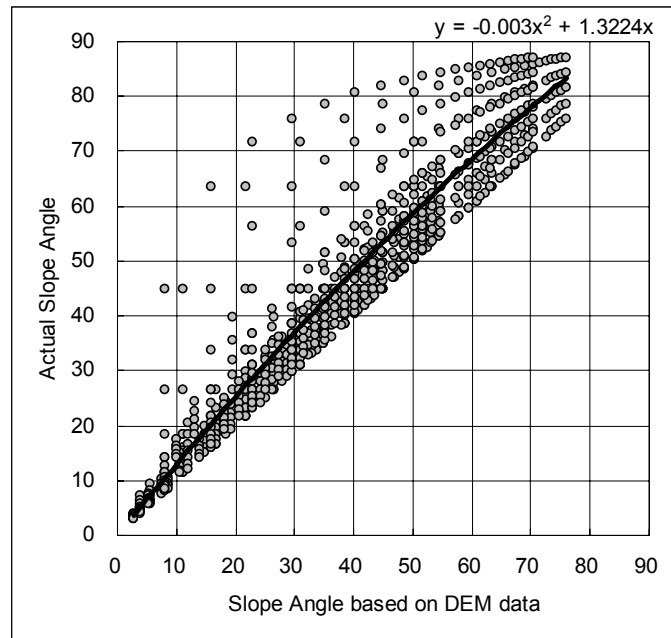
Table 5-9 shows an example of slope angle correction. If the height of the slope is 3 m and the width is 3 m, the actual slope angle is 45.0 degrees; however the slope angle calculated using a DEM with 5m interval shows 31.0 degrees because the minimum width of the DEM is 5 m. The numerical parameter study was conducted for many slopes with various heights and widths and the relationship between actual slope angle and slope angle based on the DEM was studied. Based on this study, a correction formula was developed as shown in Figure 5-36.

Figure 5-36 Correction Formula for Slope Angle

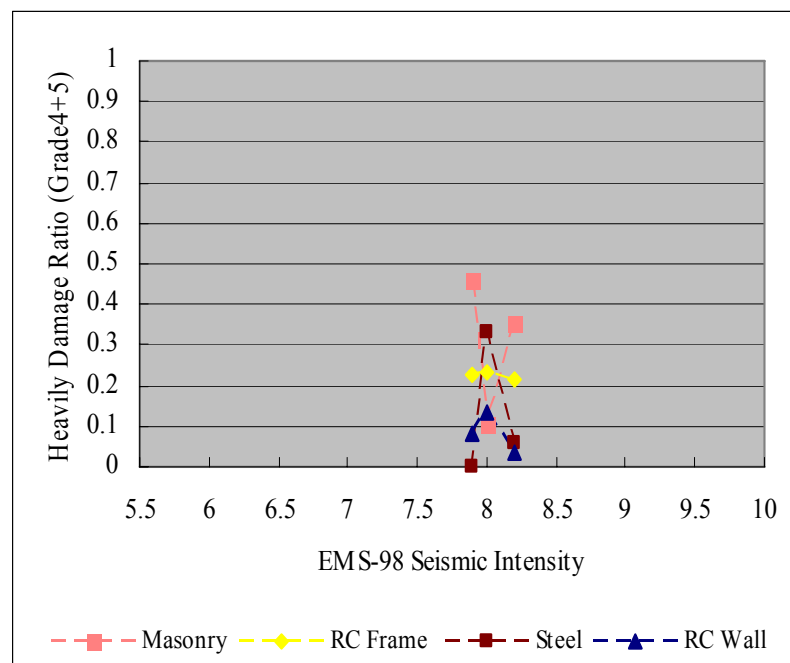
These communes are located on the east side of Wilaya Algiers, estimated EMS (formerly MSK) seismic intensity during the 2003 Boumerdes earthquake was around 8, and there was no clear difference among the three communes. As a result, it was not possible to produce a damage function for buildings from the damage survey data as shown in Figure 6-3.

Figure 6-3 Surveyed Damage Ratio for Four Structural Types and Estimated Seismic Intensity for Three Communes in the Study Area caused by the 2003 Boumerdes Earthquake

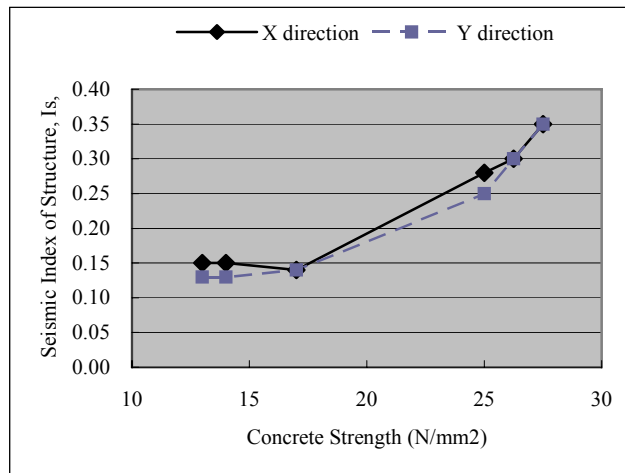
The Seismic Index of Structure, I_s , was shown for various concrete strengths. Concrete strength of 25 N/mm² was required by the standard, but concrete strength of 14 to 17 N/mm² was found in core samples of heavily damaged buildings after the 2003 Boumerdes earthquake, according to the CGS’s preliminary report. From this figure, I_s , 0.28 which was the value for concrete strengths satisfying the standard, was estimated as a typical value and a peak value of a distribution of ‘Pre-code’ RC frame structures as shown.

Figure 6-4 Seismic Index of Structure, Is, and Concrete Strength

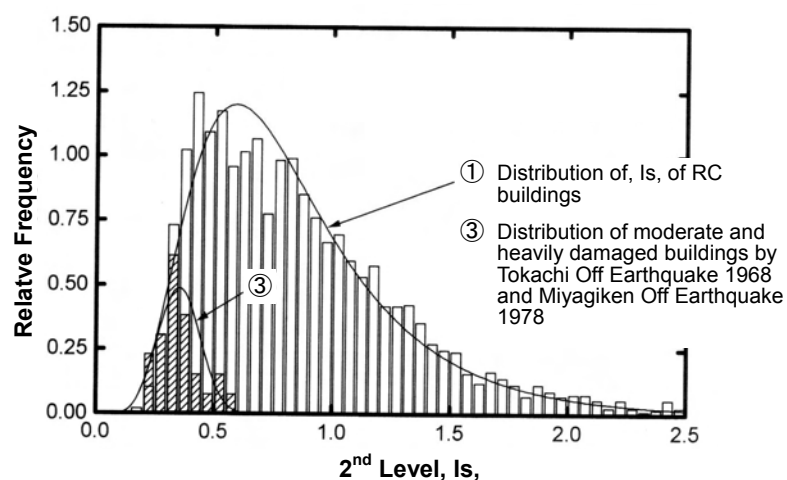
The distribution of Seismic Index of Structure, Is, of reinforced concrete buildings in Shizuoka prefecture in Japan is shown in ① of Figure 6-5 (Reference 1). The distribution of Is for moderate and heavily damaged buildings following two earthquakes is shown in ③ of the same Figure;

- (A) Distribution of the Seismic Index of Structure, Is, is approximated by a normal logarithmic distribution. (Note; as shown later, the distribution of the Seismic Index of Structure, Is, was simplified and approximated by a modified normal distribution)
- (B) Buildings with lower Is values are easily damaged and buildings with higher Is values are more difficult to damage, subject to seismic intensity.

Figure 6-5 Distribution of Seismic Index of Structure, Is, and Earthquake Damage

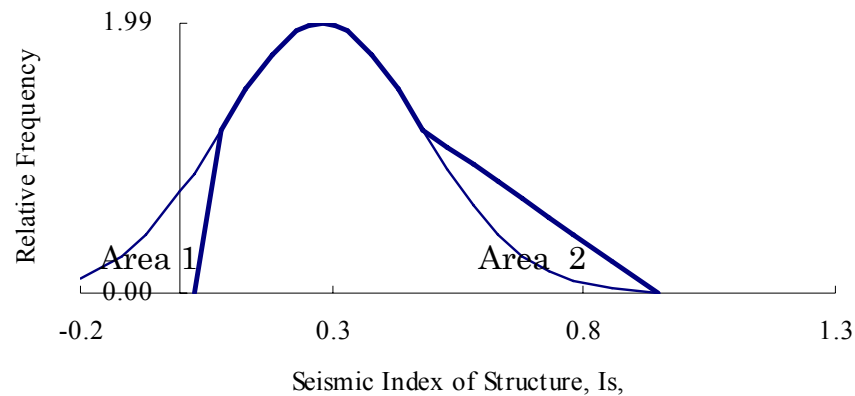
Normal distribution with a peak I_s of 0.28 and deviation of 0.20 is assumed. The distribution curve is modified with linear lines for both sides so that area 1 and area 2 are the same. The area of the modified distribution is also 1.0 (see Appendix 1, 'Deviation and Damage Function').

Figure 6-6 Distribution of Seismic Index of Structure, I_s , for Pre-code RC Frame Structures

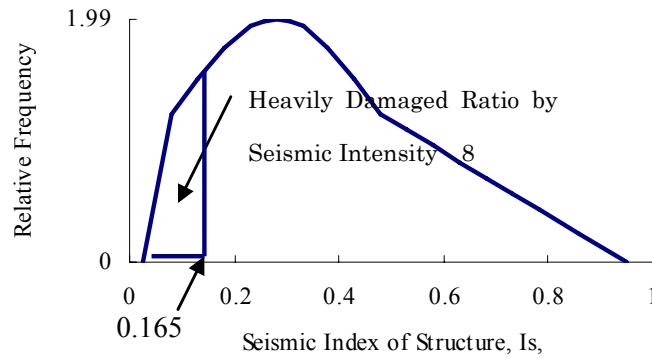
The area under the curve for the values of I_s equal to and below 0.165 was found to represent the heavily damaged ratio, 0.137, which is an average of the 'Pre-code (0.157)' and 'Low-code (0.117)' values, and this was equal to 62% of the surveyed damage ratio, as shown in Table 6-4. This assumed that the number of 'Pre-code' and 'Low-code' buildings was similar to those found in the building inventory survey. A simplified vertical I_s value line was used as a boundary line for the estimation.

Figure 6-7 Heavily Damaged Ratio shown by the Area of Distribution of I_s

The area under the curve for I_s values equal to and below 0.165 (I_s boundary value is 0.165) is 0.157 which is the damage ratio produced by EMS intensity 8 for Pre-code (Non-engineered) Reinforced Concrete Frame Buildings.

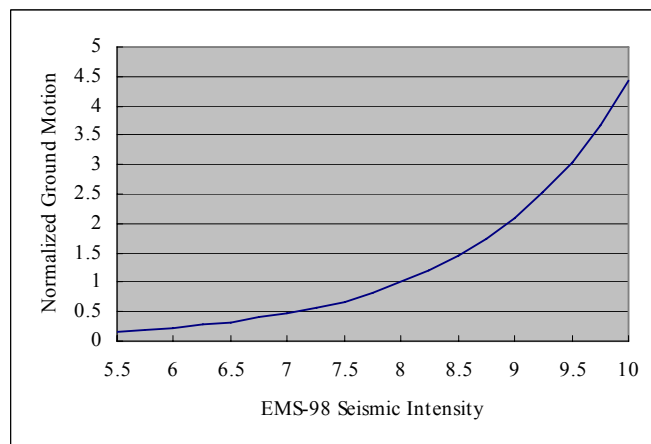
For other seismic intensities, seismic motion intensity 7 is 0.48 times of that of intensity 8. Seismic motion of intensity 9 is 2.1 times of that of intensity 8. Intensity 10 is 4.4 times of that of intensity 8 as shown in Figure 5-24, "Empirical Relation between PGA and Seismic Intensity in MSK (currently EMS) Scale" in Chapter 5.

Figure 6-8 Normalized Ground Motion and Seismic Intensity (Normalized for Seismic Intensity 8)

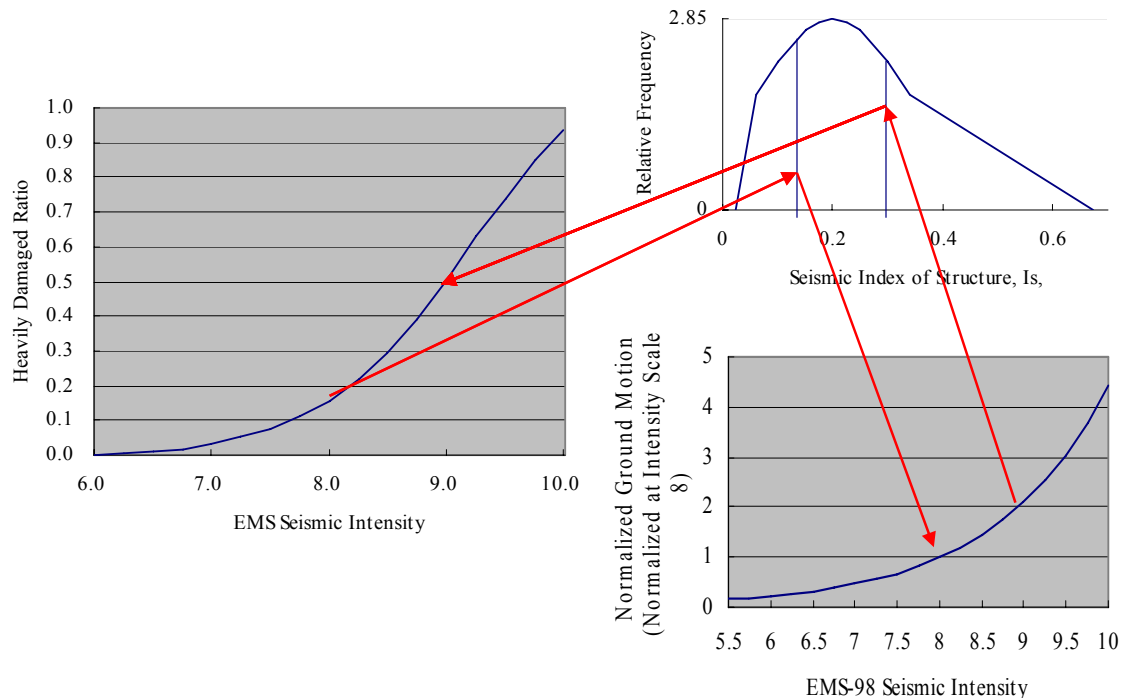
A similar calculation was done for the area of the distribution of I_s and normalized seismic intensity and thus, a 'Damage Function' for Pre-Code RC Frame structures was obtained.

Figure 6-9 Seismic Index of Structure, Seismic Intensity and Heavily Damaged Ratio

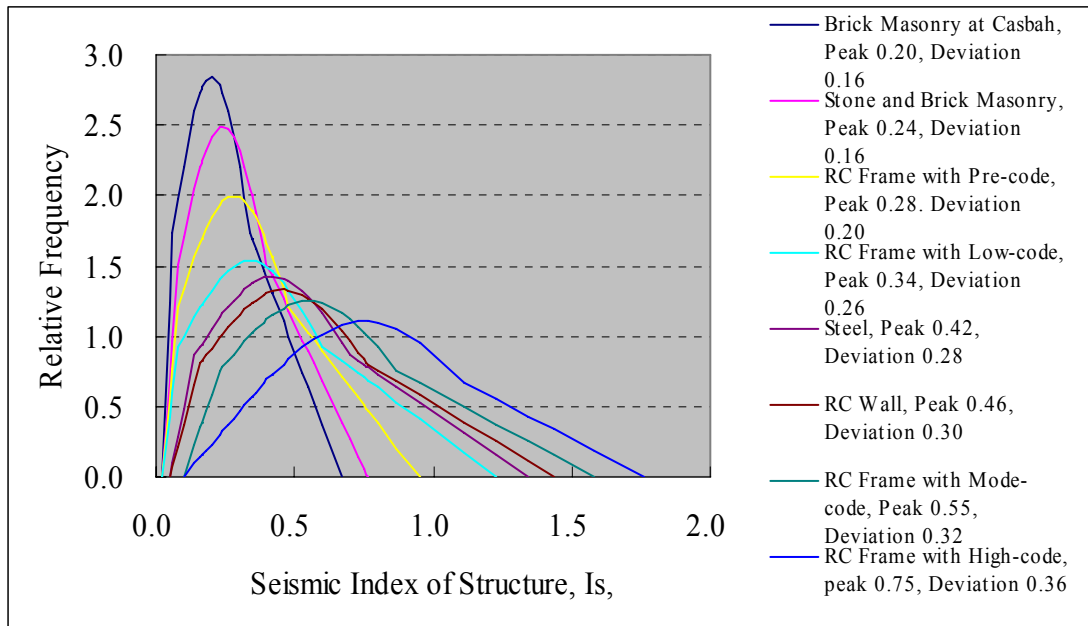
Figure 6-10 Supposed Distribution of Seismic Index of Structure, I_s , for each Structural Type

The surveyed damage ratio of the 2003 Boumerdes earthquake was utilized. A reduced seismic intensity 8.0 damage ratio was used. But the reduction ratio was not large, since the surveyed damage ratio of masonry structures at the commune Bordj El Bahri was only 10% and this was exceptionally low, because of the existence of good quality one storey masonry houses according to CGS. This was combined with the Seismic Index of Structure, I_s , distribution. The distribution of these structural types was extracted based on an analogy of RC frame structures so that the damage ratio at intensity 8 is the area under the curve for I_s values equal to and smaller than 0.165. Refer to Figure 6-10 "Supposed Distribution of Seismic Index of Structure, I_s , for each Structural Type".

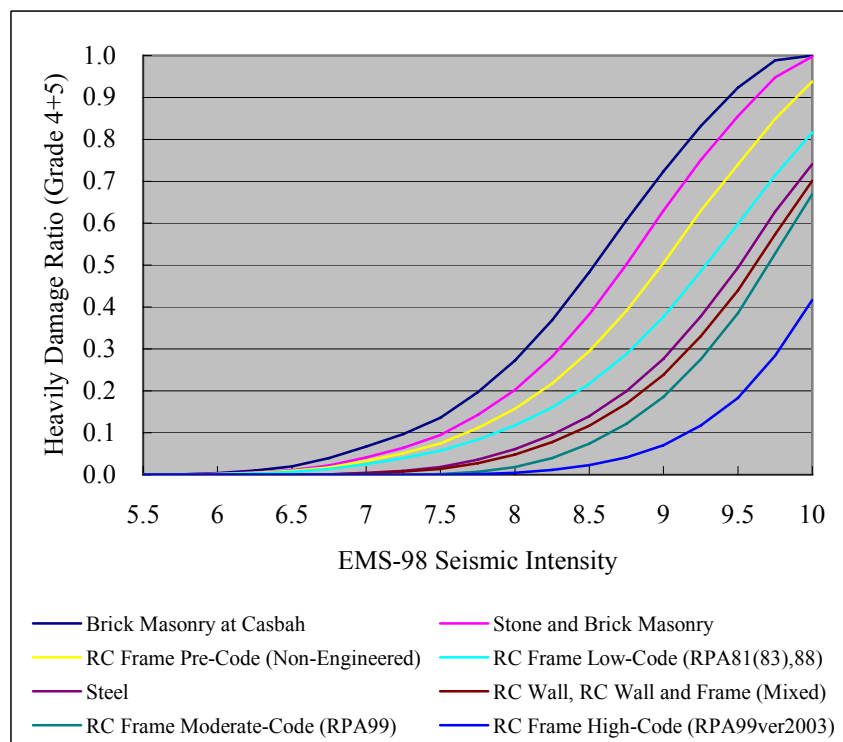
Similar estimations were done with respect to all eight structural types and the ‘Damage Function’ was obtained as follows;

Figure 6-11 Building Damage Function

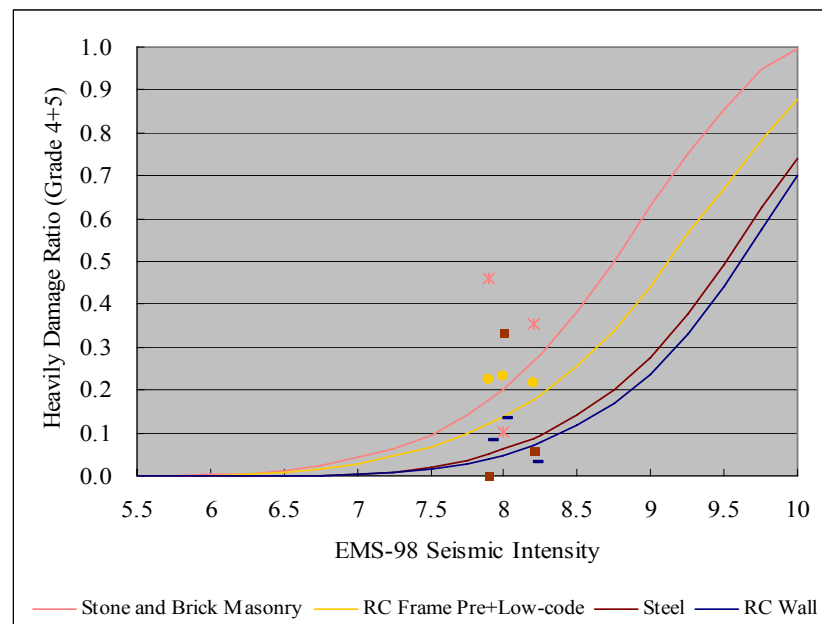
Damage functions were provided based on the surveyed damage ratios caused by the 2003 Boumerdes Earthquake for areas subject to seismic intensity 8. However, these damage ratios were reduced somewhat as indicated by engineering judgment as has been previously described. Analysis shows that average seismic intensity for each of the three communes was 7.9, 8.0 and 8.2 during that quake. Surveyed damage ratio and damage function for 'Stone and Brick Masonry', 'RC Frame Pre & Low-Code', and 'Steel' and 'RC Wall' are shown in Figure 6-12 for comparison.

Figure 6-12 Surveyed Damage Ratio caused by the 2003 Boumerdes Earthquake and Damage Function for Four Structural Types

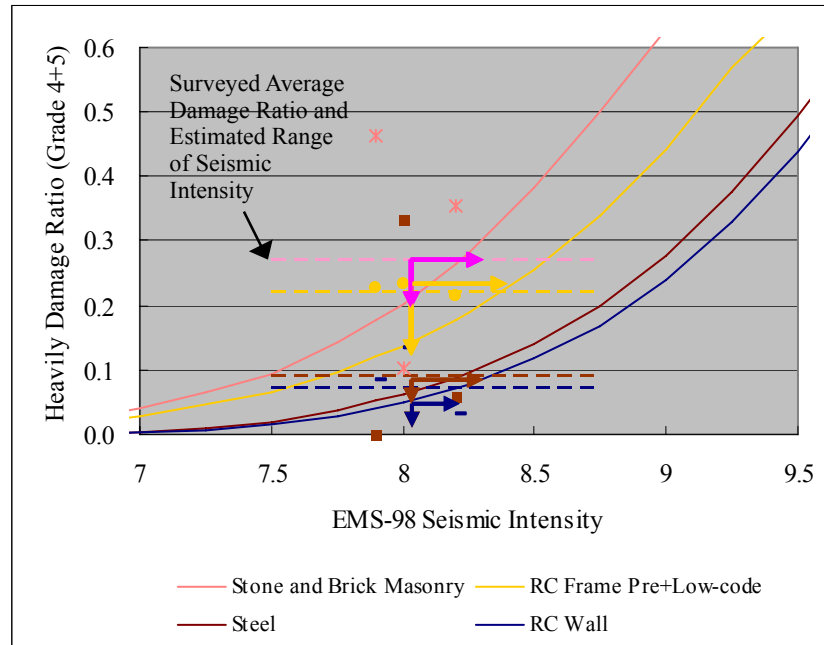
The average damage ratios estimated by the ‘Damage Function’ for grade 4 and grade 5 damage that would be caused throughout the study area of Wilaya Algiers was 28.9 % for seismic intensity EMS 8.5 and 49.4 % for EMS 9.0.

Figure 6-13 Surveyed Average Damage Ratios, Estimated Range of Seismic Intensity during the Boumerdes Earthquake and Damage Function

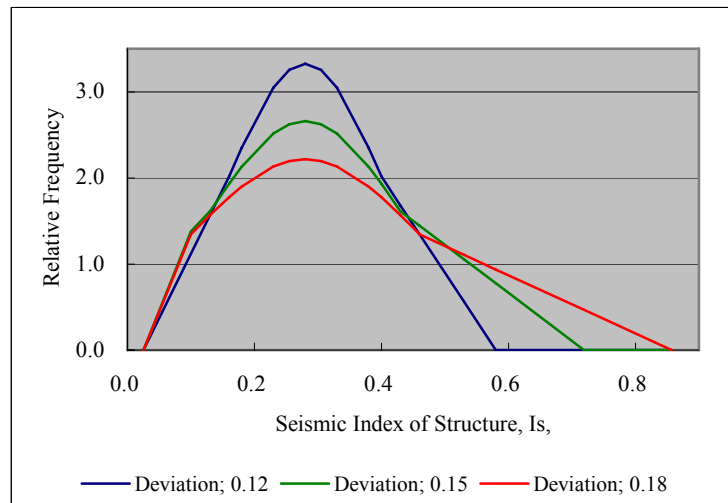
The following relative frequency distributions of structural seismic index for three different deviations (0.12, 0.15, and 0.18) show that the most frequent seismic index, Is, value is 0.28, and all three distributions have a zero frequency at an Is value of 0.025. As the size of the deviation increases, there is a relatively greater frequency of higher values of Is.

Figure 6-A1 Distribution of Seismic Index of Structure, Is, and Deviation

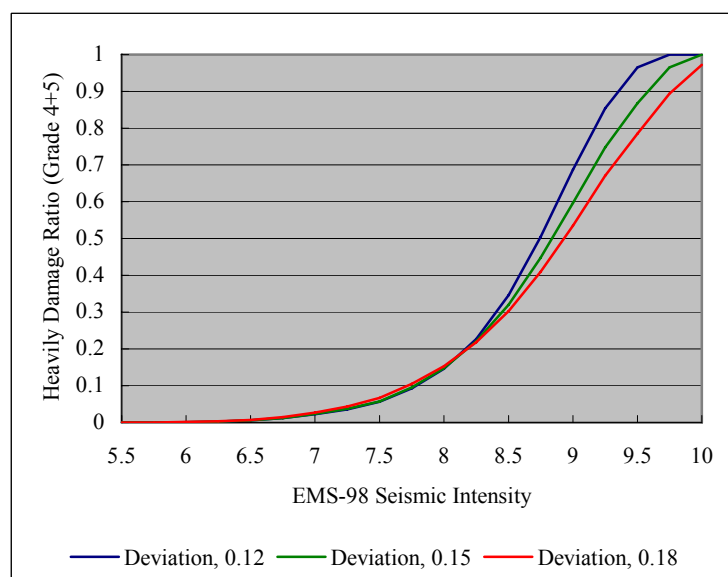
A Heavily Damaged Ratio distribution as produced by the Damage Function for an Is value of 0.28 for deviations of 0.12, 0.15 and 0.18 is shown;

Figure 6-A2 Damage Function for Different Deviation with Same, Is, of Peak Value of Distribution

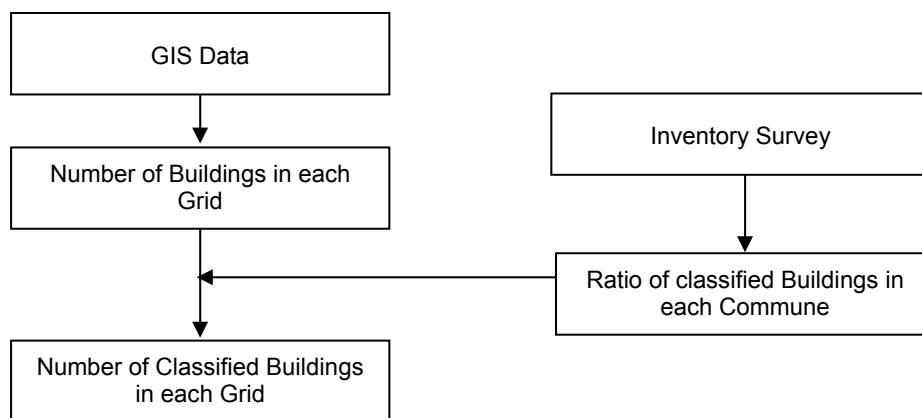
Figure 6-14 Flowchart of building inventory distribution

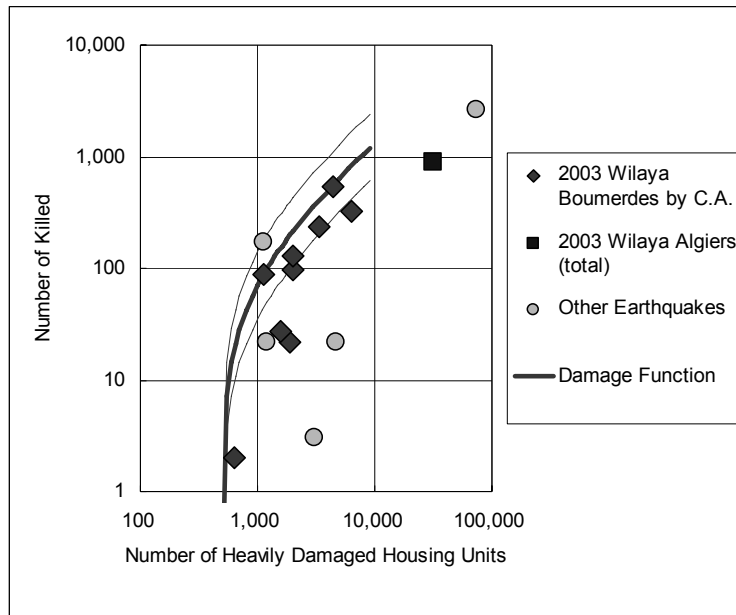
Figure 6-19 Damage Function to Estimate the Number Killed

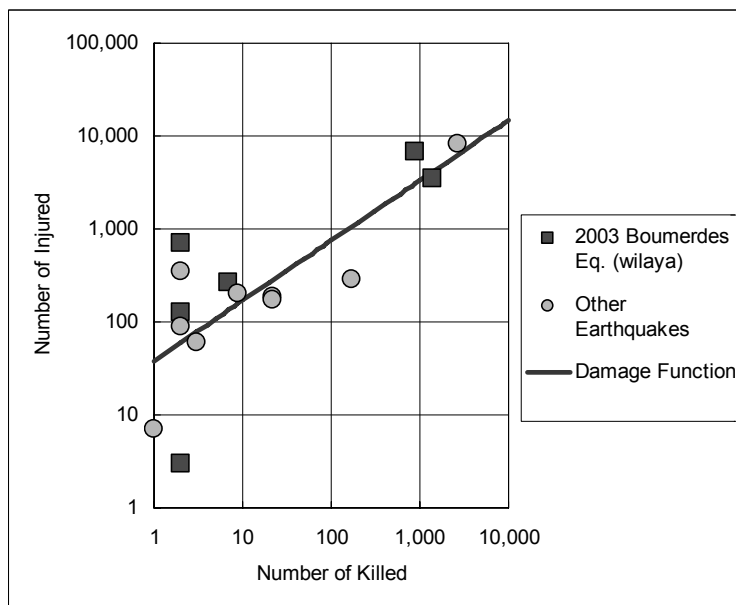
Figure 6-20 Damage Function to Estimate the Number of Injured

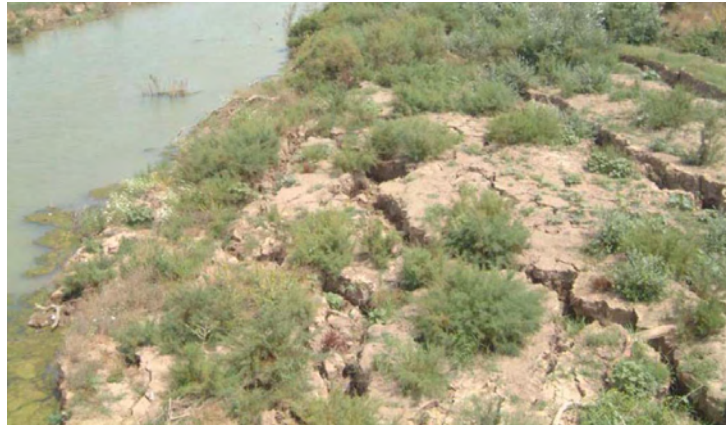
Figure 6-24 Lateral Ground Movement at a Pier of SEBAO Bridge

Liquefaction occurred at the Boumerdes Earthquake as shown in Figure 6-24. Lateral movement / displacement at the ground surface appeared in many places around the bridge, thus the liquefaction potential index (P_L) is estimated as more than 15.

The report of the actual damage to the SEBAO bridge showed that some girders were displaced due to movement of some piers of around 50 cm or less (refer to Figure 6-25), however, the girders did fall off. If no prevention system or less seat width was applied and / or a much more intense earthquake occurred, the girders might have fallen down.

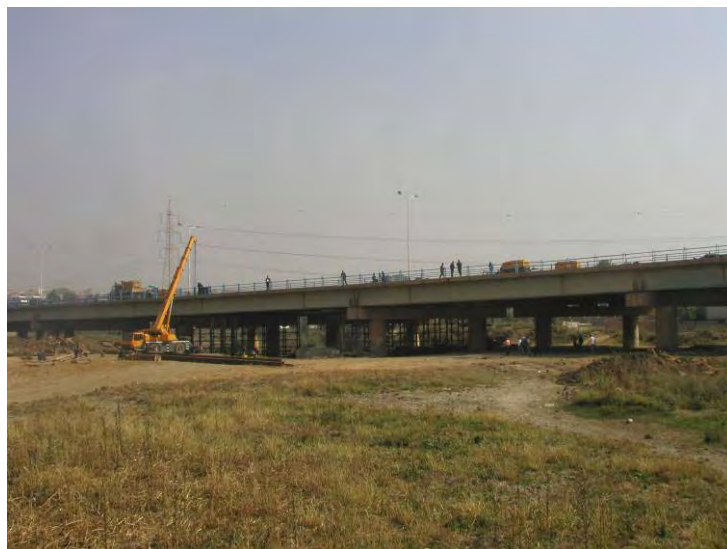
Figure 6-26 View of EL HARRACH Bridge

Structures of the EL HARRACH Bridge (refer to Figure 6-26) and the score in relation to them are shown in Table 6-15.

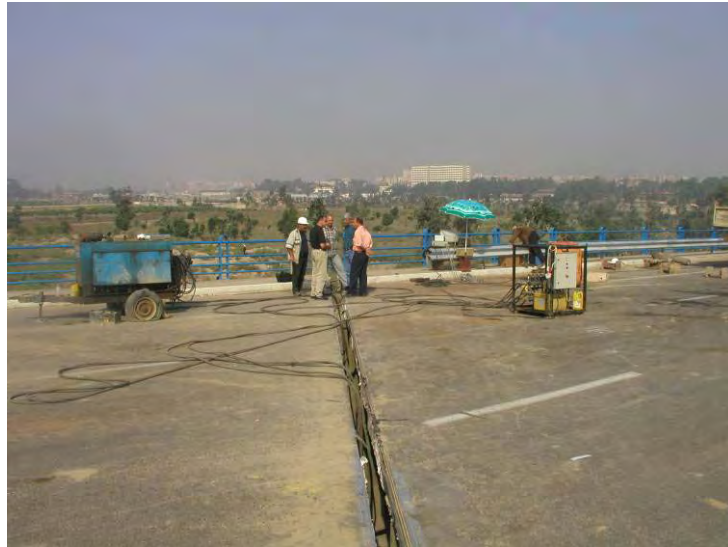
The report of the actual damage to the EL HARRACH Bridge showed that some girders were slightly displaced and cracks generated (refer to Figure 6-27), however, the girders did not fall off.

Figure 6-27 Displacement of a Girder of EL HARRACH Bridge

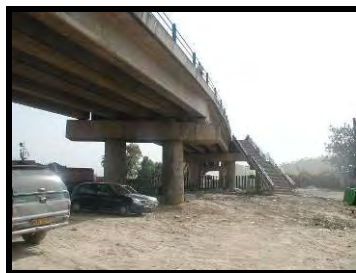
[Photograph of Class “A” Bridges]

Bridge Code	Khair al Din		Zemmouri	
	Total Score	Class	Total Score	Class
16130310	40	A	40	A
16290103	34	A	30	A
16130213	33	A	33	A
16170117	29	B	23	B
16010411	27	B	(< 22)	(C)
16290101	27	B	24	B
16290102	27	B	24	B
16300301	27	B	45	A
16020402	23	B	(< 22)	(C)
16020403	23	B	(< 22)	(C)
16020404	23	B	(< 22)	(C)
16170102	23	B	(< 22)	(C)
16170103	23	B	(< 22)	(C)
16170106	23	B	(< 22)	(C)
16170108	23	B	(< 22)	(C)
16170111	23	B	(< 22)	(C)
16170112	23	B	(< 22)	(C)
16170113	23	B	(< 22)	(C)
16260402	23	B	(< 22)	(C)
16130207	22	B	22	B
16130208	22	B	22	B
16160202	22	B	22	B
16200212	(< 22)	(C)	24	B

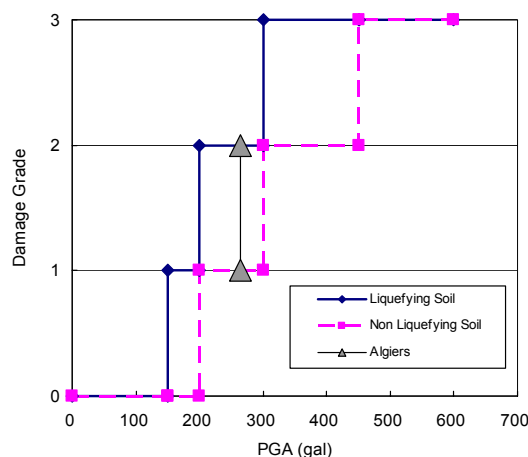
The above mentioned damage is judged as damage grade 1 (slight damage) to 2 (moderate damage) under the occurrence of liquefaction. And the peak ground acceleration near the Algiers Port was around 265 gal according to information from the counterpart. These pieces of information / data are plotted as shown in Figure 6-32.

Figure 6-32 Verification of the Damage Function for the Port
