CHAPTER 6

INITIAL STUDY ON BRIDGE LOCATION

AND ROUTE ALIGNMENT

6.1 Identification of Bridge Location and Route Alternatives

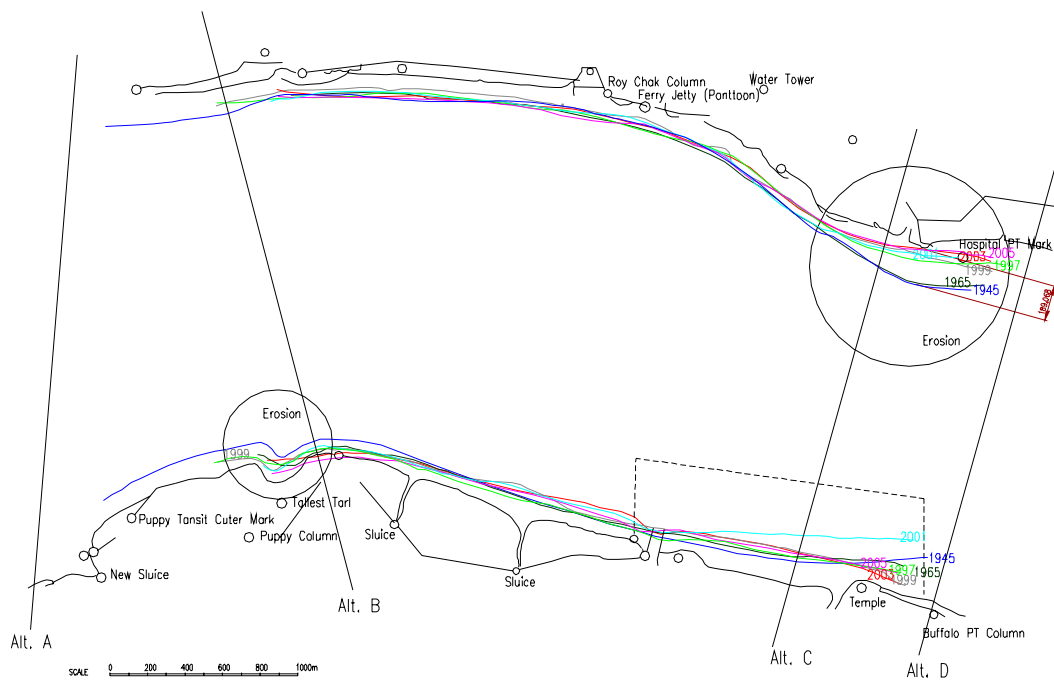
Figure 6.2.1 Chronological Waterside Line from 1945 to 2005

Charts around the alternative sites are collected from 1945 to 2006. **Figure 6.2.1** and **Figure 6.2.2** show 10m depth contour line and waterside line, respectively.

Movement of the waterside line is not significant except around Hospital PT Mark. The waterside line around the Hospital PT Mark has moved out about 190 m during 60 years.

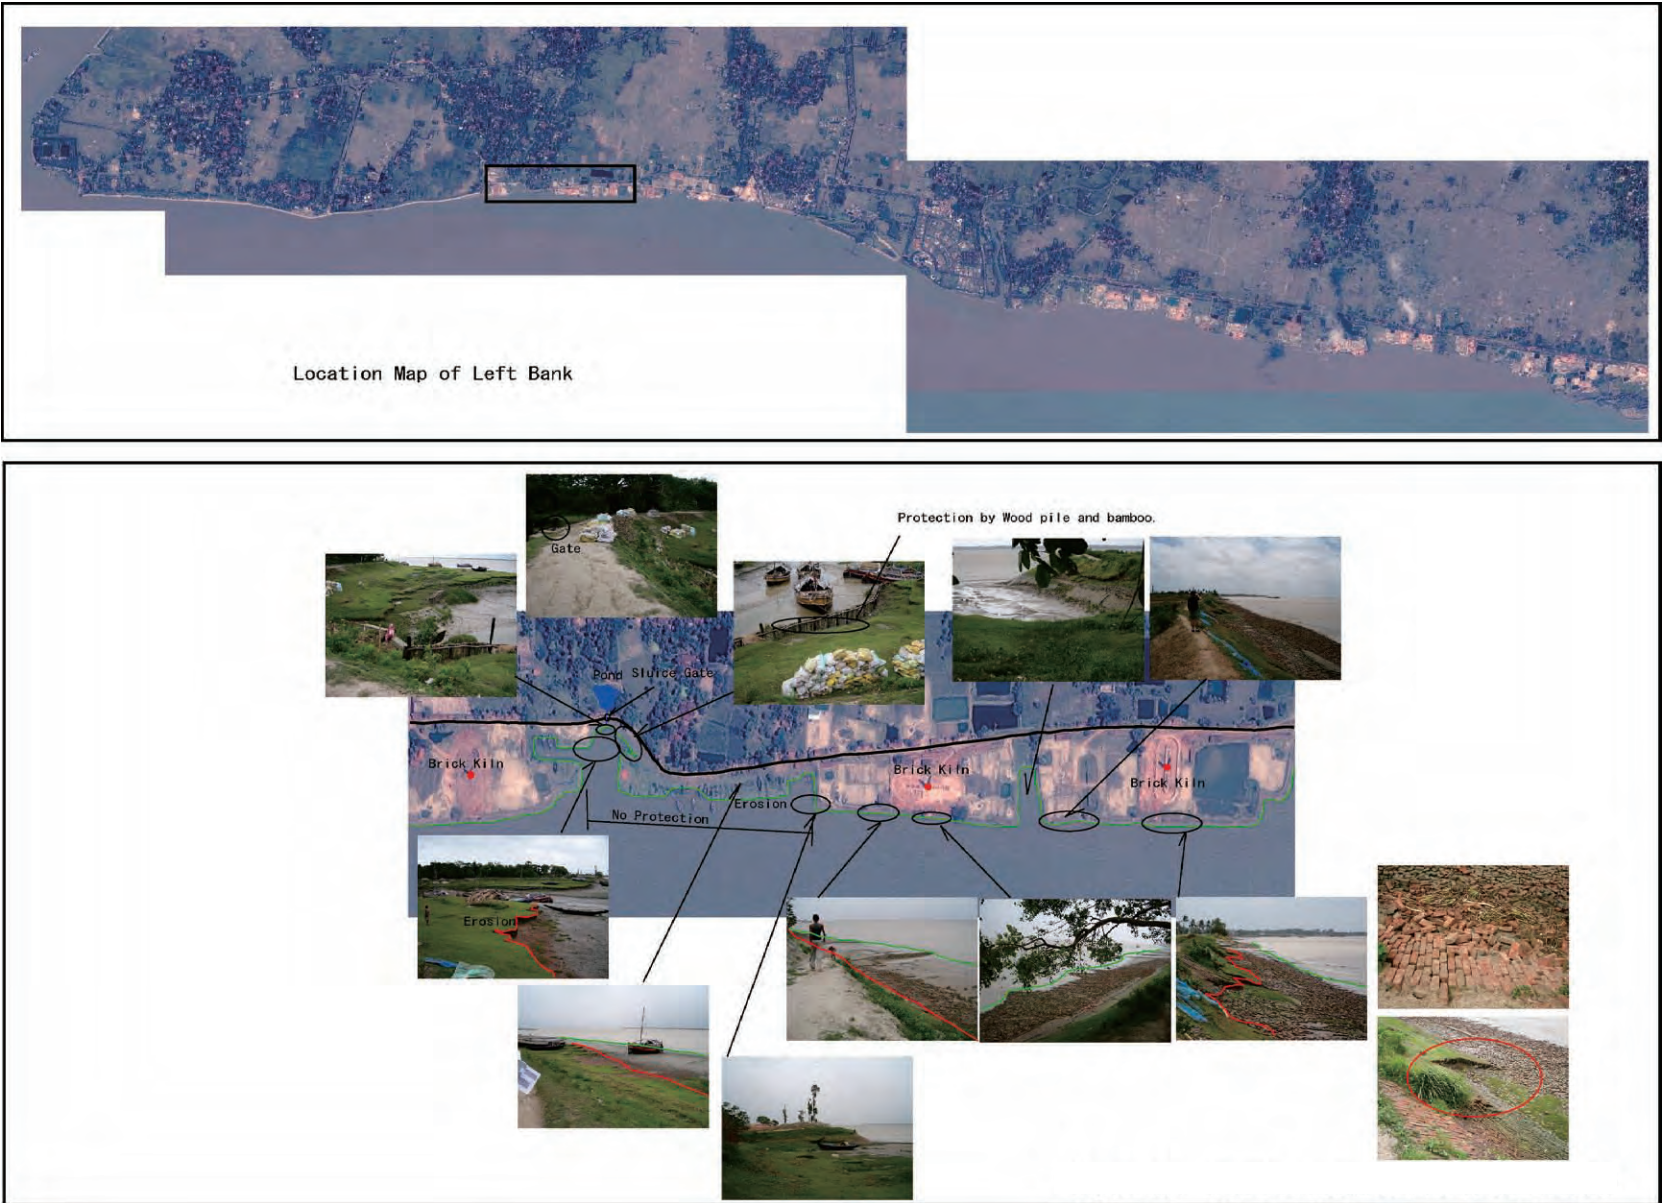
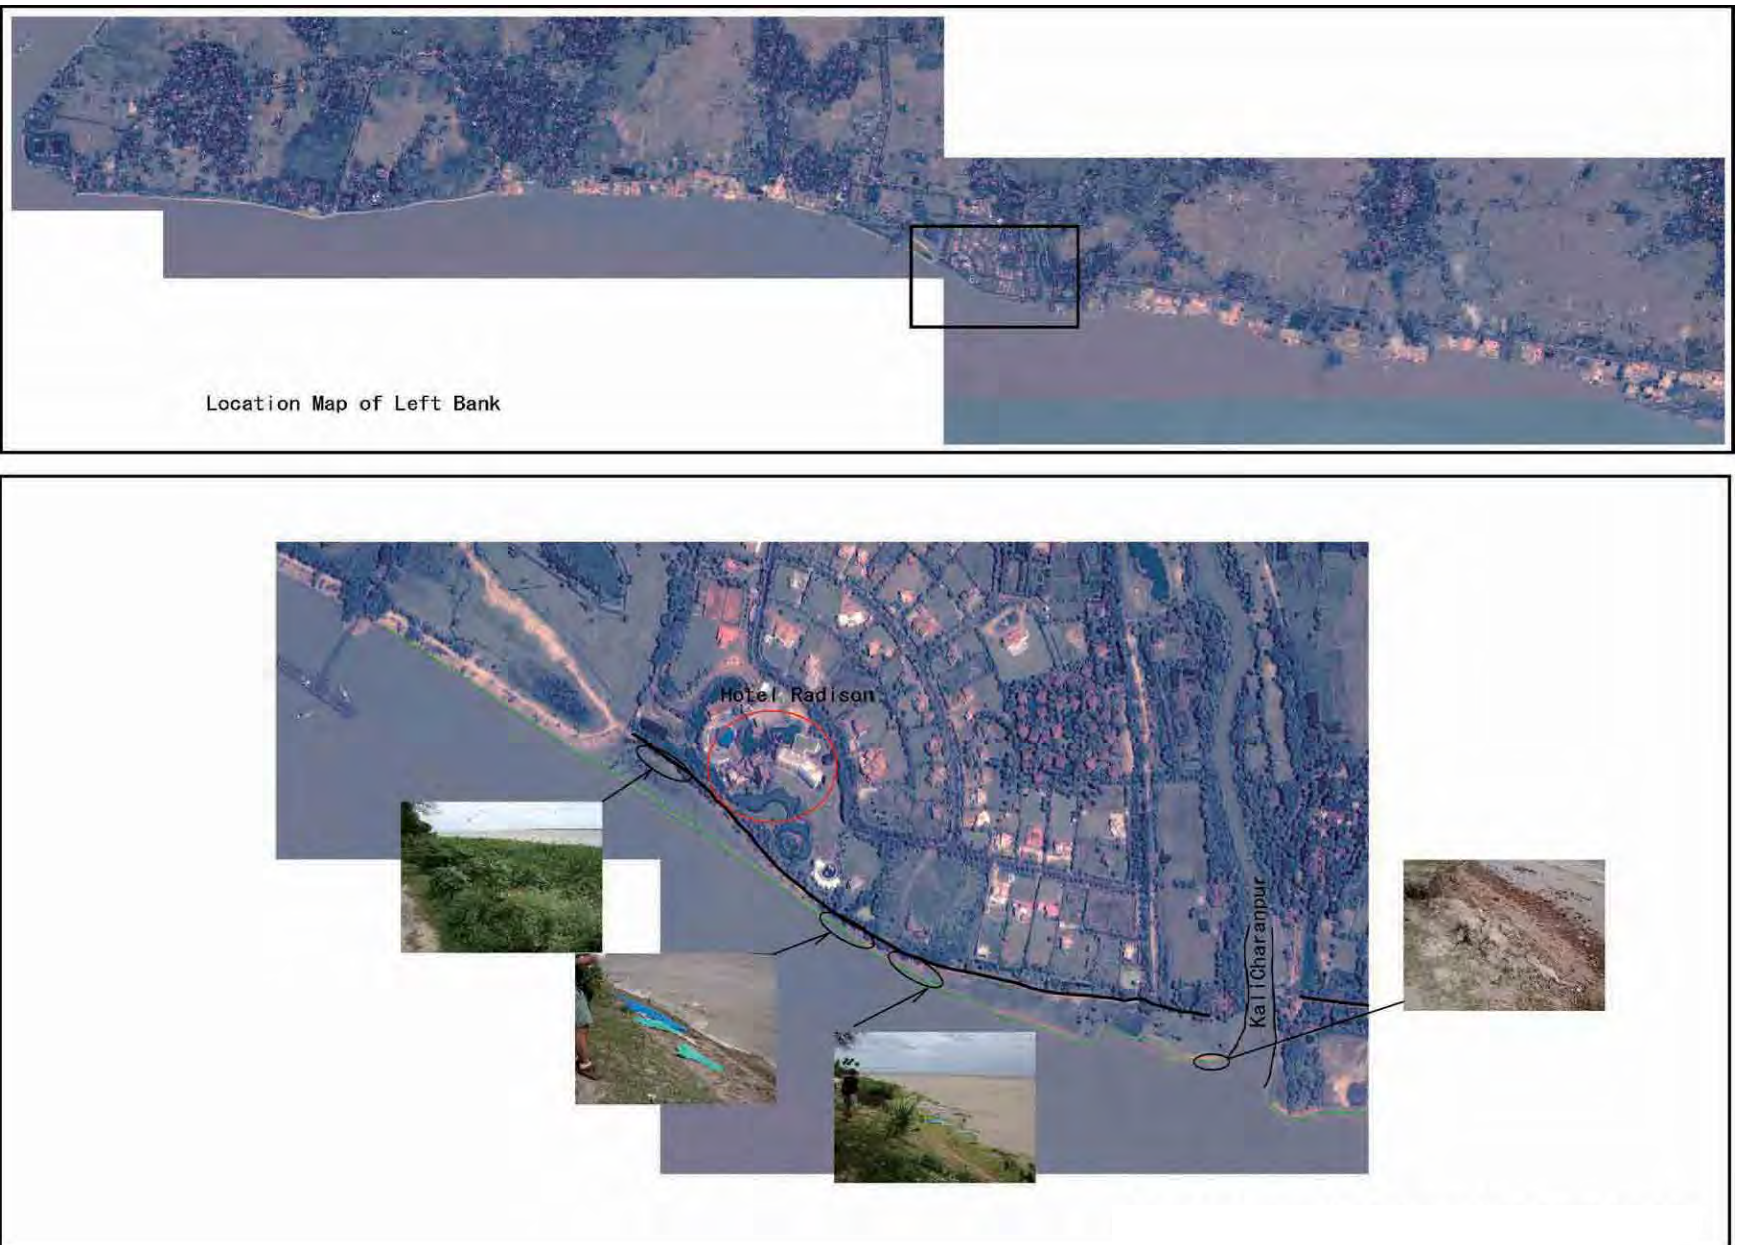
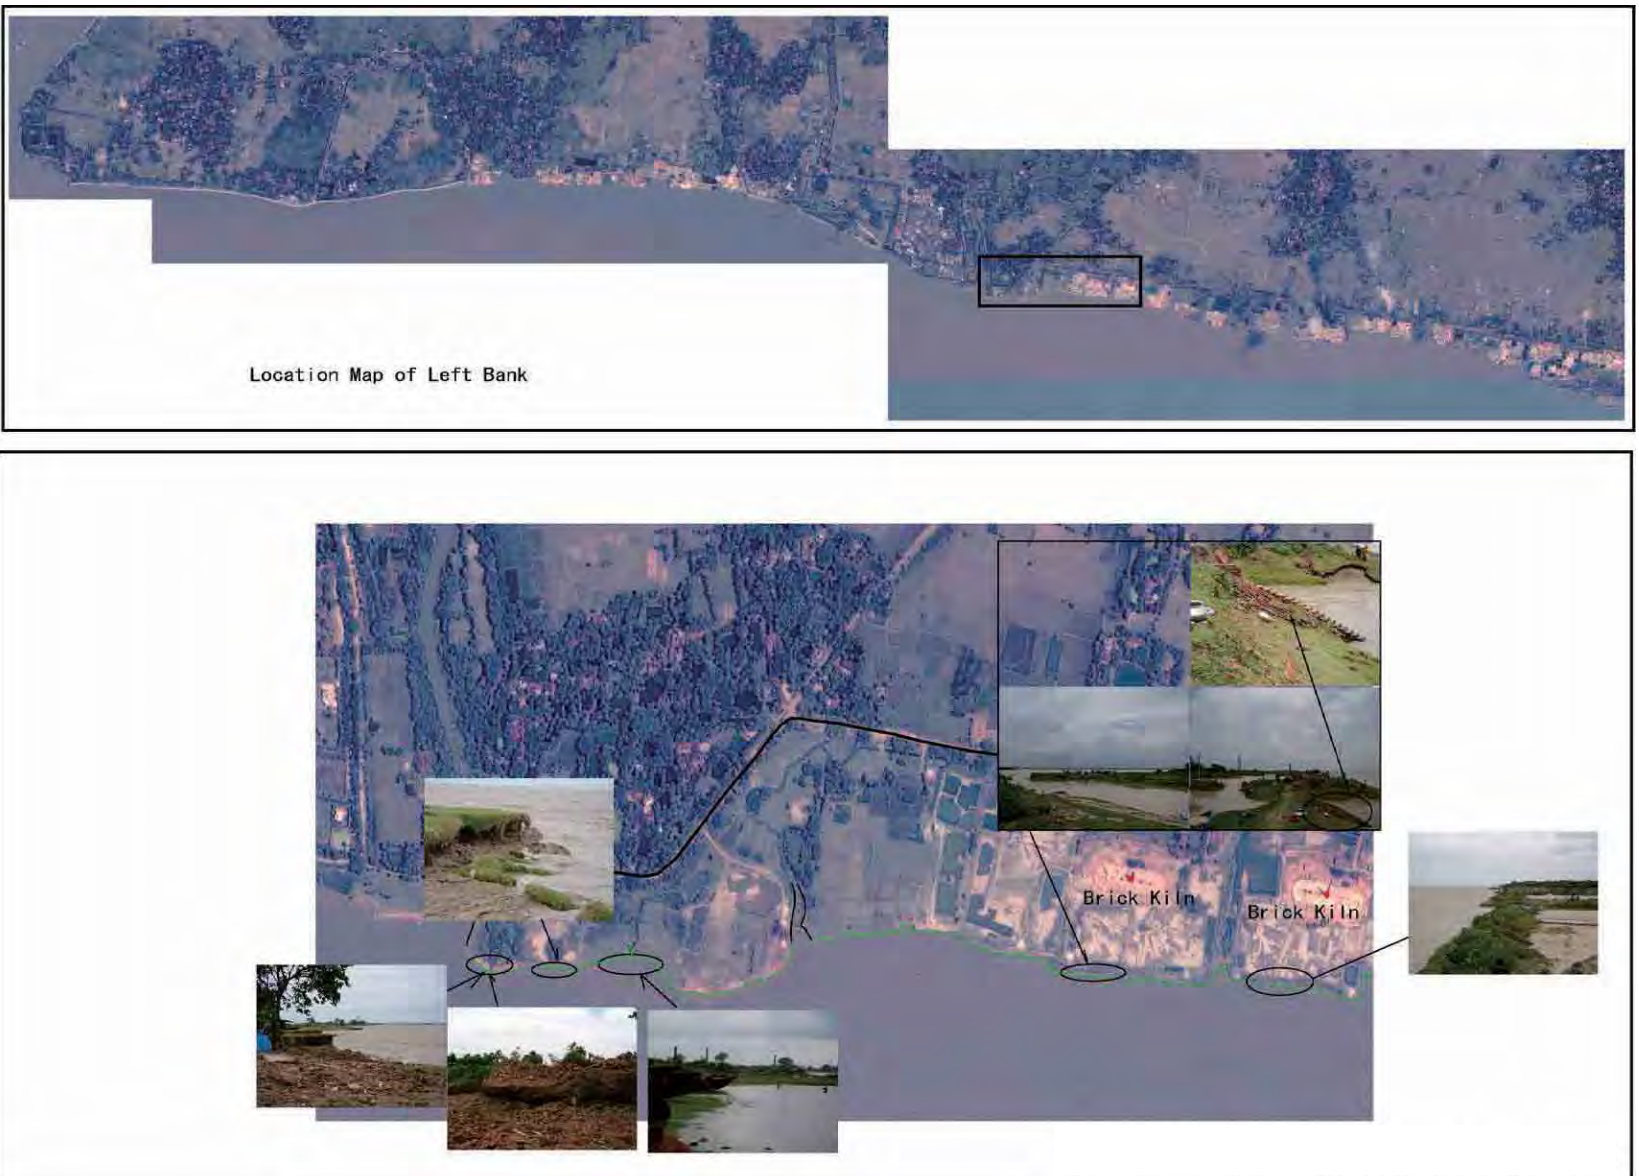
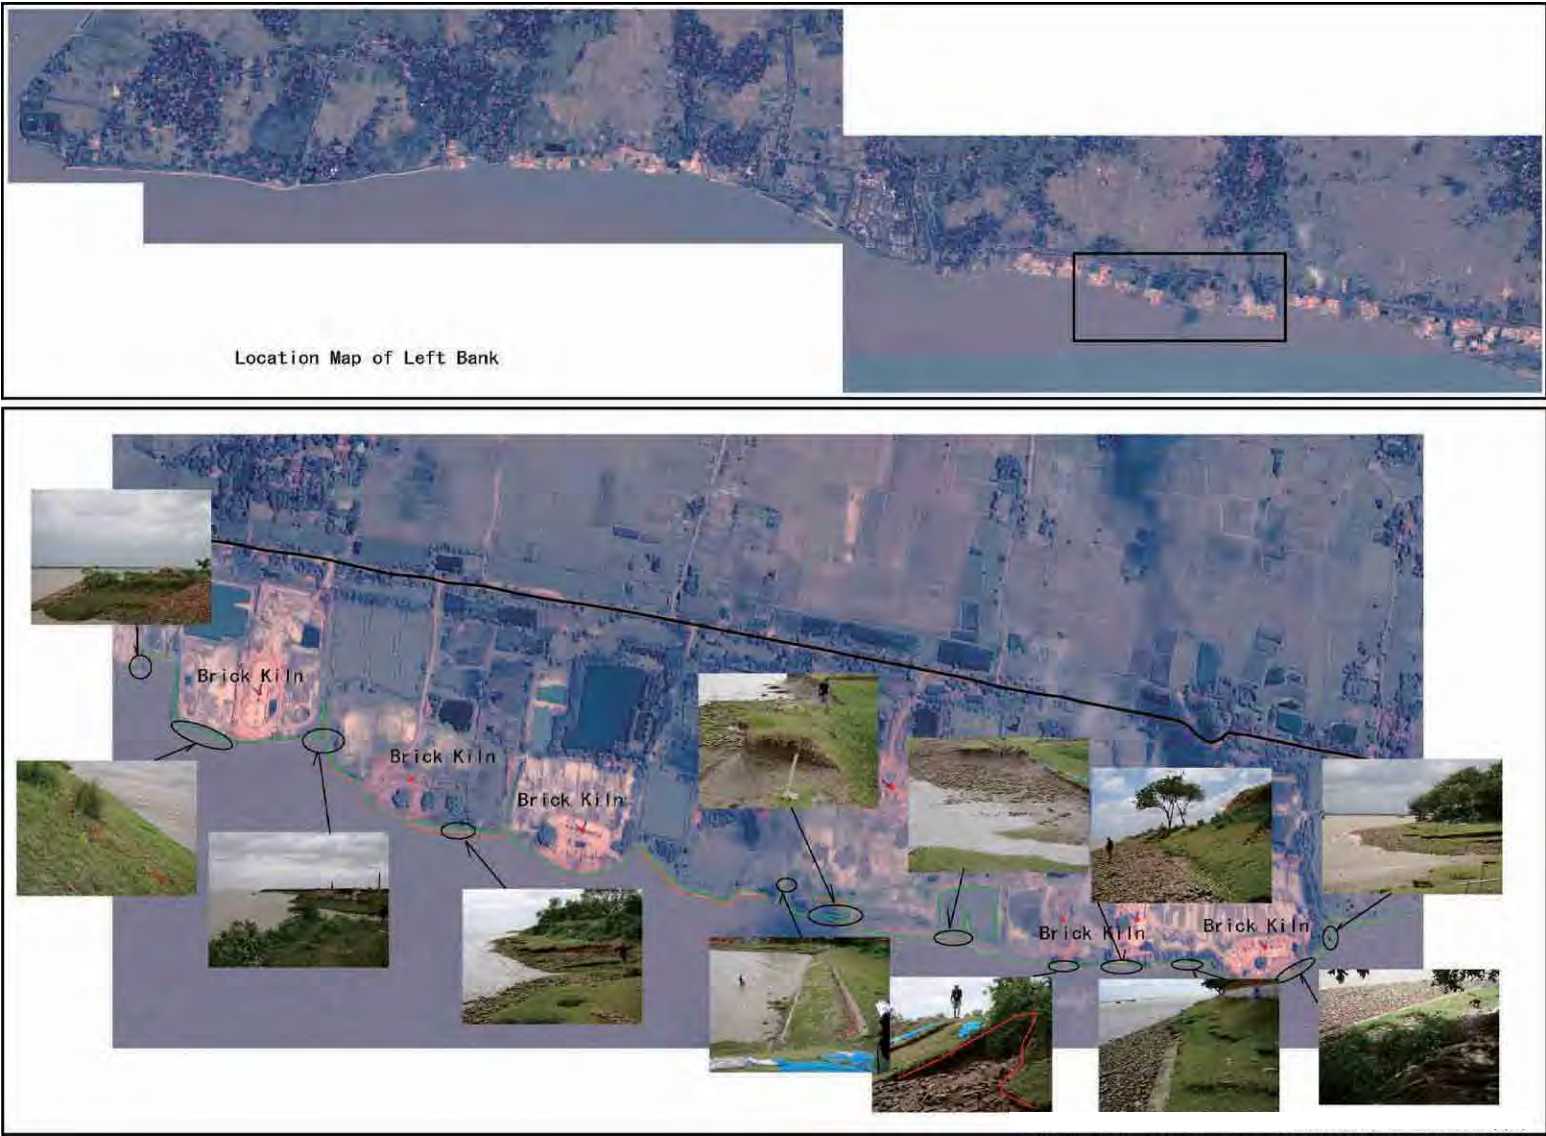
Figure 6.2.6 River Bank Protection Works at Left Bank (1/6)

b) Left bank (Raichak Side) (see Figure 6.2.6 (1)-(6))

There is riverbank protection by wet brick masonry and gabion mattress provides the foot protection. There is no collapse of the riverbank protection.

There are six (6) brick kilns in this area. The riverbank protection is brick masonry. However, in some parts of the protection has collapsed due to erosion. Bamboo fencing and sand bagging is provided near the sluiceway.

There are two (2) jetties and riverbank protection is provided by wet masonry. Sedimentation has occurred about 200m from Roy Chak ferry port, but there is no sedimentation in other locations. There are some temporary houses on the bank crest.

There is an upper-class residential area on the protected land. Access between this area and river is interrupted by a fence. The riverbank protection is constructed in brick masonry.

There is no protection for about 1.2km from the confluence. High river velocity and waves have caused severe erosion in this area. There are many brick kilns in this area with brick masonry bank protection. In some locations there is wave erosion and sedimentation.

Alternative	Alt-A	Alt-B	Alt-C	Alt-D
Evaluation	B	B	C	C
