Pavement Structure Designed for Traffic Volume

5.3 Traffic Characteristics

Chapter 6 Traffic Management and Safety

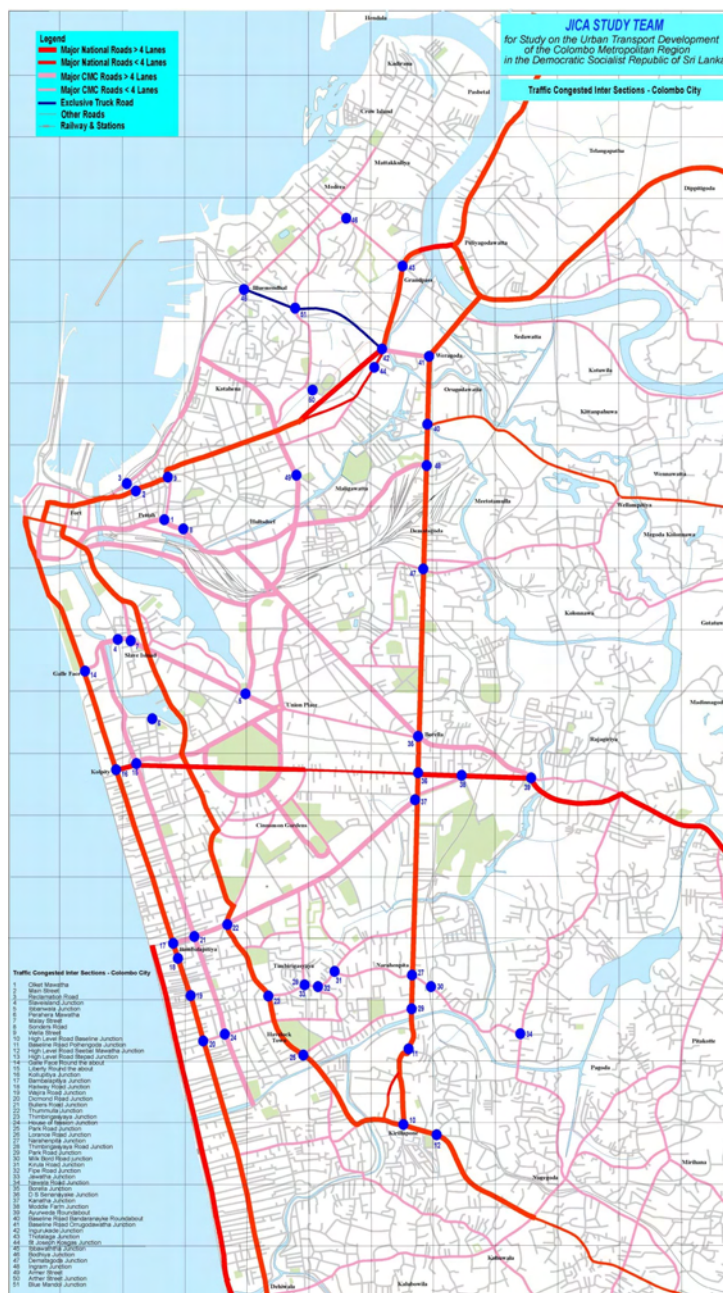
Figure 6.1 Congested Locations in Colombo

In comparison with other Asian capitals, Colombo is smaller in size and streets are less congested; however, traffic congestion is increasingly becoming a serious problem. This is partly due to the insufficient amount of roads and inappropriate traffic management. Congested locations were identified at the meetings of TMSWG. The identified congested locations inside Colombo are shown in Figures 6.1, with those outside Colombo in Figure 6.2. Not all of the congested intersections are where two primary roads meet; instead some congested roads are performing the functions of a primary road, while lacking the necessary design standards.

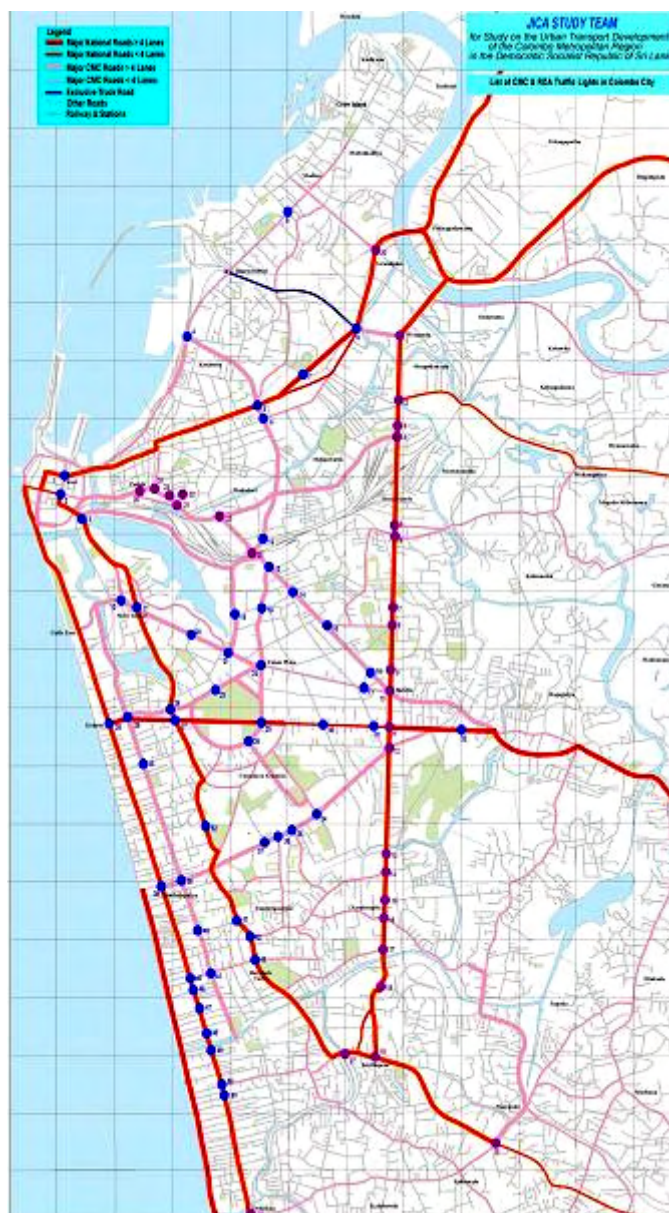
Figure 6.3 Existing Signals in Colombo and Vicinity

Traffic signals in Colombo are not consistent in engineering standards, which is the result of piecemeal approach that has lacked systematic consideration and a long-term vision. Two agencies, the Road Development Authority (RDA), a national government agency, and the Colombo Municipal Council (CMC), a local government, are tasked with designing, installing, and operating signals in the study area. Signals managed by two agencies are shown in Figure 6.3 and list of signals is given in Appendix 9.

As shown in the figure, RDA manages signals along Baseline Road and Olcott Mawatha in Colombo. All other signals are managed by CMC. According to the two agencies, the signals on Baseline Road and Olcott Mawatha were supposed to be transferred to CMC, but since they are not in a good condition, CMC does not want to accept them. RDA accepts this as valid and they are trying to improve the operation of these signals with better signal timing plans, but no definite deadline has been set.
