Chapter 5

WATER QUALITY IN THE LAKE
BILLINGS AND RIO GRANDE ARM

5.1 Situation of Water Quality Based on the Previous Studies

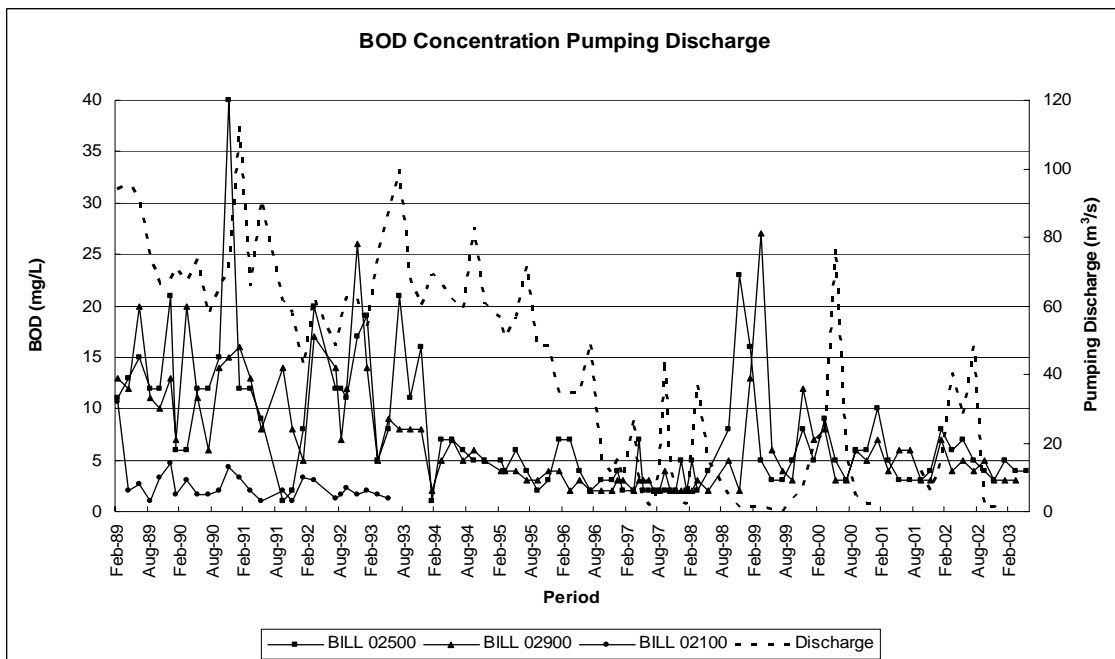
Figure 5.1.3 Secular Changes in Water Quality (BOD) of the Lake Billings (Relationship between Lake Water and Pumping Discharge from Pedreira)

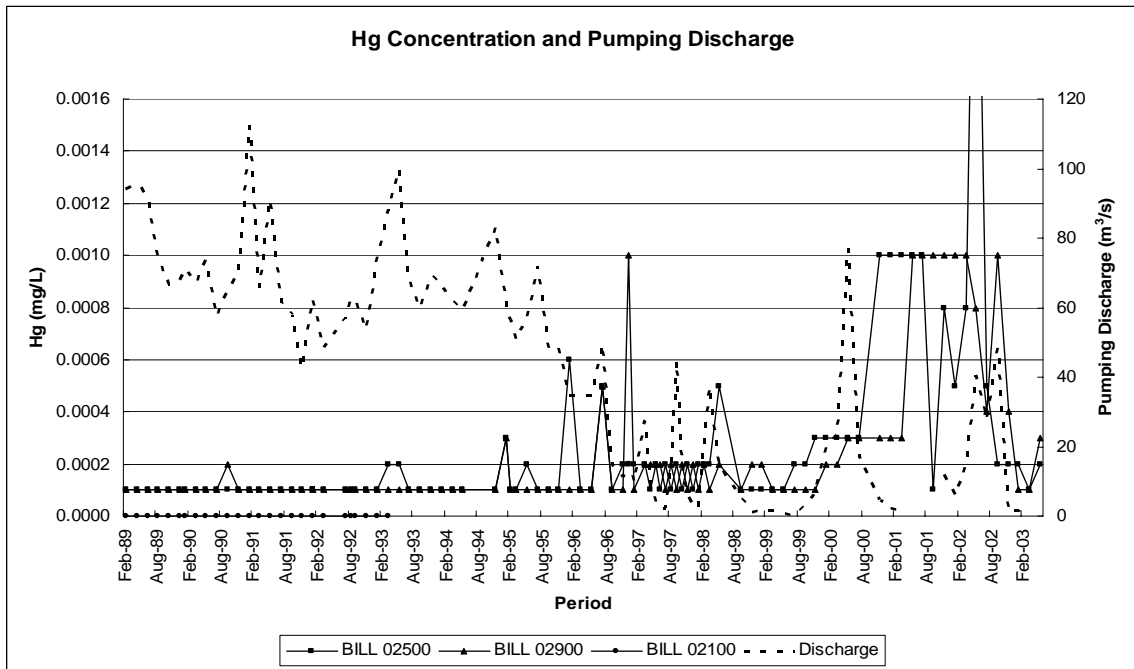
**Figure 5.1.5 Secular Changes in Water Quality (Hg) of Lake Billings
(Relationship between Lake Water and Pump Discharge from Pedreira)**

However, heavy metals such as Hg, Mn and Fe, after showing a tendency toward improvement, are deteriorating. This is considered to be the result of elution from bottom sludge accumulated in the lake.

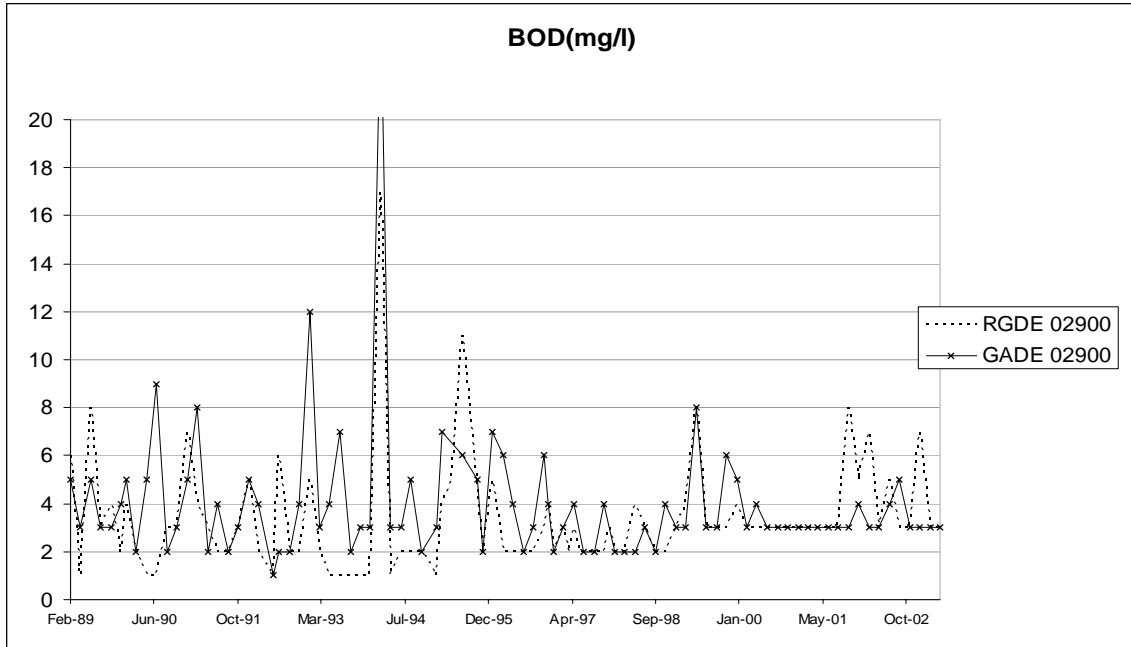
Figure 5.1.6 Secular Changes in Water Quality (BOD) of Lake Rio Grande Arm

Figures 5.1.6 to 5.1.8 show the secular changes in water quality of Lake Rio Grande Arm for each of the water quality items (BOD, NH₄ and Chlorophyll-a). As far as these figures are concerned, TN, TP and Chlorophyll-a have an upward trend, showing the gradual advance of eutrophication.

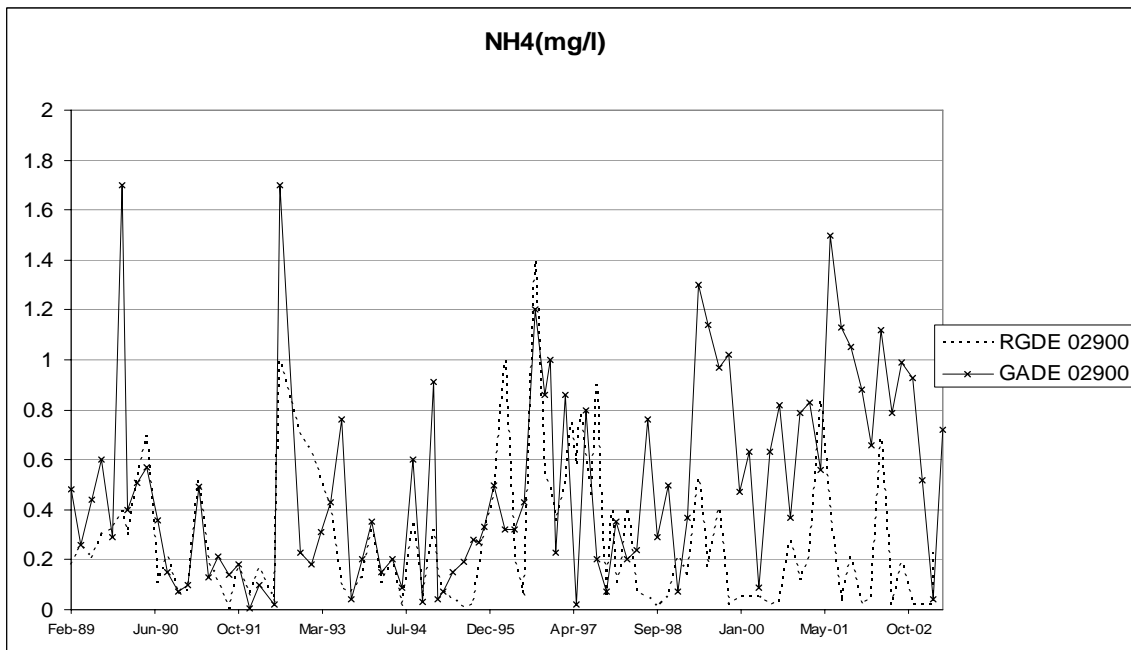
Figure 5.1.7 Secular Changes in Water Quality (NH₄) of Lake Rio Grande Arm

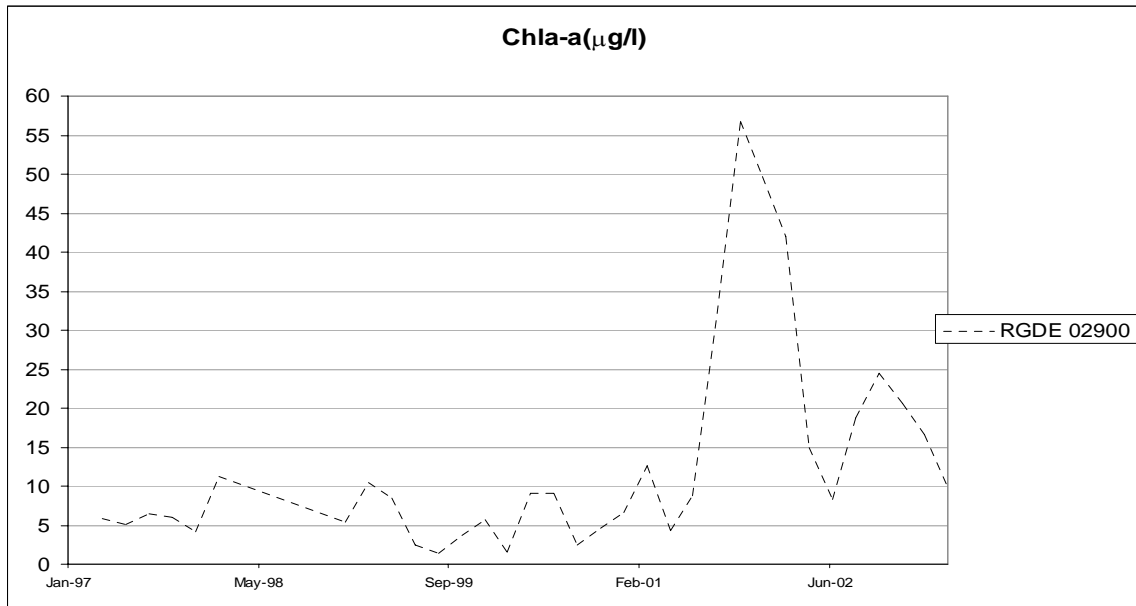
Figure 5.1.8 Secular Changes in Water Quality (Chlorophyll-a) of Lake Rio Grande Arm

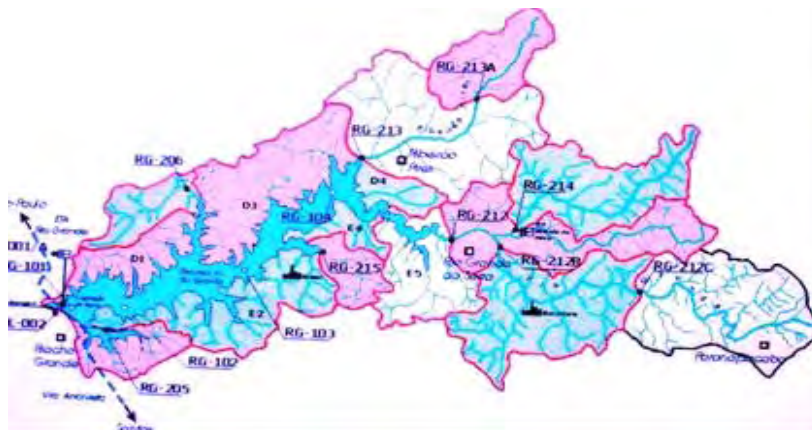
Figure 5.1.9 Sampling Point by SABESP in Rio Grande Arm

SABESP monitors the conditions of algae generation in Rio Grande Arm regularly because the algae sometimes causes odor problems. SABESP is taking much effort to control algae-generation because algae-generation fluctuates very much by year. Rio Grande Arm is divided into four areas for monitoring and water sampling is done at RG101, RG102, RG103 and RG104 as presented in **Figure 5.1.9**.

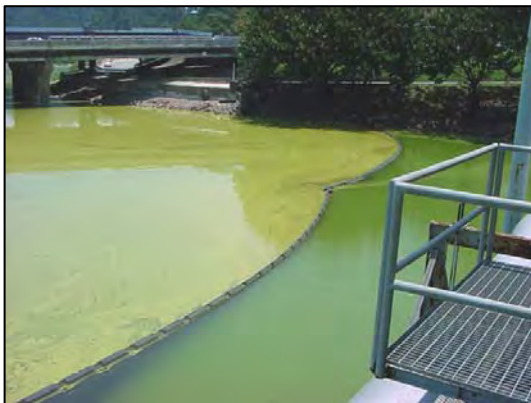
Photo 5.1.1 Water Bloom near Intake Point in 2001

When the water level became down to 50 % of ordinal year in 2001-2002, water bloom increased explosively at the intake point. In that time the fence was installed to stop entering of water bloom. The water level in 2005 is 85% of ordinal year.

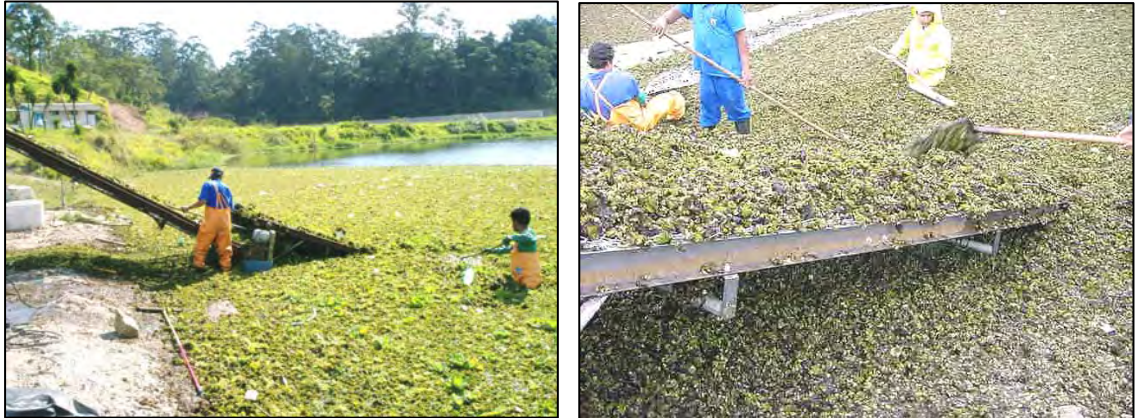
Photo 5.1.2 Removal Macrofitas

Plant-Generation in the Arm is not correlative with water and atmospheric temperature but the water level. The lower water level become, the more aquatic plant generates. This correlation may result from high nutrient concentration of the Arm in low water level. Aquatic plant in Arm is called Macrofitas as generic name. The dominant aquatic species are Salvinia and Pistia. Water Hyacinth is also seen partly.

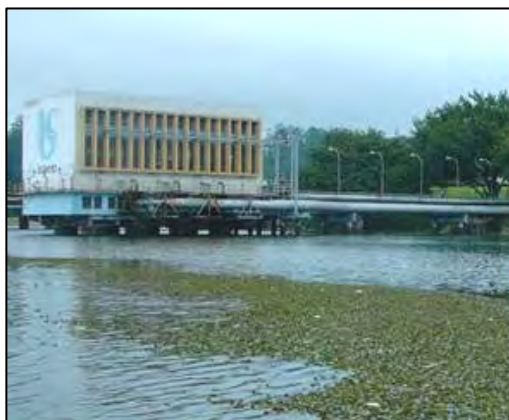
Photo 5.1.3 Aquatic Plant around Intake P/S

The following pictures taken in September 2005 show aquatic plants near the intake point and the belt conveyor. Amount of aquatic plants looks not so much. According to the interview to the staff of SABESP, aquatic plants decrease from September then disappear in October because of water level raise due to starting rainy season.

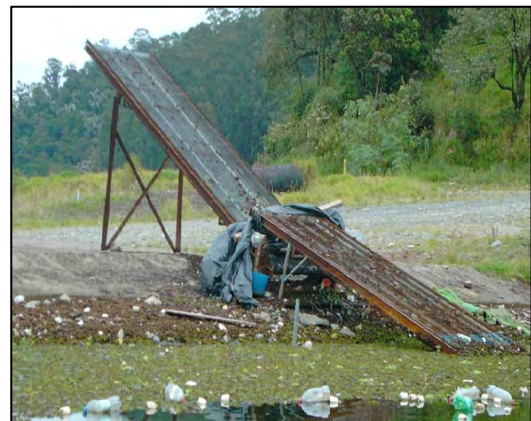
Photo 5.1.4 Belt Conveyor for Removal of Aquatic Plant

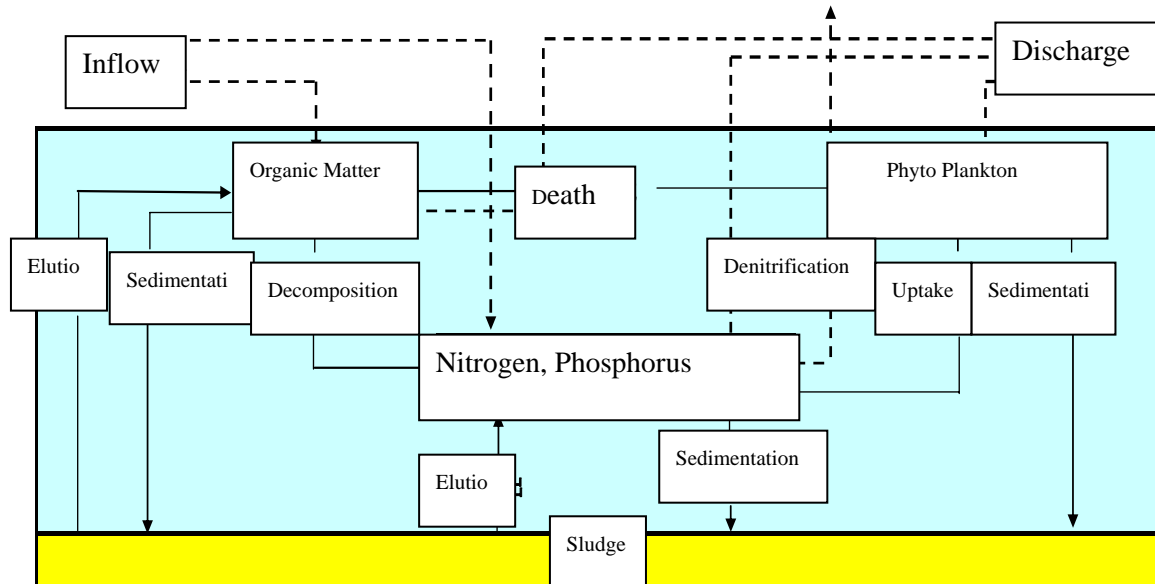
Figure 5.2.1 Mass circulation by inflow, internal production, sedimentation, elution and discharge in a lake

city area. Internal production which is the organic matter production by phytoplankton must be taken up as another contamination. It is reported by the latest research that there are some type of water body in which the organic matter by internal production reaches 50 % of all the organic matters generated in the water during a summer.

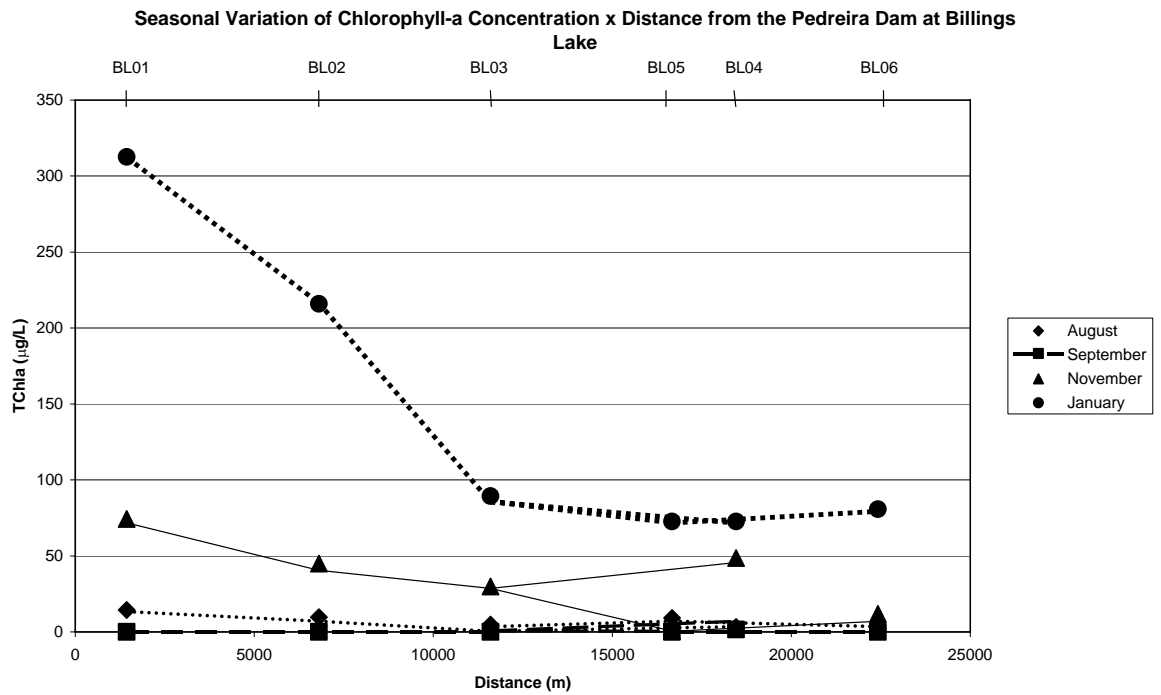
Figure 5.3.3 (2) Horizontal variation of water quality (TN,Chlo-a) along the river drifts at the Billings Lake

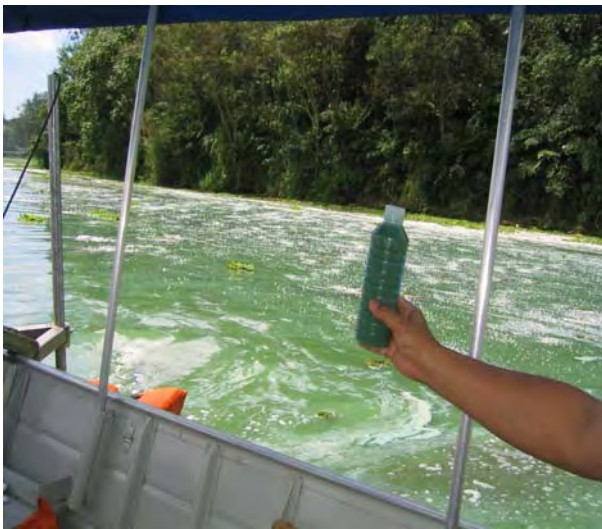
Mechanism of occurrence of Algae Bloom
In the lake with water of a high level of eutrophication, when the water temperature rises under sunny weather, the population of phytoplankton is activated to multiply abnormally, taking up nitrogen and phosphorus as nutrients. While the plankton population remains small, the lake surface looks as if green watercolor paint has been mixed, which will turn foul and emit offensive odors when the population becomes large. This phenomenon is called Algae Bloom. As the species constituting Algae Bloom, those of the genus of blue-green algae *Myrostris* are indicated in the narrow sense. Generally speaking, however, they include other blue-green algae belonging to genera *Anabaena* and *Aphanizomenon* as well.

(January 14, 2006, at the monitoring point RGDE-3)

In order to identify the degree of eutrophication in Lake Rio Grande Arm, the relationship between TN-TP is shown in **Figure 5.3.10** (for reference, the data of water quality collected from principal lakes in Japan are also included). Compared to Lake Billings, in Lake Rio Grande Arm the process of eutrophication is apparently less advanced. However, at the monitoring point RGDE-3, downstream of the outlet of Rio Grande, the water quality in terms of indices is in such a condition as to cause the occurrences of Algal bloom with a high probability. As a matter of fact, at the time of the water depth measurement on 14th January, 2006, the occurrence of a large quantity of Algal bloom was confirmed at the outlet of Rio Grande.

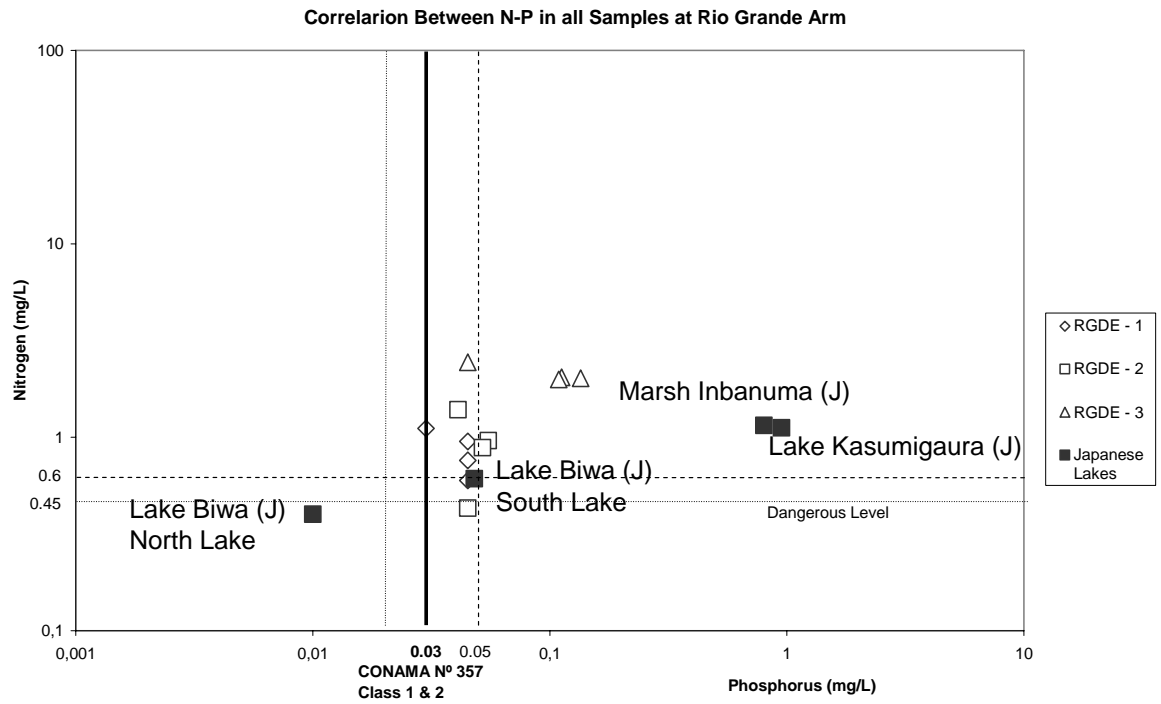
Figure 5.3.10 Relationship between parameters (T-N vs. T-P and F-Coli vs. BOD) at Rio Grande Arm

For reference, regarding the degree of pollution due to organic matters, the BOD-F-Coli relationship is shown in **Figure 5.3.10**.

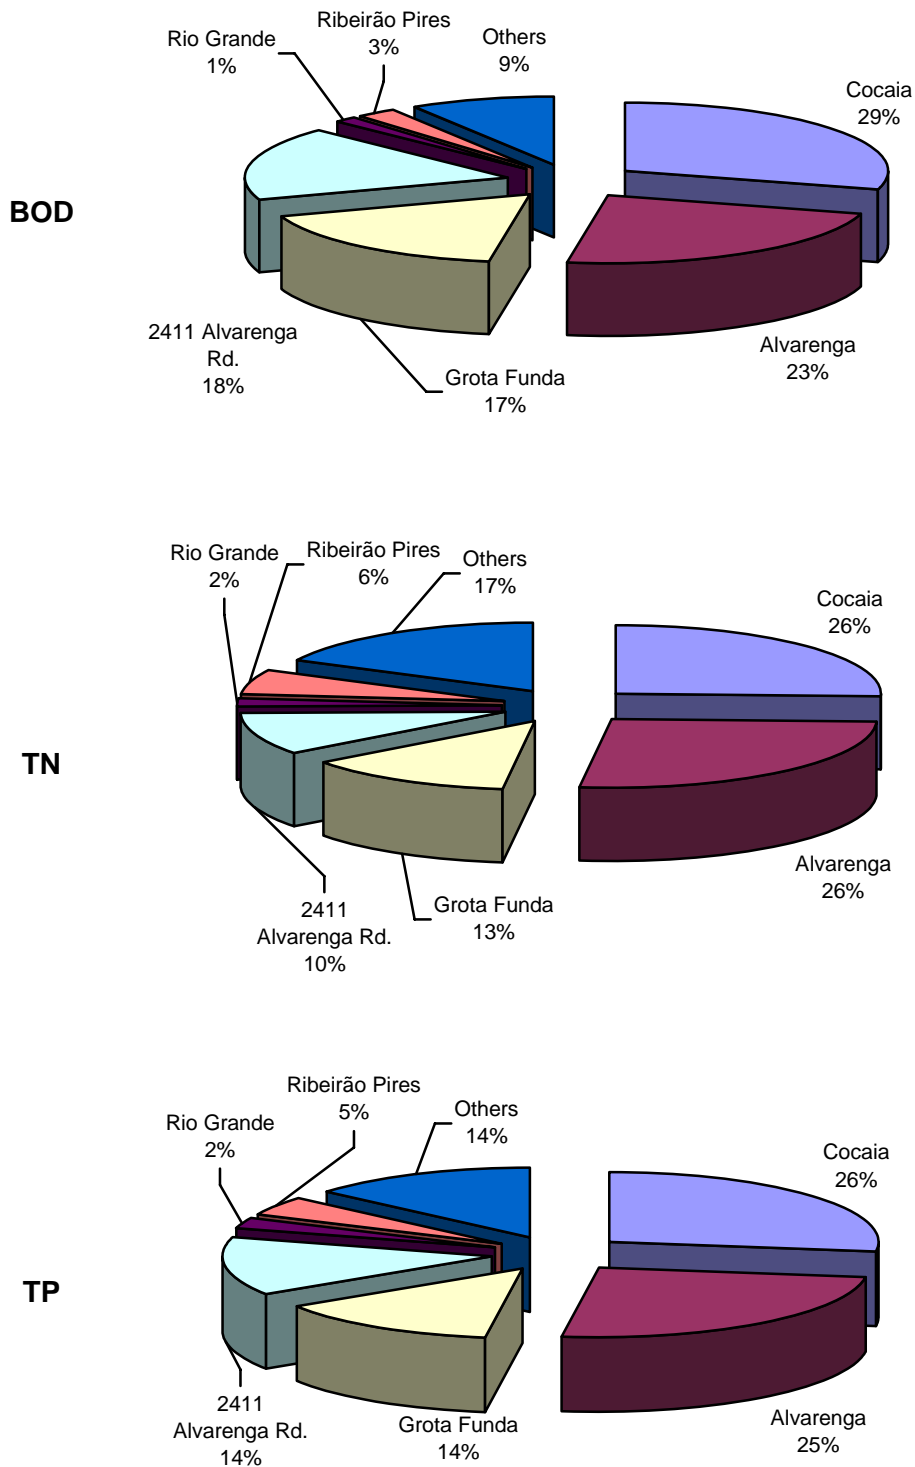
Figure 5.3.13 Proportion of contribution by river in runoff load (BOD, T-N, T-P) during dry season

- Among the 20 rivers flowing into the lakes, those which contributed a large share in the total influx were 4 rivers, R-1 Cocaia, R-13 Alvarenga, R-15 Grota Funda, and R-16 2411 Alvarenga which made up 86 % of the total BOD load of pollutants. Besides, the contribution rates of these rivers in the load in terms of TN and TP were 75 % and 79 %, respectively. Moreover, contribution rates of these 4 rivers in the pollutant load during the rainy season were 67 % for BOD, 61 % for TN, and 71 % for TP respectively, representing substantial proportions similar to those in the dry season. The proportion shared by 2 rivers, Rio Grande and Ribeirao Pires, which contributed relatively small fractions of the total load during the dry season, constituted a significant part during the rainy season, by contributing 17 % of BOD load, 25 % of TN load, and 13 % of TP load.

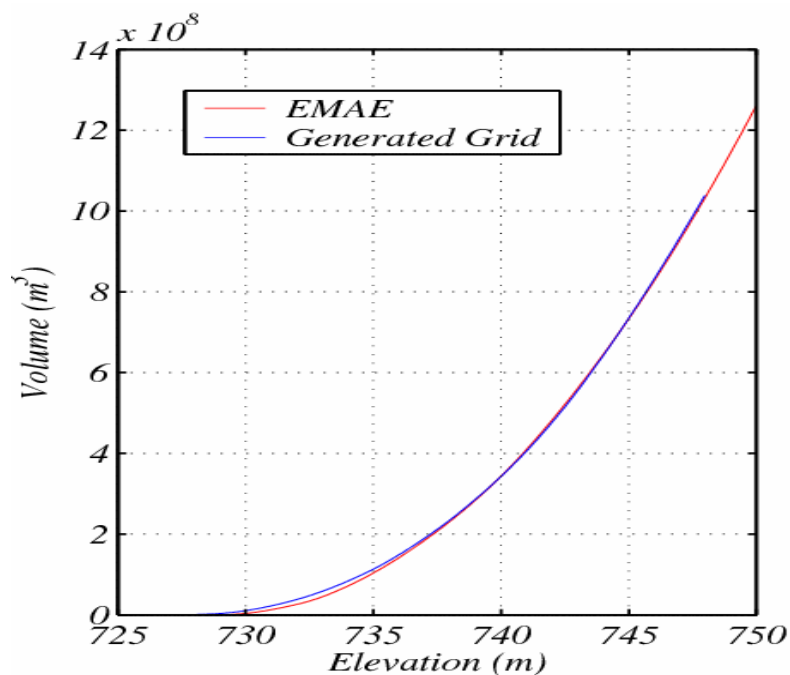
Figure 5.3.15 H-V Curve of EMAE

As regards the Lake Billing, EMAE, the administrative agency of the reservoir, prepared a chart of depth sounding in 1984-85. Furthermore, the agency recently carried out a project of sounding and compiled a new depth chart in 2004. In our study, we relied on these 2 sets of data to estimate the quantity of sediment soil by superimposing one over the other.

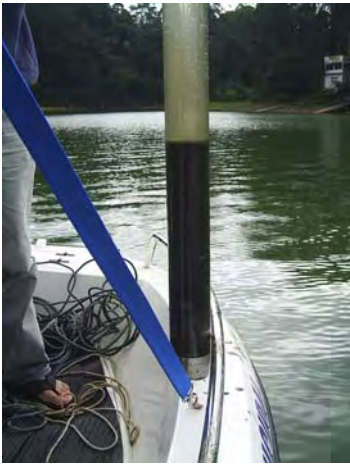
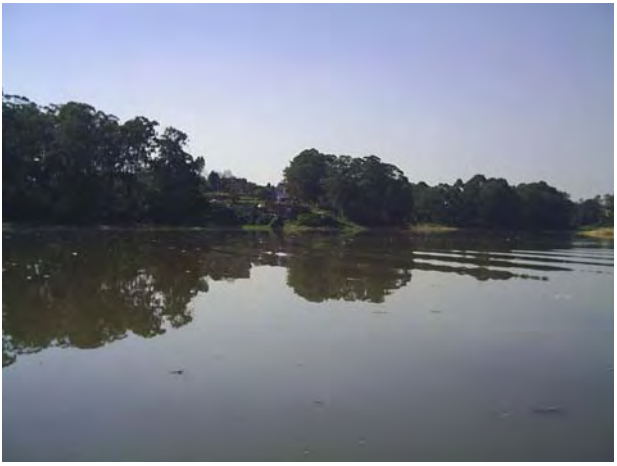
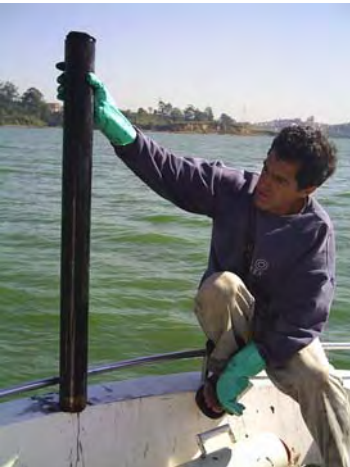
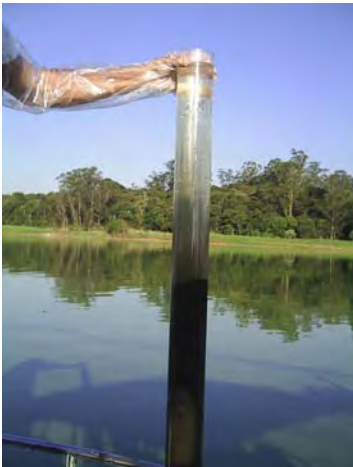
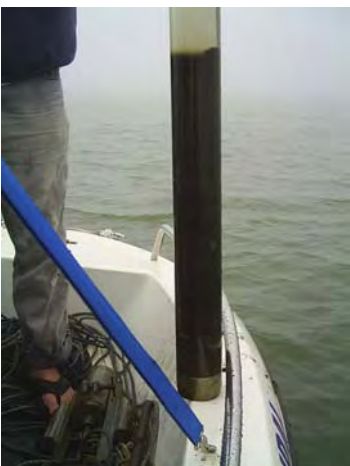
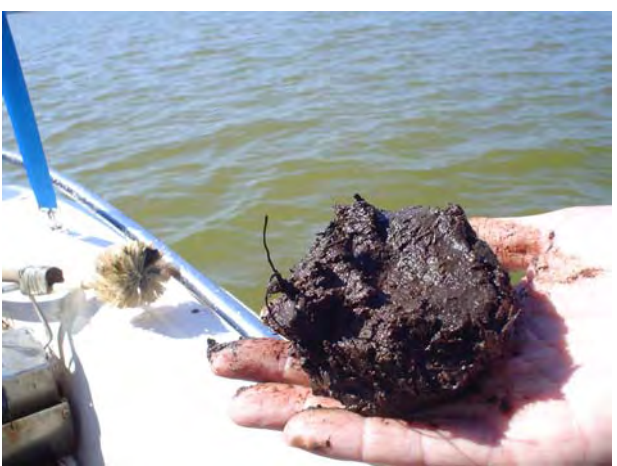
Photo 5.3.1 Sludge Thickness Survey in the arms of the Lake Billings

The JICA Study Team conducted the situational survey on depth and quality of sediment in cooperation with Prof. Antonio A. Mozeto of San Carlos University. Locations of sampling were in the Central Channel, downstream of the Rio Grande River, and Arms of Alvarenga, Taquacetuba, Capivari and Rio Pequeno for three days starting from November 11, 2006, using acryl columnar sludge sampler (see **Figure 5.3.16** and **Photo 5.3.1**) Volume of sediment was estimated based on the results of measurement, as shown in **Figure 5.3.17**. Accordingly, it was 47 million m³ in the Lake Billings and 5 million m³ in the Rio Grande Arm with average thicknesses of 51cm and 34 cm, respectively.

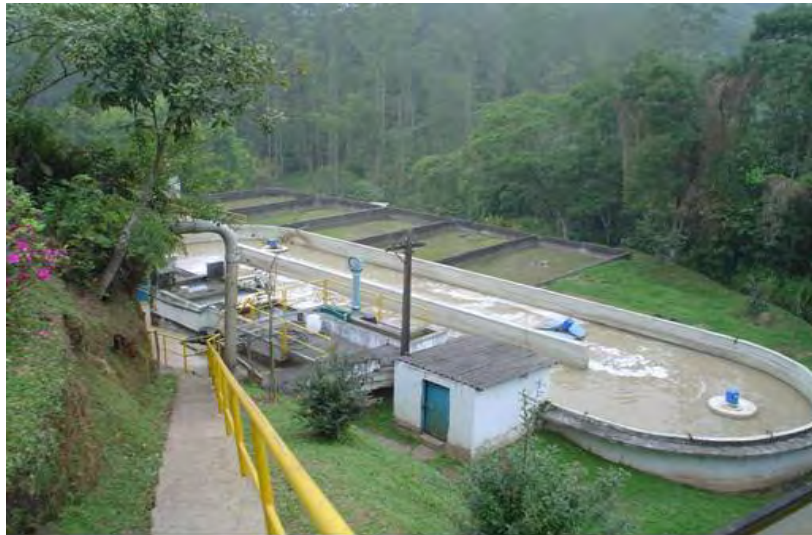
Photo 6.4.1 OD operation status of the Yakult factory

Waste water treatment facilities were installed to treat wastewater and the attitude to maintain the facility right was shown. Moreover, three of eight companies interviewed were not discharging effluent to outside. For example, in Yakult, spray irrigation has been carried out to neighboring woods by the automatic sprinkler. This is based on instruction of CETESB.

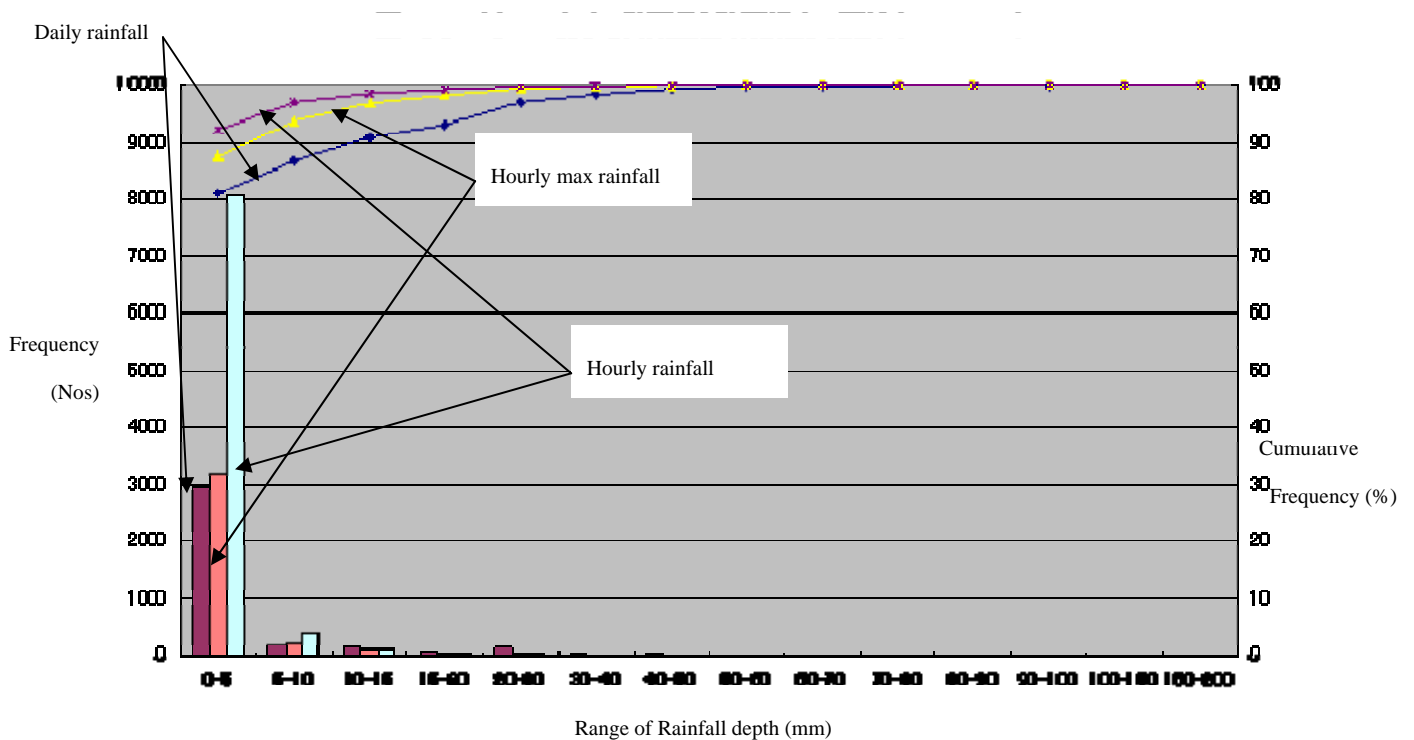
Figure 6.9.1 Rainfall frequency distribution of meteorological observatory in Sao Paulo University

Rainfall frequency distribution of the same data is analyzed as follows.
